Sonnax Solutions for Toyota U140E/F, U240E & U241E

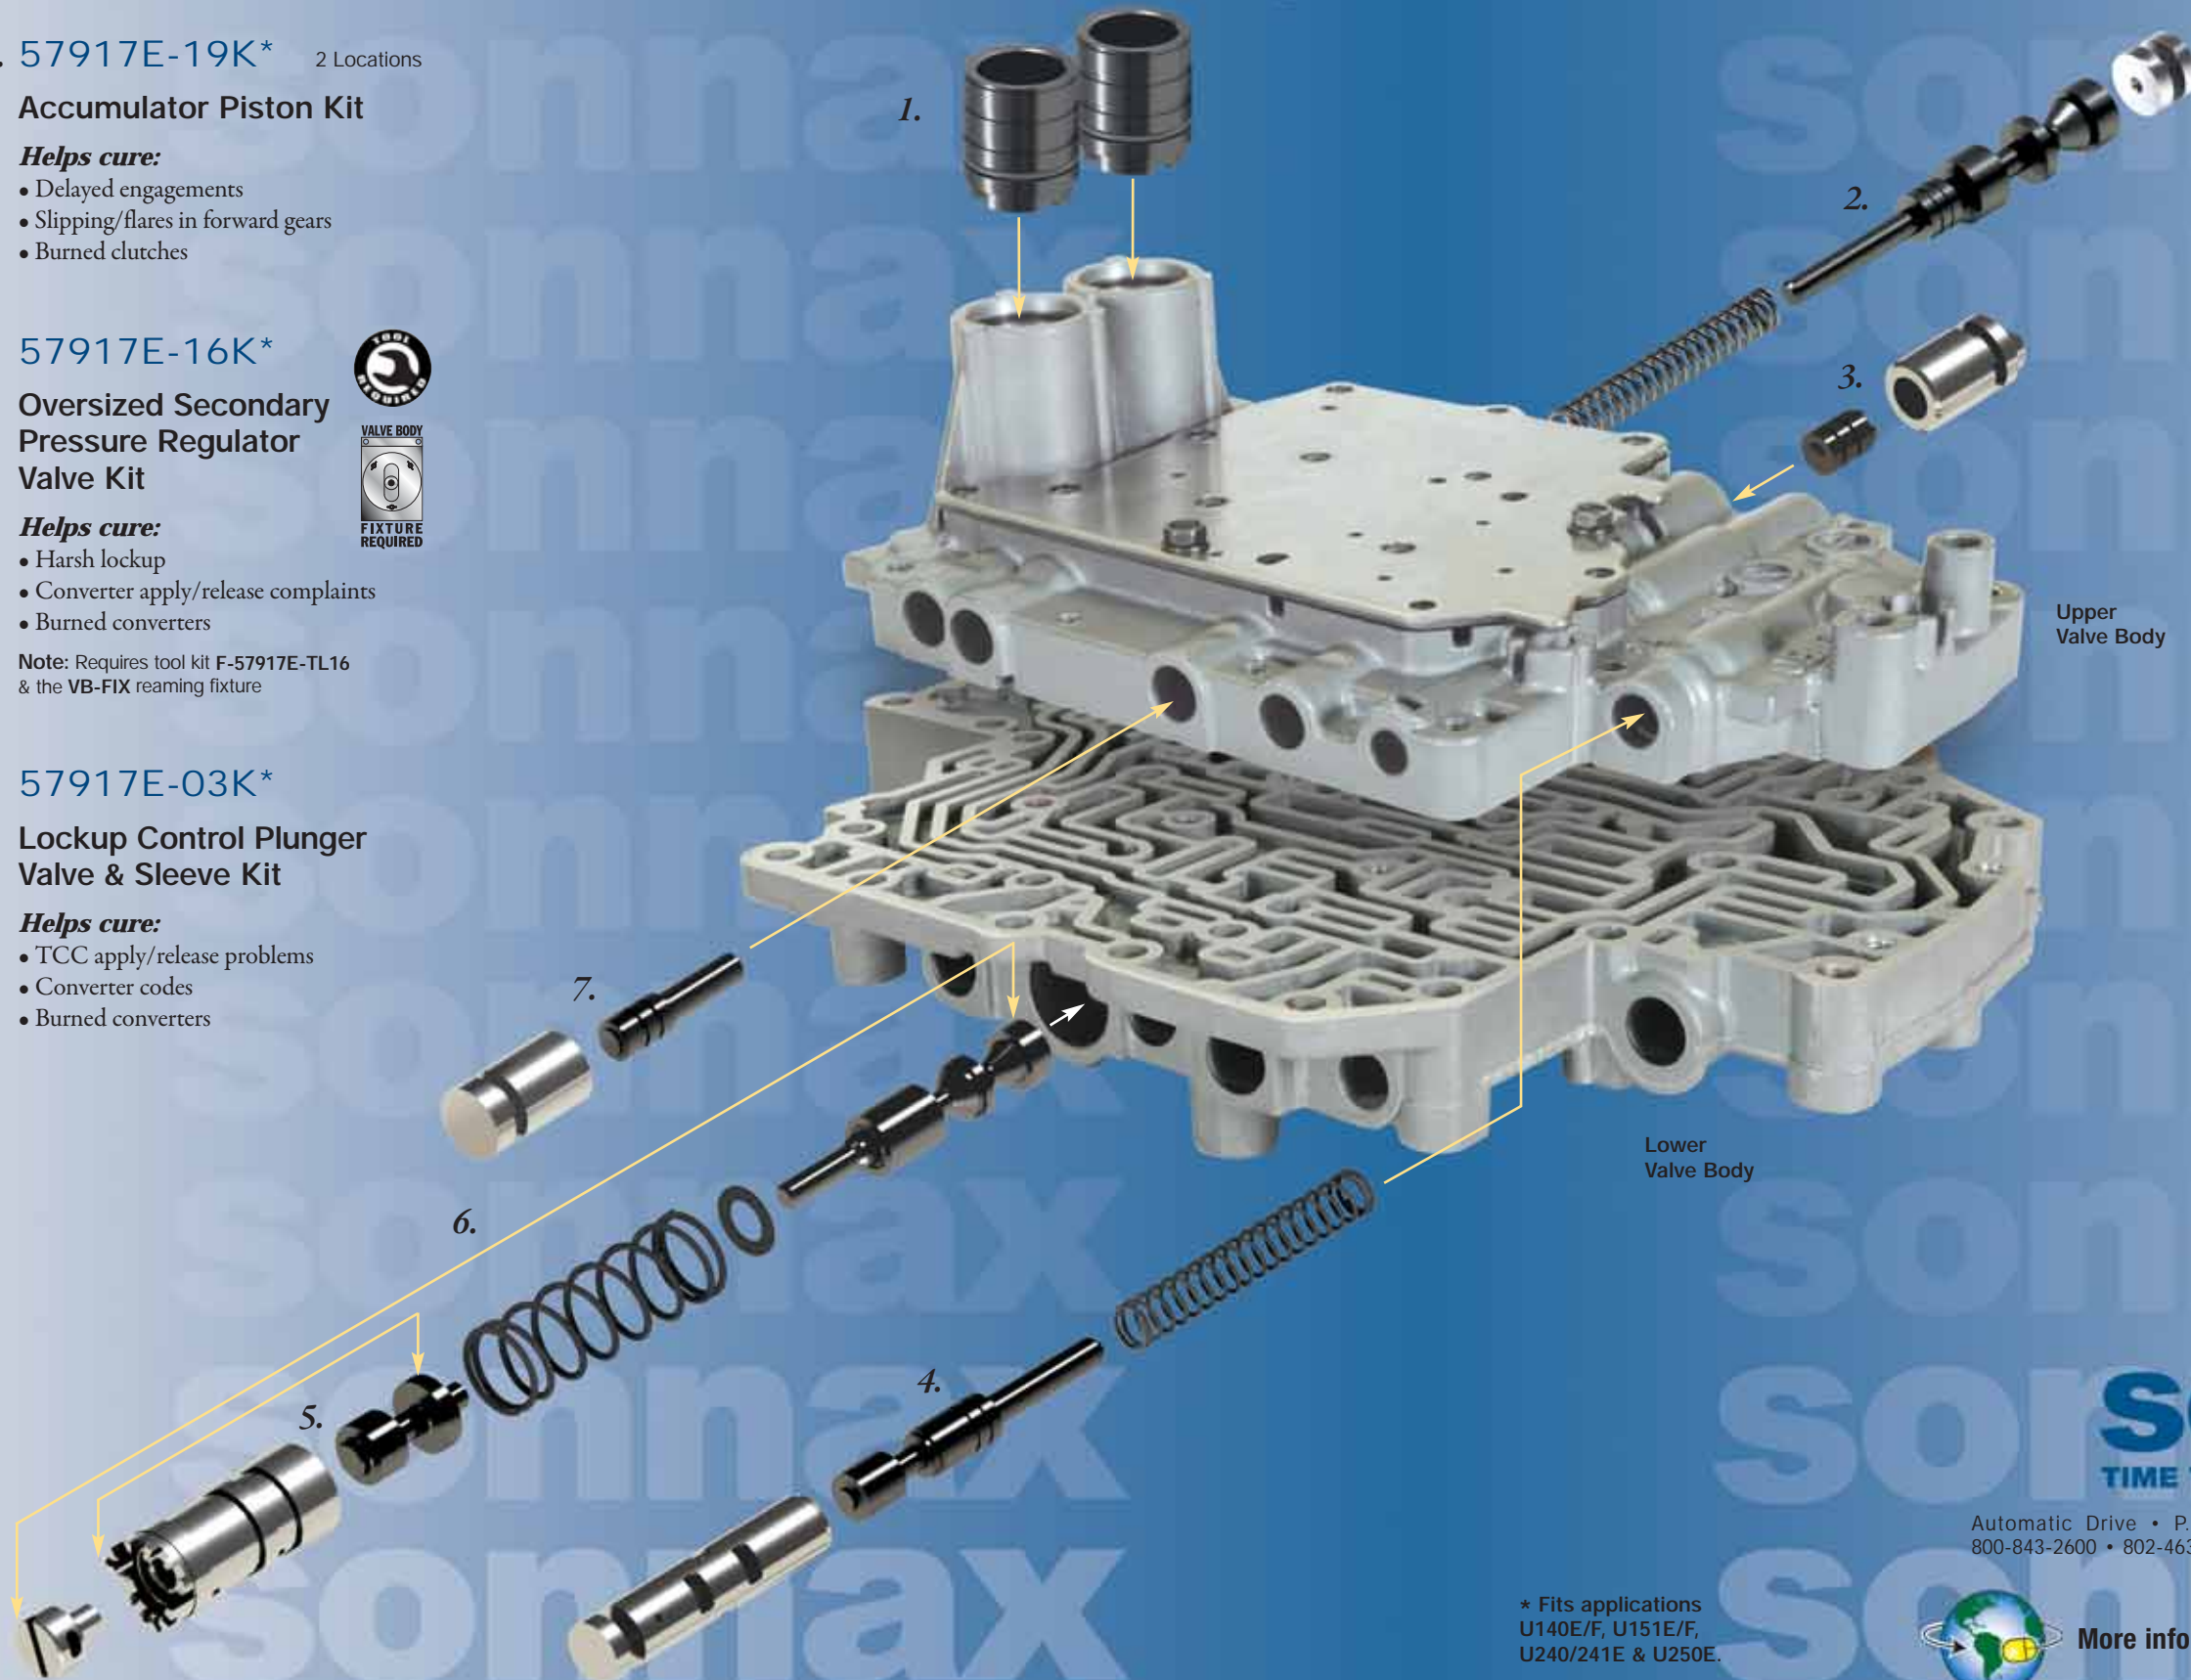
1. 57917E-19K* 2 Locations

Accumulator Piston Kit

- Delayed engagements
- Slipping/flares in forward gears
- Burned clutches

2. 57917E-16K*

Oversized Secondary Pressure Regulator Valve Kit

- Harsh lockup
- Converter apply/release complaints
- Burned converters

3. 57917E-03K*

Lockup Control Plunger Valve & Sleeve Kit

- TCC apply/release problems
- Converter codes
- Burned converters

4. 57917E-13K

Solenoid Modulator Valve Kit

- Harsh/Flare upshifts
- TCC slip or RPM cycling
- Lower cooler flow

5. 57917E-01K

Boost Valve Assembly

- Insufficient line rise in drive ranges
- Higher-than-normal reverse pressures
- Soft shifts

6. 57917E-08K

Oversized Pressure Regulator & Boost Valve Kit

- Low/high line pressure
- Soft and/or harsh shifts
- Clutch and band failures

7. 57917E-05K

Clutch Apply Control Plunger Valve & Sleeve Kit

- Clutch failure
- Burned clutches
- Shift complaints
