Article No.: EL_TC Tip_07-06

Author: Ed Lee

A different fix for an old problem

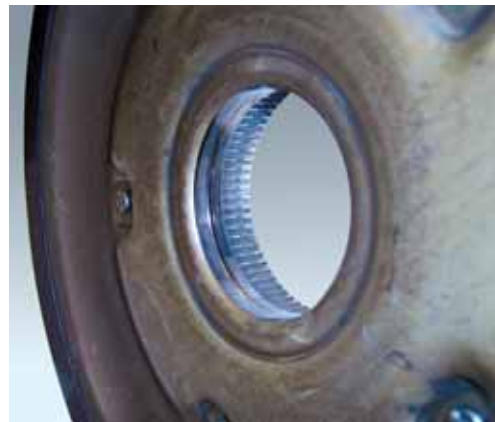
The E4OD piston in Figure 1 is a good example of bore wear. Machining the piston and installing a replacement sleeve is the current industry fix. This method works well and most replacement sleeves are harder than the original bore, for longer life.

The area of the piston bore that is the sealing surface seldom shows any wear because it is not used for centering. Of course, the rest of the bore will wear faster due to the small surface area remaining.

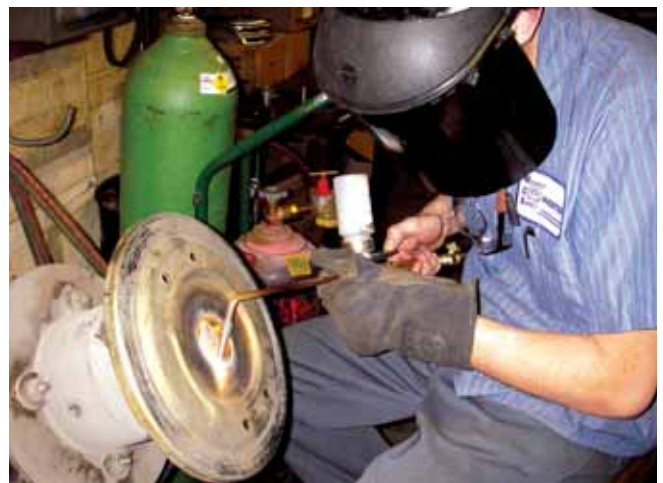
Dick Lewis of Midwest Converter Supply decided to address his bore problems at a different level. Dick's shop renews the bore surface by spray welding the original bore and then remachines the bore back to its original dimension (see Figure 2).

The torch operator shown in Figure 2 is using a "Stoody" jet spray torch (model No. JS-100, made by the Thermadyne Corp.). The media used for welding is held in the canister mounted on the torch. The type of welding media used controls the hardness of the finished weld. For this application media No. HSW25 was used, giving a finished hardness of 36 to 38 Rockwell – hard enough to extend the life expectancy of the part and still soft enough for machining to a good surface finish. The amount of the weld being applied is controlled by the lever on the torch below the welder's right thumb.

The piston is placed on to a standard welding turntable. A sleeve attached to the turntable centers the piston and also keeps any welding debris from getting into the damper assembly. The turntable is set at a 45-degree angle and the piston's own weight keeps it in position.

There are many different gas combinations that will work with this torch, but the oxygen/acetylene combination being used in this instance seems to work best. The welding process takes about four to five minutes from start to finish.
