Mustafa Saribudak* and Nico Hauwert**

Where is all the groundwater flow coming from into the Barton Springs Pool? A geophysical case study

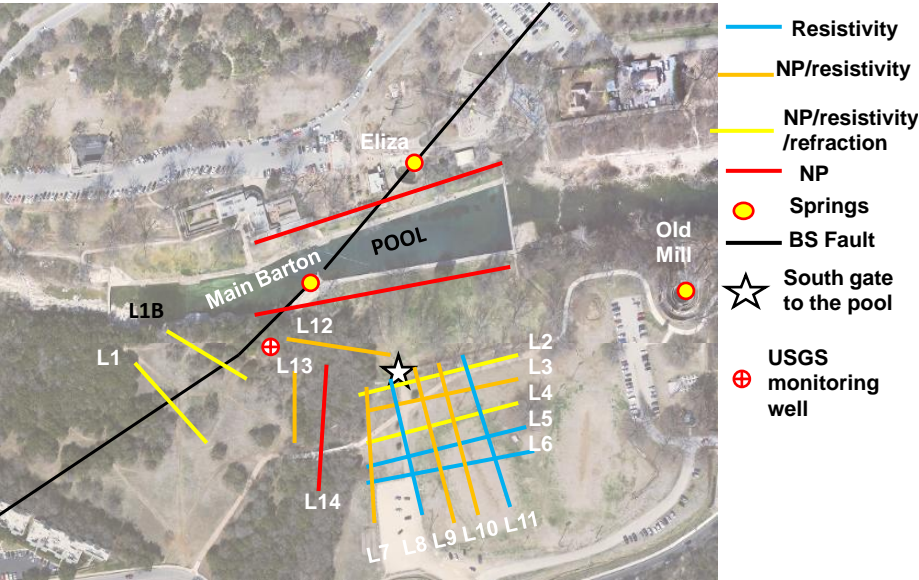
Location of Geophysical Profiles at the vicinity of Barton Springs Pool, Austin, Texas

To test this hypothesis geophysical surveys [2D and 3D resistivity imaging, natural potential (NP), seismic refraction tomography, induced polarization, and ground penetrating radar] were performed across the Barton Springs fault and in the southern part of the Zilker Park. Only NP surveys were allowed within the boundaries of the pool because of endangered species of Barton Springs Salamander. The purpose of the surveys was multi-folded: 1) to locate the precise location of the Main Springs on the south banks of the Barton Springs pool; 2) to determine the potential location of caves and active flow paths beneath the spring; 3) to characterize the geophysical signature of the fault crossing the Barton Springs pool.
