## Safe and Aesthetic Design of Urban Roadside Treatments

## NCHRP REPORT 612

# Safe and Aesthetic Design of Urban Roadside Treatments

This report presents the findings of a research project to develop recommended design guidelines for safe and aesthetic roadside treatments in urban areas and a toolbox of effective roadside treatments that balance pedestrian, bicyclist, and motorist safety and mobility. The report will be of particular interest to designers and safety practitioners responsible for the design of arterial and collector-type facilities in urban areas.

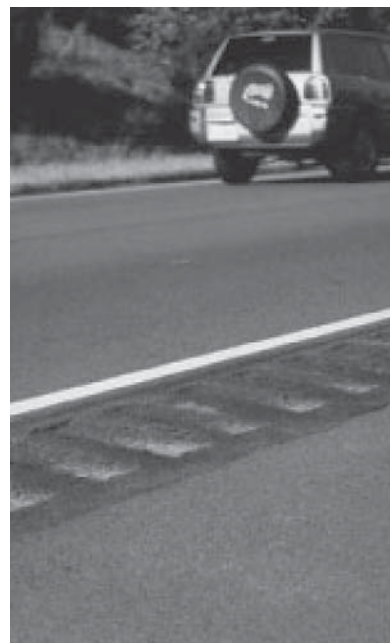
**Figure 1. Rumble strips.**

Physical rumble strips are grooves placed into the roadway or paved shoulder and are aimed at alerting the driver of potentially hazardous conditions (see Figure 1). A similar alert can also be achieved using thermoplastic rumble strips which are generally placed on the surface of the road in conjunction with lane edge delineation. While transverse rumble strips are often used for purposes such as alerting the driver of a downstream stop condition such as a toll booth or a stop-controlled intersection, longitudinal rumble strips are also effective for alerting the driver that he or she is leaving the travelway. Although rumble strips do not have speed-reducing capabilities (23), they cause a vehicle to vibrate and make noise when it crosses over them, thereby signaling to the driver that greater attention to the traveling environment is warranted. The sound made by a vehicle crossing rumble strips typically does not exceed that of the ambient sound experienced by the driver (24); thus, the ability of rumble strips to alert drivers

to hazardous conditions is largely restricted to the vibration the rumble strips produce. This vibration is nevertheless a substantial cue for increasing the driver's awareness of the roadway environment. Several studies of the effectiveness of rumble strips have determined that placement of rumble strips can decrease the number of run-off-road crashes between 30 and 85 percent (25, 26).

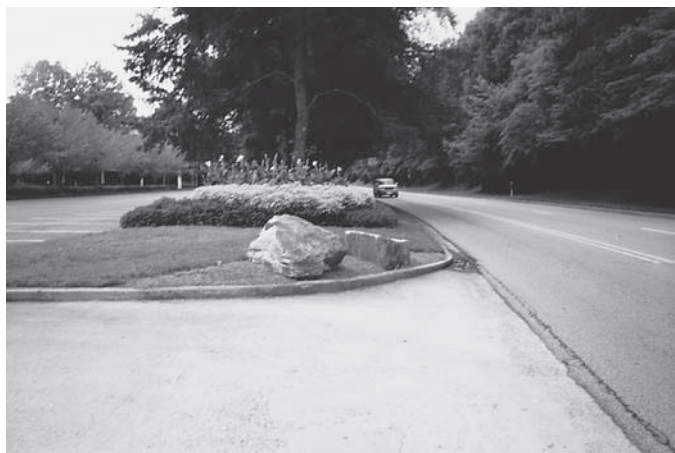
**Figure 4. Landscaping in sight triangle for driveway.**

Many landscape policies do not directly stipulate tree placement near driveways, but use an approach similar to the New South Wales guidelines, which simply state that drivers exiting driveways should be able to see approaching traffic and pedestrians (61). As an example, the attractive landscaping depicted in Figure 4 seems reasonable upon

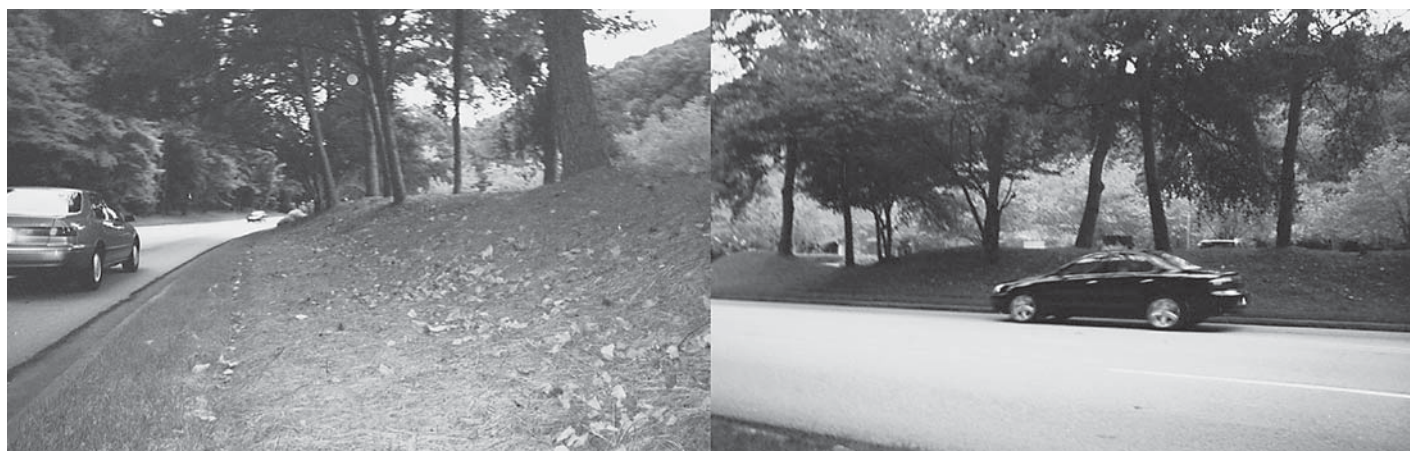
**Figure 6. Landscape berm that blocks horizontal sight distance.**

Figure 6 depicts another type of encroachment into the vertical clear vision space. Often landscape berms are used to screen adjacent parking from the roadway. The photo on the left shows a longitudinal landscape berm and the effect it has on horizontal sight distance. At the location shown, the road has a horizontal curve to the right (in the direction the vehicle shown is traveling) and has numerous driveways that are not easily visible due to the berm height. The photo on the right depicts the same location but more clearly shows that the height of the berm exceeds the height of a typical passenger car. This type of landscape treatment is a common roadside treatment in many urban areas.

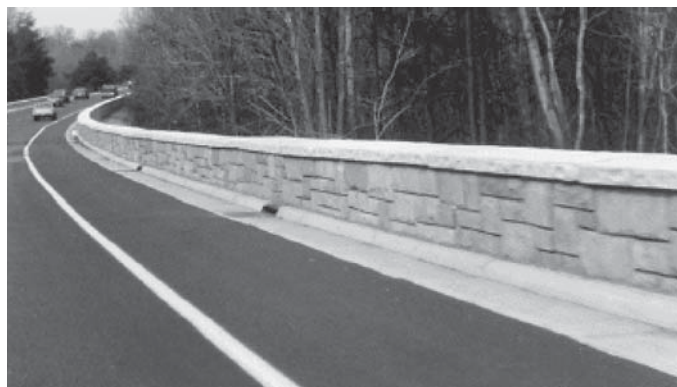
**Figure 12. Stone masonry barrier.**

In locations where aesthetics are important and a barrier is required, jurisdictions may develop crash-tested options such as the Vermont-approved stone masonry system shown in Figure 12 (in addition to the various aesthetic barriers identified in the California report previously indicated [90]).

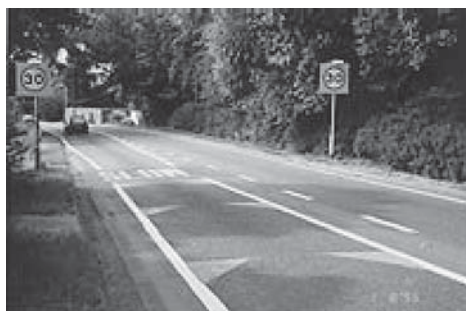
**Figure 14. Dragon-teeth marking.**

In a 1997 study in the United Kingdom, researchers at the Transport Research Laboratory performed a before-after evaluation of a series of traffic calming strategies on major roads (112). The traffic volume on candidate roads was greater than 8,000 vehicles per day, and at least 10 percent of the traffic was composed of heavy vehicles. Speeds at inbound gateways were reduced at eight out of nine locations tested. Mean speed reductions ranged from 5 to 21 km/hr (3 to 13 mph). The study evaluated a variety of treatments, including speed reduction signage, narrowings, dragon teeth marking, speed cushions, colored pavement, and advanced signing. The researchers determined that the signing provided a high visual impact and resulted in large speed reductions. Physical devices such as the speed cushions resulted in a greater level of speed reduction than signing alone. The use of colored bands placed laterally across the road and placed in a series seemed to result in some speed reduction, but did not result in large decreases in speed. The researchers did not test the speed reduction signs and so could not comment on the effectiveness of these devices. Dragon-teeth marking, identified as one of the strategies, is depicted as a schematic and a photograph in Figure 14.
