ROCK BLANKET

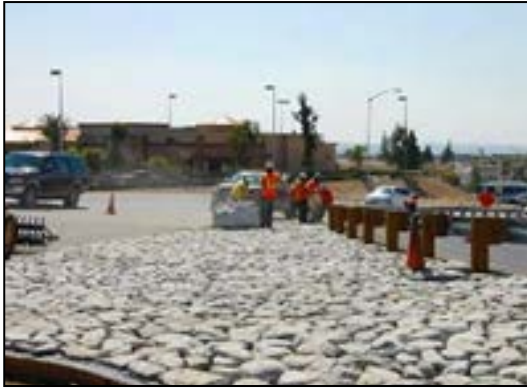
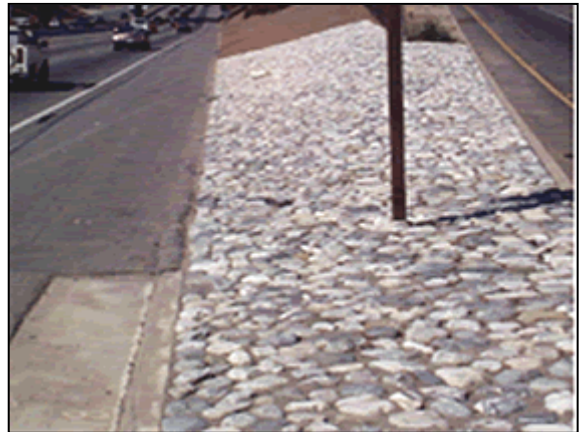
Description: Rock cobble installed using mortar with or without concrete base
