**Aim ⇨** To find the VI characteristics of the P-N Junction Diode and to find the cut-in voltage.

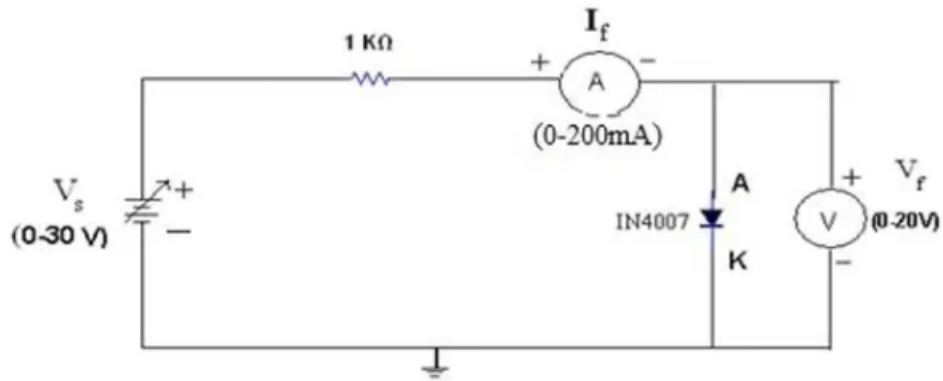
Fig 1. Forward Bias

When a forward bias voltage is applied to the diode (positive voltage to the P-region and negative to the N-region), the potential barrier of the depletion region is reduced. This reduction in barrier allows majority charge carriers (holes in the P-region and electrons in the N-region) to cross the junction more easily, resulting in a significant increase in current flow through the diode. Conversely, when a reverse bias voltage is applied (negative voltage to the P-region and positive to the N-region), the potential barrier is increased, which widens the depletion region and prevents the flow of majority charge carriers. This results in only a minimal current flow, known as reverse leakage current, until the reverse breakdown voltage is reached.

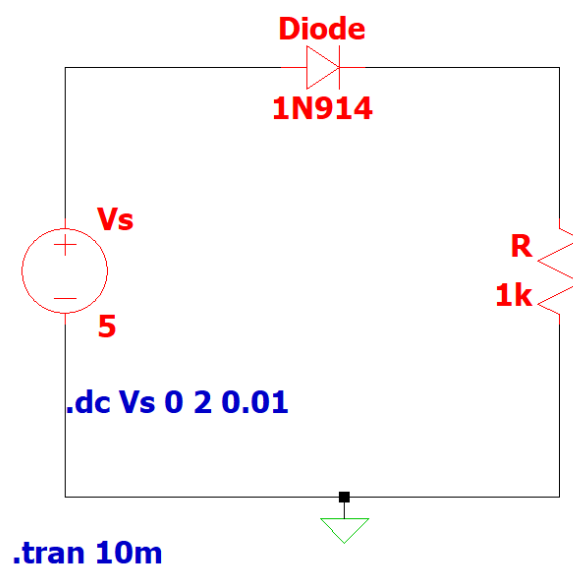
Fig 3. Circuit in LTSpice
