DEER CREEK CULVERT REPLACEMENT

BPA Contract #00037152

Completion Report

November 2009

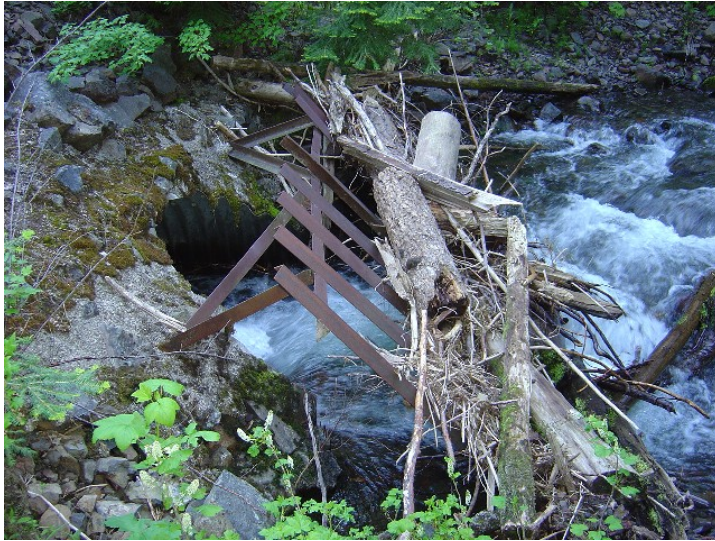
Deer Creek culvert inlet with trash rack; Aug 2006

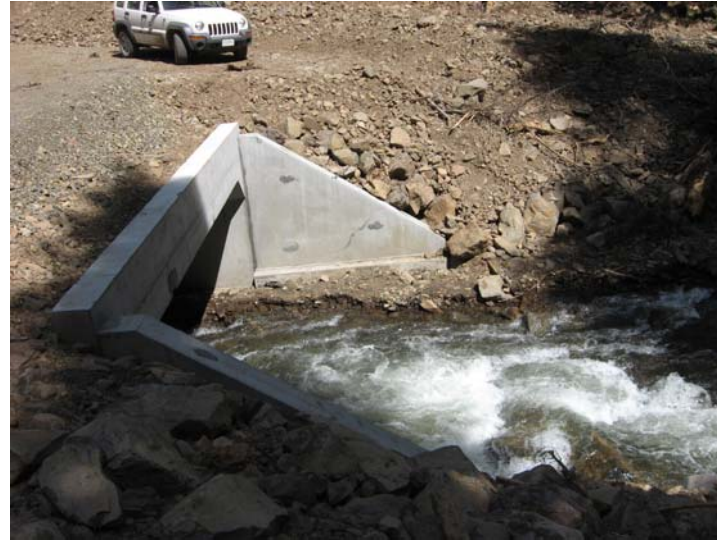
Deer Creek arch inlet; May 2009

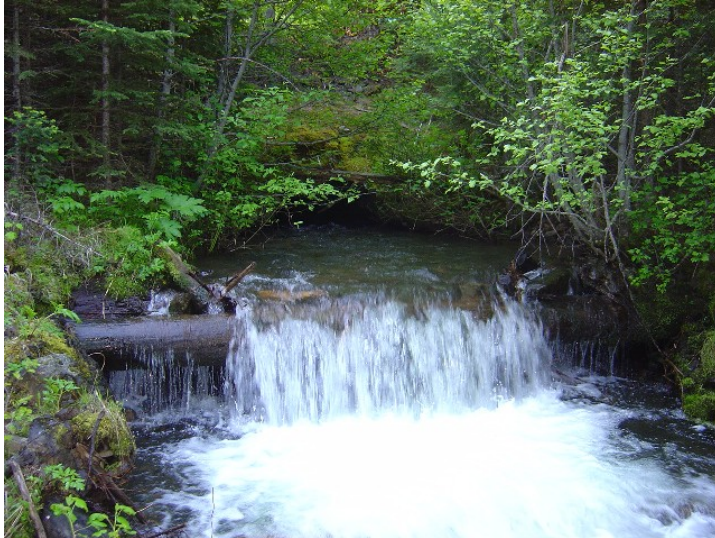
Deer Creek culvert outlet; Aug 2006

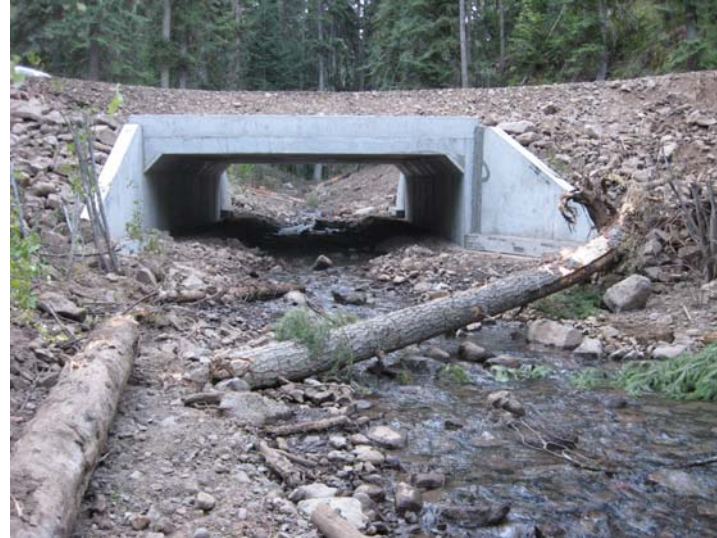
Deer Creek arch outlet; Sep 2008

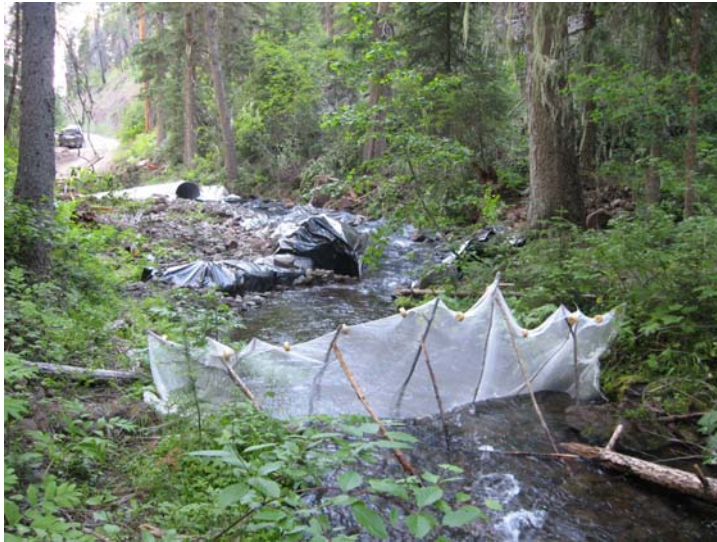
Deer Creek upstream fish net and diversion; Jul 2008

The project didn't go as smoothly as Henderson Logging would have preferred. They struggled to keep the site dewatered, but did a good job overall with the culvert replacement, rising to the "dewatering" challenge by using several different techniques and finally utilizing a combination of collection ponds with sump pumps and a French drain that worked in unison with the diversion culvert to keep the site mostly dry. The project also started later than anticipated as water flows were much higher than normal for that time of year. The delayed start also caused a delayed finish, with the project needing a work window extension which the Oregon Department of Fish and Wildlife granted immediately.

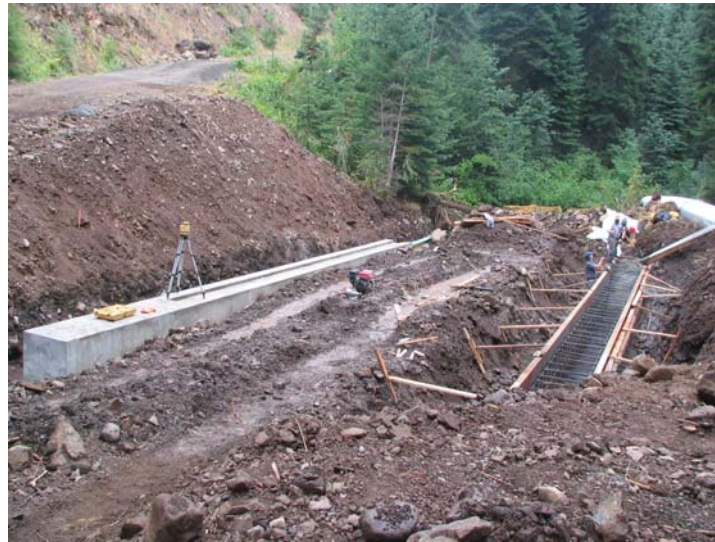
Deer Creek footing construction; Aug 2008

Project changes from the original designs included using local streambed simulation rock instead of a commercial source, correcting one inaccurate footing elevation in the designs, and pouring more concrete than expected, resulting in a change order and increased cost to the project for which the W-WNF paid.

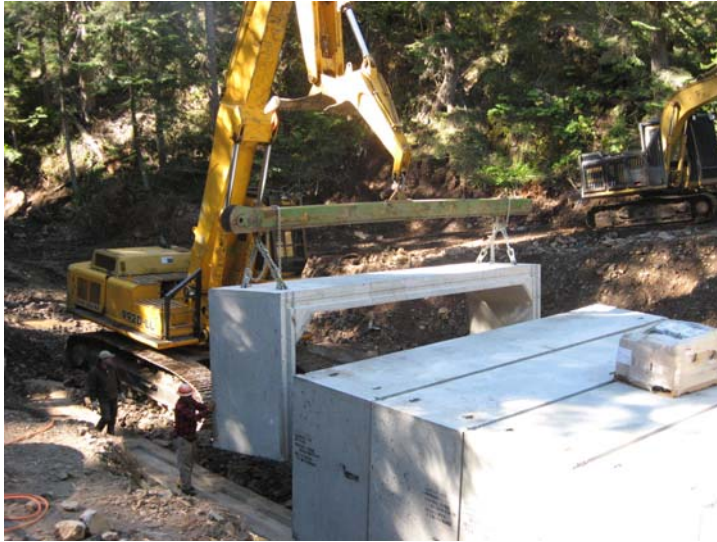
Deer Creek box arch placement; Aug 2008

An existing 8.4' x 5' x 61' arch was removed and replaced with a 23' x 7' x 40' concrete bottomless box arch with wingwalls on Deer Creek in Wallowa County on USFS land. The box arch was designed to pass the 100-year peak flow event and to be 5 feet wider than the bankfull width of Deer Creek to accommodate stream banks inside the arch. The log weir downstream was removed, and 248 total feet of stream channel (extending 116 feet upstream and 68 feet downstream of concrete box arch) was reconstructed to its natural gradient of 5% with a bankfull width of 18' using the San Dimas Technology and Development Center's Stream Simulation design. Thirteen rock steps were constructed approximately 20 feet apart throughout the reconstructed channel to provide grade control and imitate the natural steps found in the channel up- and down-stream of project area. More than 20 mature hardwood plants at least 2" in diameter were trimmed to 5-6 feet were transplanted by the contractor from places close by to the disturbed streambanks on both sides of Deer Creek.

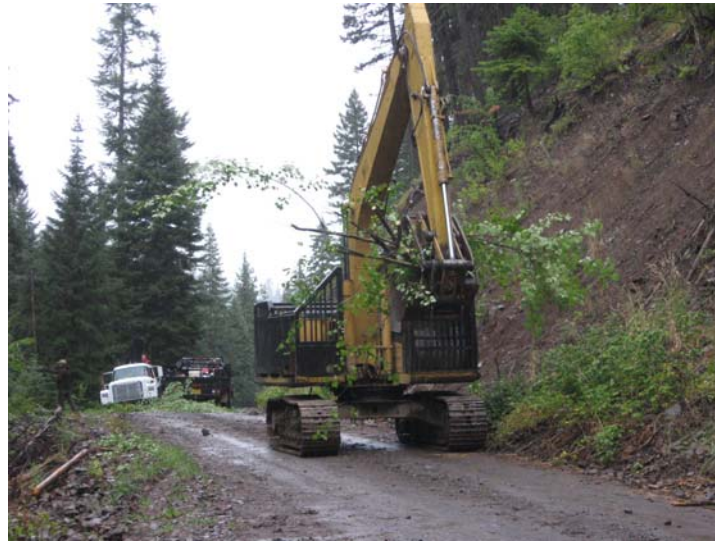
Transplanting native hardwoods with bucket; Aug 2008

Twenty riparian shrubs at least 2" in diameter were trimmed to 5-6 feet tall by the contractor and transplanted in the streambanks to the east and west of Deer Creek both upstream and downstream of the new structure immediately following construction. The project was completed by a local Wallowa County contractor, Henderson Logging, Inc., with oversight from Joe Neer, W-WNF Engineer, and Dana Nave, W-WNF Hydrologist.

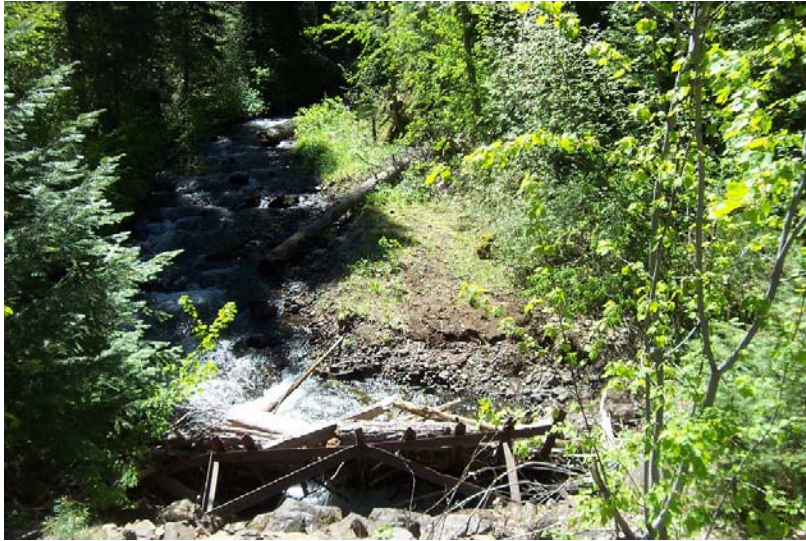
Deer Creek view upstream from culvert; May 2007

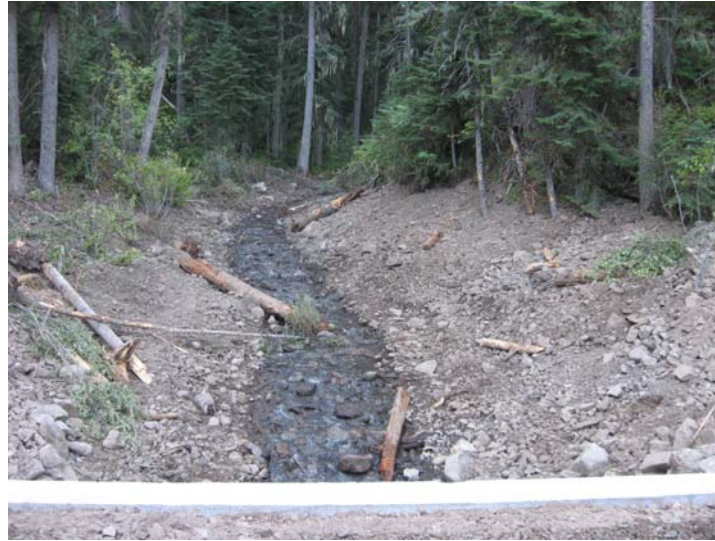
Deer Creek view upstream from arch post-construction; Sep 2008

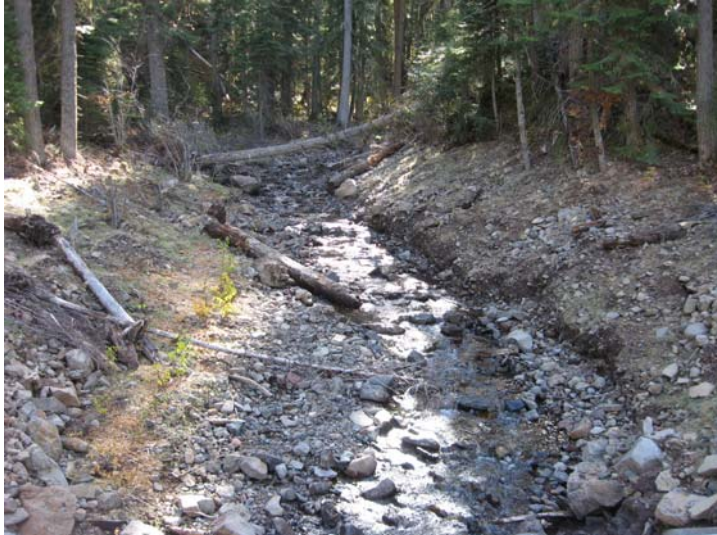
Deer Creek view upstream from arch; Oct 2009

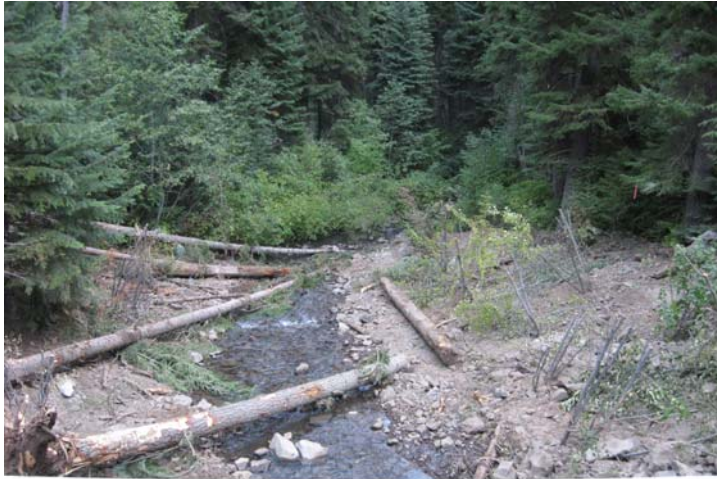
Deer Creek view downstream from new arch; Sep 2008

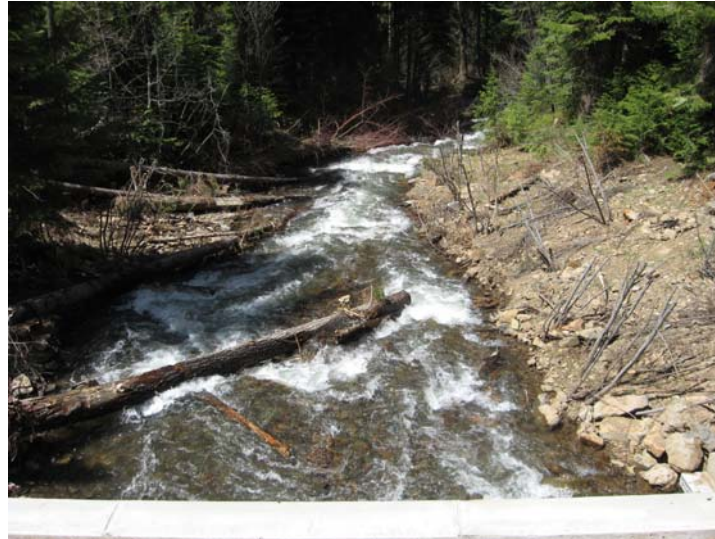
Deer Creek view downstream from arch; May 2009

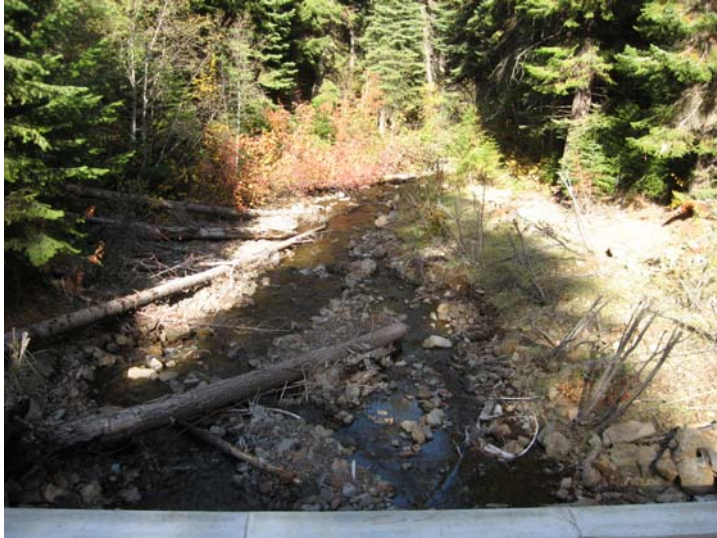
Deer Creek view downstream from arch; Oct 2009
