2020 Tampa Bay Water Quality Assessments

A Tampa Bay Estuary Program Initiative to Maintain and Restore the Bay's Seagrass Resources

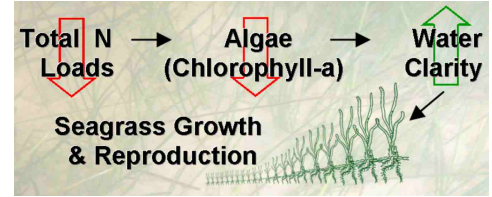
Figure 2: Seagrass restoration with N management.

Light availability to seagrass is the guiding paradigm for TBEP's Nitrogen Management Strategy. Because excessive nitrogen loads to the bay generally lead to increased algae blooms (higher chlorophyll-a levels) (Figure 2) and reduce light penetration to seagrass, an evaluation method was developed to assess whether load reduction strategies are achieving desired water quality results (i.e. reduced chlorophyll-a concentrations and increased water clarity).

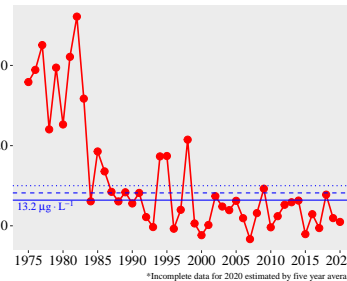
Figure 3: Historic chlorophyll-a annual averages for the four bay segments.

Water quality (chlorophyll-a and light penetration) remained supportive of seagrass in Hillsborough Bay (HB), Middle Tampa Bay (MTB), and Lower Tampa Bay (LTB) (Table 1, Figure 3). The nuisance algae, *Pyrodinium bahamense*, was again reported in Old Tampa Bay (OTB) during May - September 2019, contributing to a large magnitude chlorophyll-a exceedance that has persisted for a long duration (5yrs). However, it should be noted that effective light penetration was still observed to be supportive of seagrass in all bay segments, including OTB (Table 1).

— Annual Mean — Management Target — +1 se (small exceedance) — +2 se (large exceedance)

*Incomplete data for 2020 estimated by five year average
