2020 Tampa Bay Water Quality Assessments

A Tampa Bay Estuary Program Initiative to Maintain and Restore the Bay's Seagrass Resources

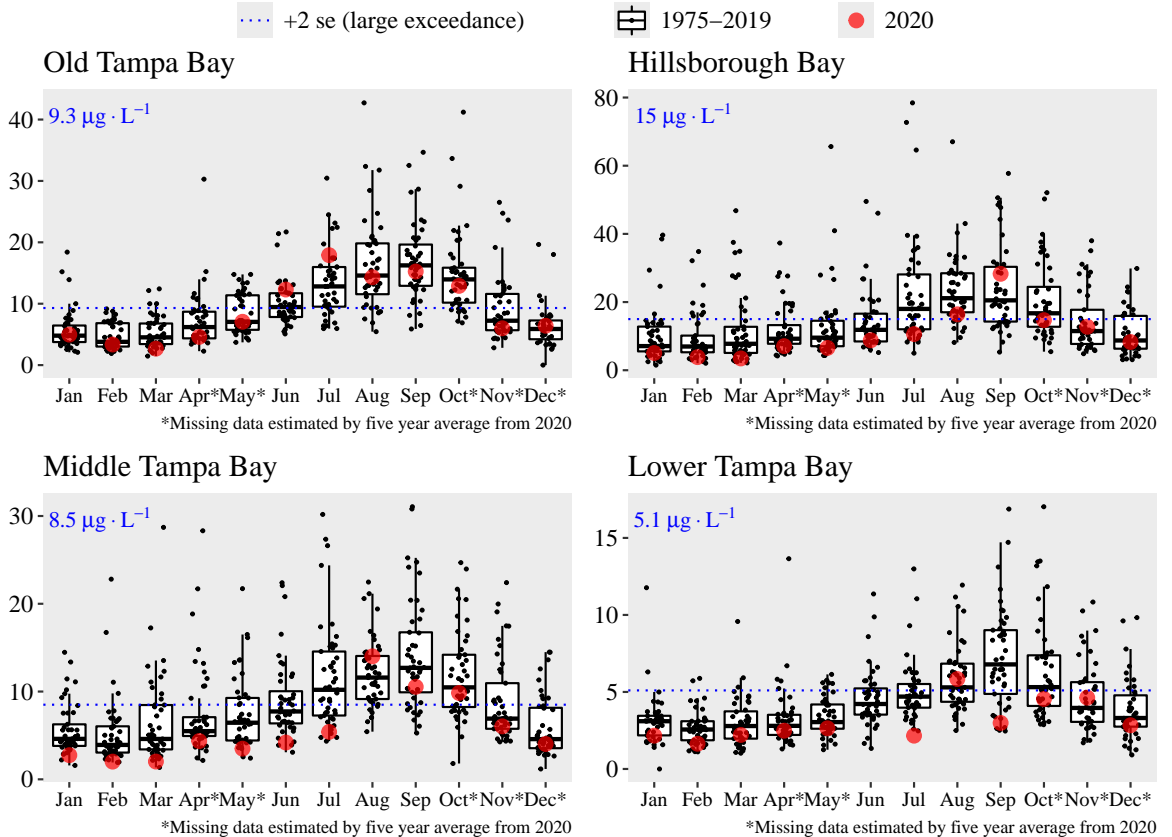
Figure 6: Chlorophyll-a monthly averages from 1975-2019 for the four bay segments. The monthly averages for 2020 are shown in red. Historic chlorophyll-a annual averages for the four bay segments.

Chlorophyll-a concentrations were evaluated within the bay on a monthly basis during 2020 and compared to prior years' levels (Figure 6). Elevated concentrations in Old Tampa Bay were primarily due to *Pyrodinium bahamense* during the late Summer months. Lower Tampa Bay also showed elevated concentrations in August 2019, potentially due to non-harmful algae blooms.
