2020 Tampa Bay Water Quality Assessments

A Tampa Bay Estuary Program Initiative to Maintain and Restore the Bay's Seagrass Resources

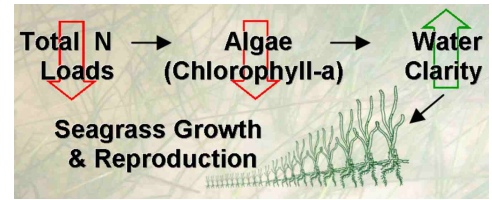
Figure 2: Seagrass restoration with N management.

Light availability to seagrass is the guiding paradigm for TBEP's Nitrogen Management Strategy. Because excessive nitrogen loads to the bay generally lead to increased algae blooms (higher chlorophyll-a levels) (Figure 2) and reduce light penetration to seagrass, an evaluation method was developed to assess whether load reduction strategies are achieving desired water quality results (i.e. reduced chlorophyll-a concentrations and increased water clarity).
