2020 Tampa Bay Water Quality Assessments

A Tampa Bay Estuary Program Initiative to Maintain and Restore the Bay's Seagrass Resources

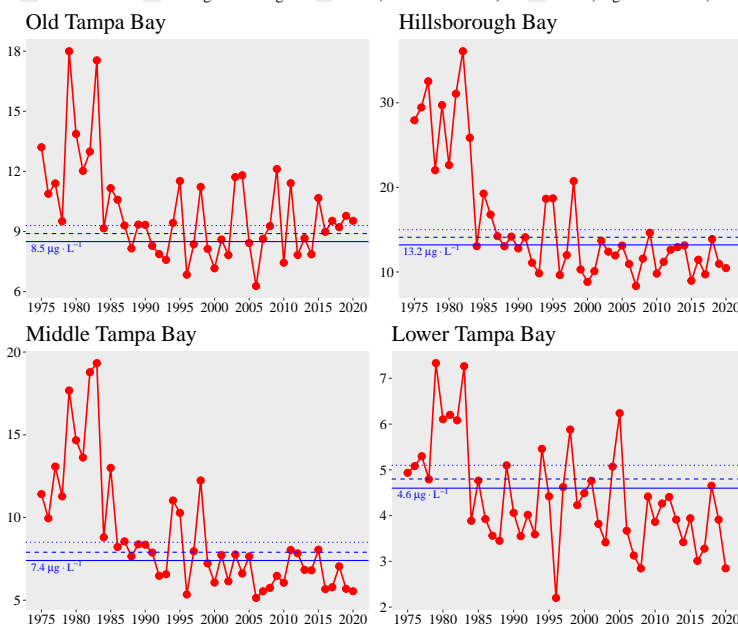
Figure 3: Historic chlorophyll-a annual averages for the four bay segments.

— Annual Mean — Management Target - - +1 se (small exceedance) - - +2 se (large exceedance)

Water quality (chlorophyll-a and light penetration) remained supportive of seagrass in Hillsborough Bay (HB), Middle Tampa Bay (MTB), and Lower Tampa Bay (LTB)(Table 1, Figure 3). The nuisance algae, *Pyrodinium bahamense*, was again reported in Old Tampa Bay (OTB) during June - Sept 2020, contributing to a large magnitude chlorophyll-a exceedance that has persisted for a long duration (6 yrs). However, it should be noted that effective light penetration was still observed to be supportive of seagrass in all bay segments, including OTB (Table 1).
