2020 Tampa Bay Water Quality Assessments

A Tampa Bay Estuary Program Initiative to Maintain and Restore the Bay's Seagrass Resources

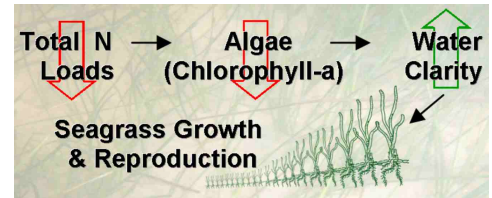
Figure 2: Seagrass restoration with N management.

Light availability to seagrass is the guiding paradigm for TBEP's Nitrogen Management Strategy. Because excessive nitrogen loads to the bay generally lead to increased algae blooms (higher chlorophyll-a levels) (Figure 2) and reduce light penetration to seagrass, an evaluation method was developed to assess whether load reduction strategies are achieving desired water quality results (i.e. reduced chlorophyll-a concentrations and increased water clarity).

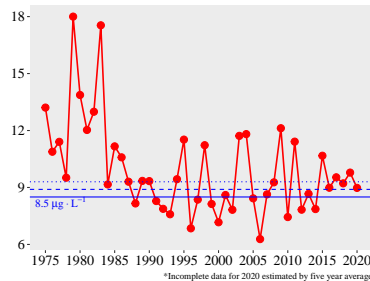
Old Tampa Bay*

Figure 3: Historic chlorophyll-a annual averages for the four bay segments.

Water quality (chlorophyll-a and light penetration) remained supportive of seagrass in Hillsborough Bay (HB), Middle Tampa Bay (MTB), and Lower Tampa Bay (LTB)(Table 1, Figure 3). The nuisance algae, *Pyrodinium bahamense*, was again reported in Old Tampa Bay (OTB) during May - September 2019, contributing to a large magnitude chlorophyll-a exceedance that has persisted for a long duration (5yrs). However, it should be noted that effective light penetration was still observed to be supportive of seagrass in all bay segments, including OTB (Table 1).
