# 2020 Tampa Bay Water Quality Assessments

A Tampa Bay Estuary Program Initiative to Maintain and Restore the Bay's Seagrass Resources

# Progress Towards Meeting Regulatory Goals

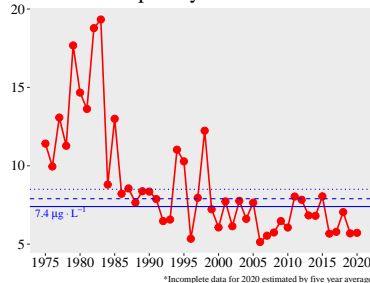
Figure 3: Historic chlorophyll-a annual averages for the four bay segments.

Water quality (chlorophyll-a and light penetration) remained supportive of seagrass in Hillsborough Bay (HB), Middle Tampa Bay (MTB), and Lower Tampa Bay (LTB) (Table 1, Figure 3). The nuisance algae, *Pyrodinium bahamense*, was again reported in Old Tampa Bay (OTB) during May - September 2019, contributing to a large magnitude chlorophyll-a exceedance that has persisted for a long duration (5yrs). However, it should be noted that effective light penetration was still observed to be supportive of seagrass in all bay segments, including OTB (Table 1).

— Annual Mean — Management Target — +1 se (small exceedance) — +2 se (large exceedance)
