Silicon Microstrip Sensors for SiD:

R&D Review and Future Plans

M. Breidenbach, C. Kenney, T. Nelson, A. Tomada

SLAC National Accelerator Laboratory

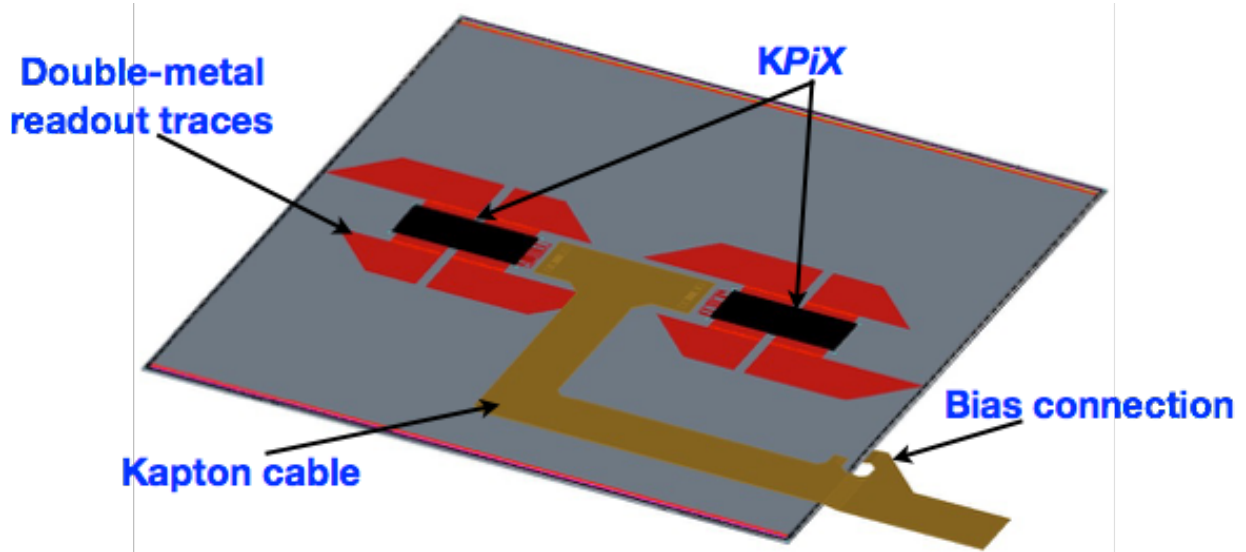
FIG. 1: The module concept for the SiD outer tracker. Each sensor is read out by a pair of KPiX readout ASICs via a polyimide flex cable, which also provides bias to the sensor.

KPiX to the external DAQ and power supply, as well as providing bias to the sensor. As shown in Figure 1, the design calls for each sensor to be read out by a pair of 1024-channel bump-bonded KPiX, which are controlled and read out by a single cable which attaches to the sensor between the two readout chips. In early 2008, after extensive development of the

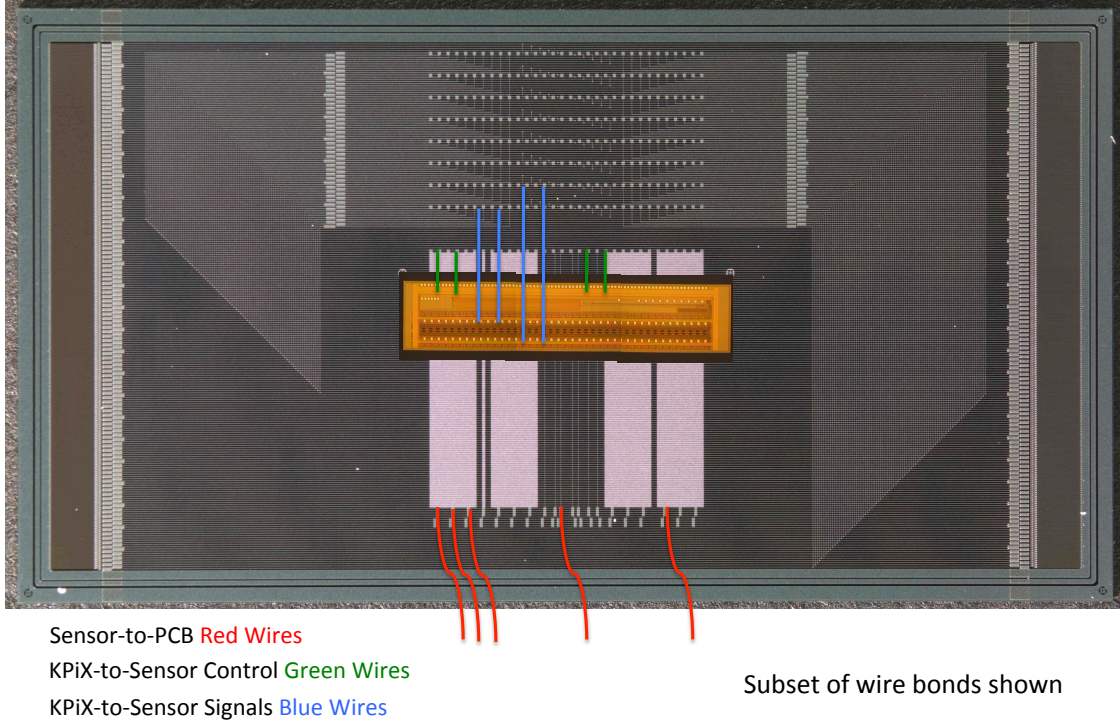
FIG. 2: The layout for initial testing with a 64-channel KPiX readout ASIC and double-metal test sensor. The KPiX is glued to the face of the sensor with bump bond pads facing up to allow wirebonding of KPiX to both the power/control traces (second metal) and the readout traces (first metal) of the sensor. For this test, the other end of the power/control traces were bonded to an underlying PCB instead of a polyimide flex cable.

a 64-channel KPiX prototype upside-down (with bump bond pads facing upwards) to allow wirebonding to the test sensor. The primary purpose of this test was to assess crosstalk from KPiX clock traces that are routed on the second metal layer to the underlying sense traces. The wirebonding layout for this test is shown in Figure 2. This wirebonding was

performed by Amtech Microelectronics Inc., the packaging and SMT vendor used by SLAC for all contract assembly and wirebonding. Although the wirebonds on this prototype appeared successful, testing revealed that the wirebonds on the sensor had shorted the second metal layer to the first-metal readout traces. A second attempt was made with the same vendor with the same results. In order to have more control over the wirebonding process, further prototypes were sent to colleagues at UC Santa Cruz and wirebonded there on their Hesse&Knipps BJ820 by an experienced technician. The results of this effort were similar and, in general, the rate of punch-through during bonding appears to be at least 10%. Table I summarizes the measured resistance between the second metal clock trace and the

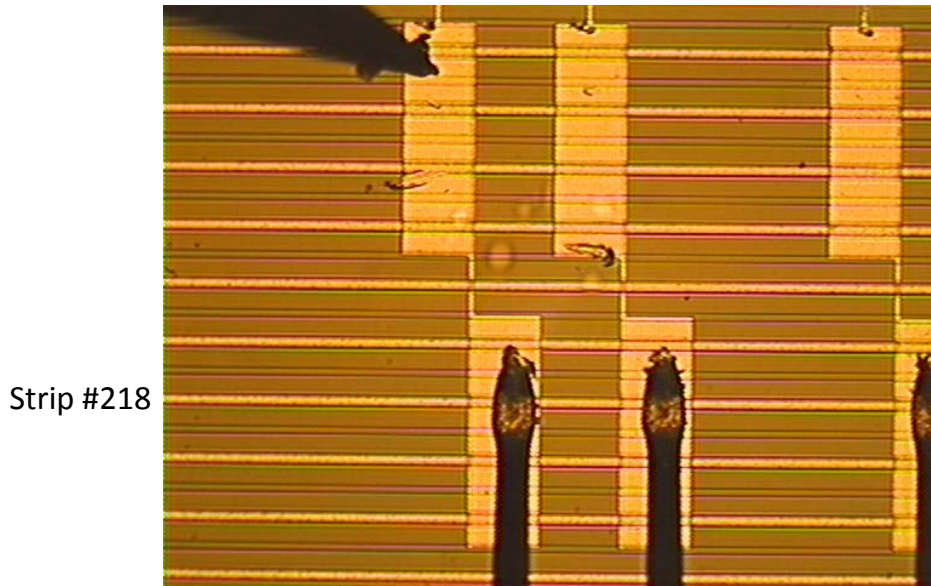
FIG. 3: The setup for measuring the resistance between the clock trace, shown being probed at the spare wirebonding pad, and the underlying readout traces. As indicated strip 218 lies underneath the pad where the wirebond was made to the PCB.

first metal readout traces that lie underneath the bonding pads on one of these prototypes. Figure 3 shows a closeup image of the wirebond pad that was found to have only 70Ω resistance to the underlying readout trace. Since then, the same technician using the same

TABLE I: The resistance between the clock trace (second metal) and the underlying readout traces (first metal) after wirebonding. Strip 218 is underneath the wirebond pad for bonding the clock trace to the PCB.

machine performed approximately 50000 wirebonds to Hamamatsu sensors fabricated for the DØ Run IIb upgrade in producing sensor modules for the HPS experiment without a single failure, resulting in a completed detector with a bad channel rate of less than 0.01%. Therefore, it has become clear that the oxide layer between the first and second metal layers

on these prototype sensors are, for an unknown reason, simply not robust enough to allow wirebonding.

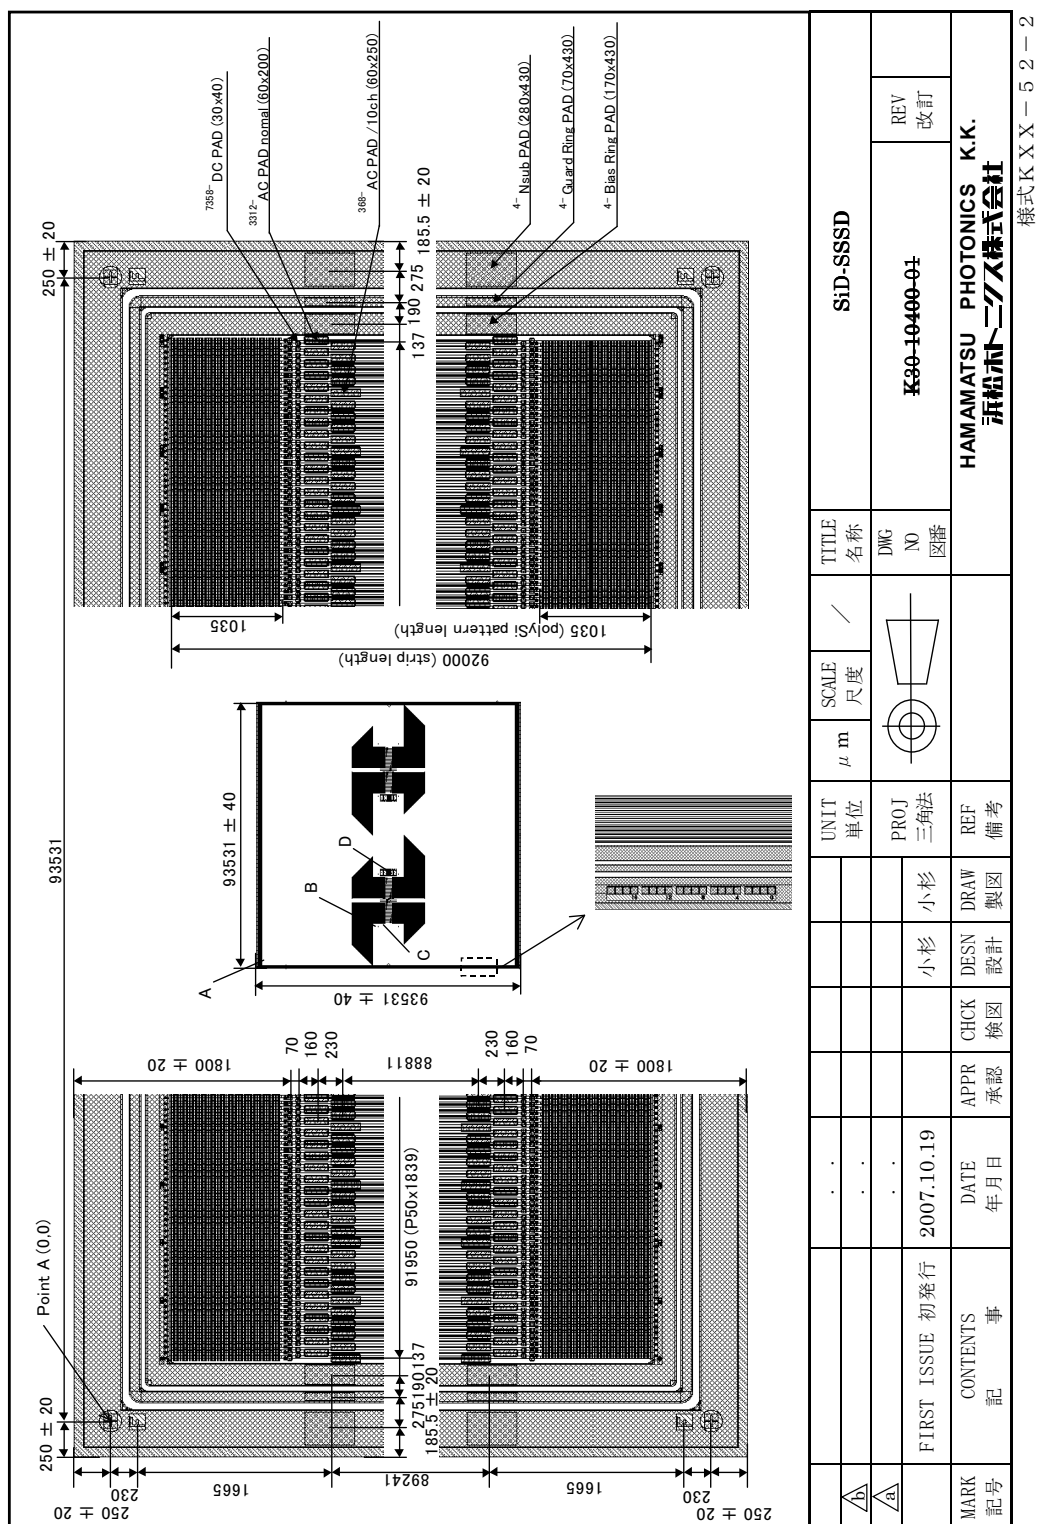
FIG. 5: The Hamamatsu overview drawing for the tracker sensor prototypes.

The specifications for the sensors are shown in Figure 4. The drawings for the full-sized sensors are shown in Figures 5, 6 and 7. The drawing for the test sensors is shown in Figure 8.

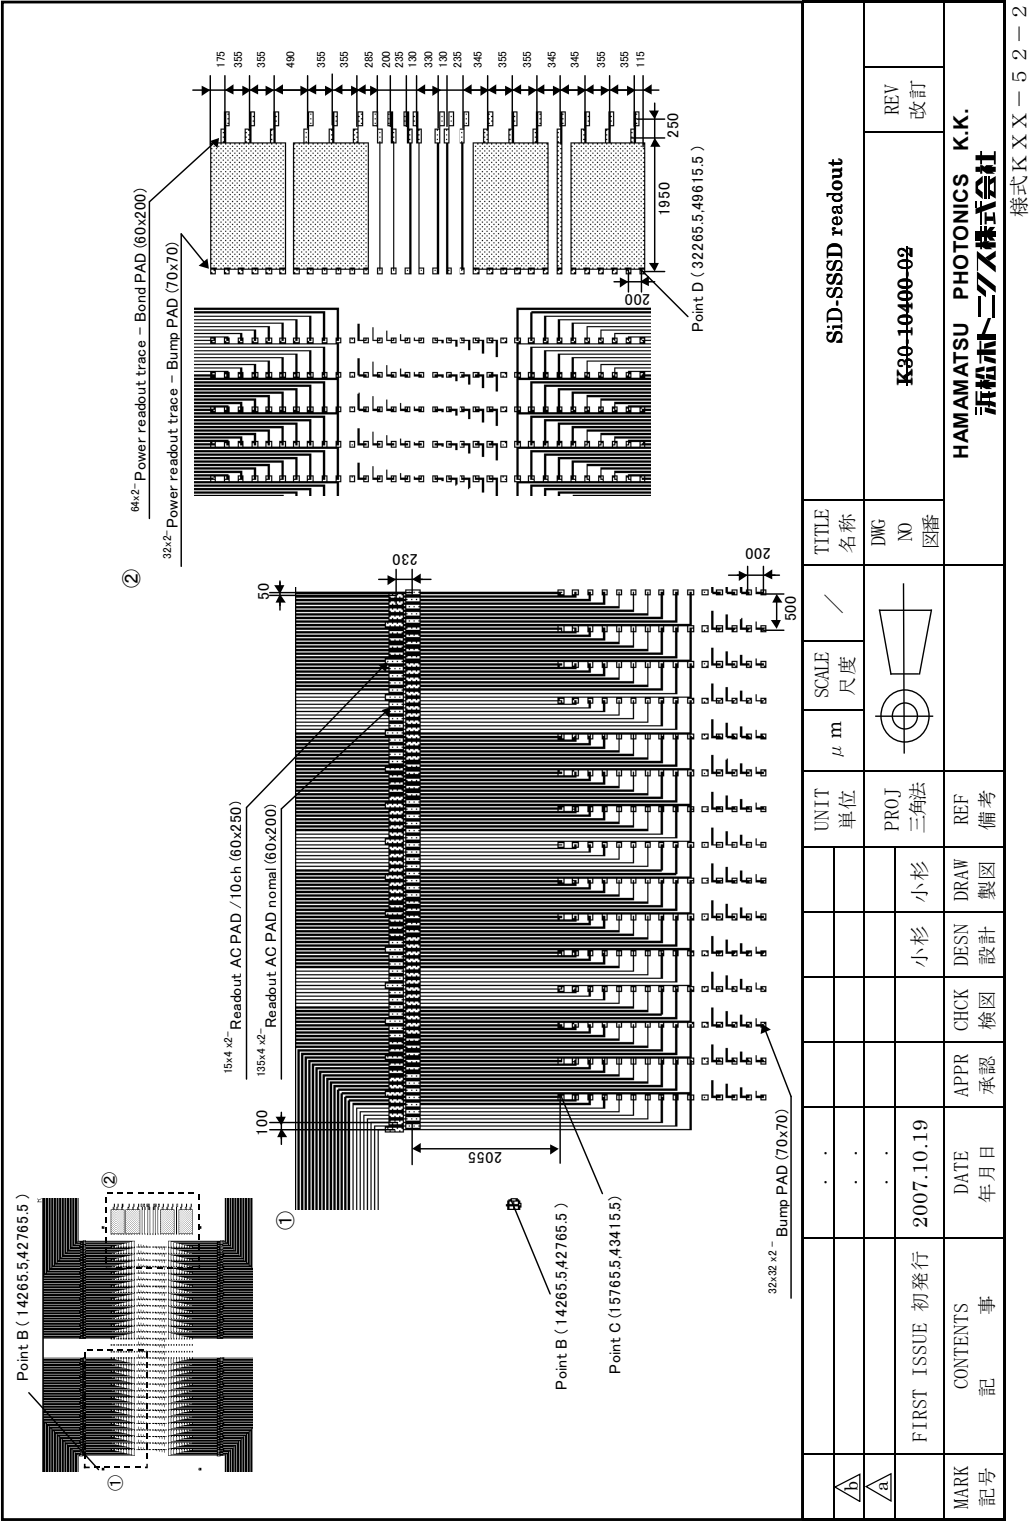
FIG. 6: The Hamamatsu drawing for the tracker sensor prototypes showing the KPiX and cable bonding region in detail. The wirebonding pads are along the right edge of the drawing.
