PERMIT # P20110466
10353 RIVER ROAD
ST ROSE, LA 70087

MISSISSIPPI RIVER RESTORATION, LLC

EXHIBIT
2-A
PLAN VIEW OF
BANK LINE REPAIR

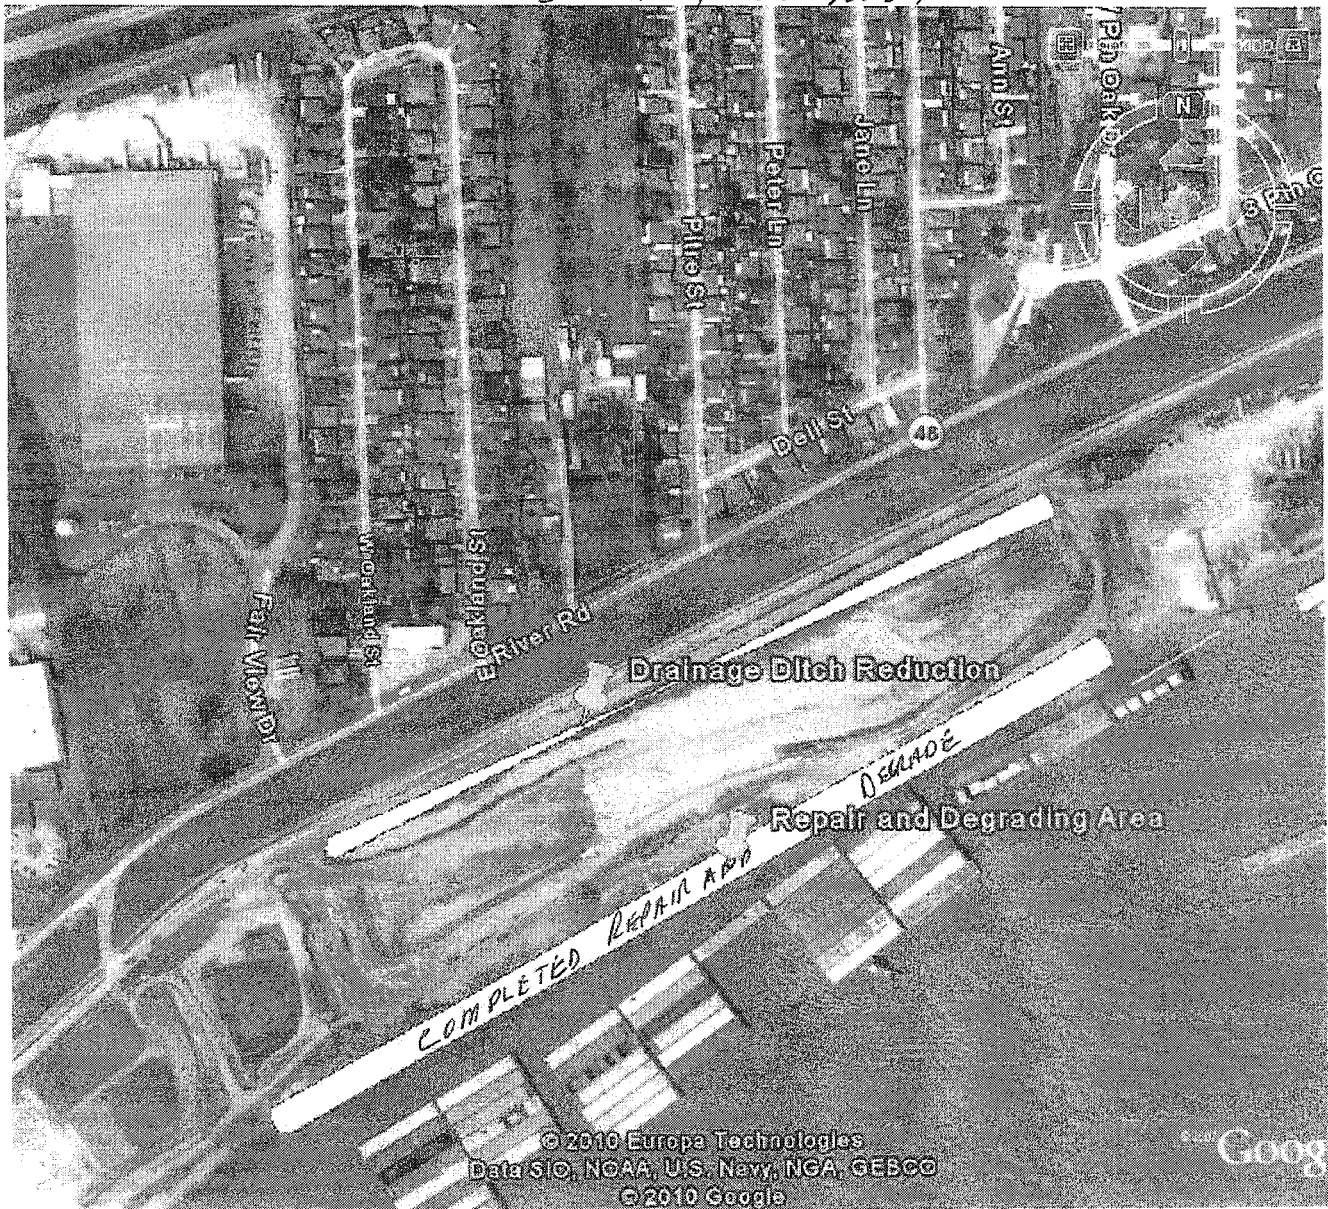
EXHIBIT 1-A

RIVERBANK REPAIR COMPLETE

2100 FEET DELRADED, REPAIRED

BANK IS GRADED TO 25/30 DELRADES FOR 25 TO 30 FEET
TO THE RIVER AT STAKE 12 FEET AT THE CARROLLTON
CAULE

(SEE CROSS SECTION)

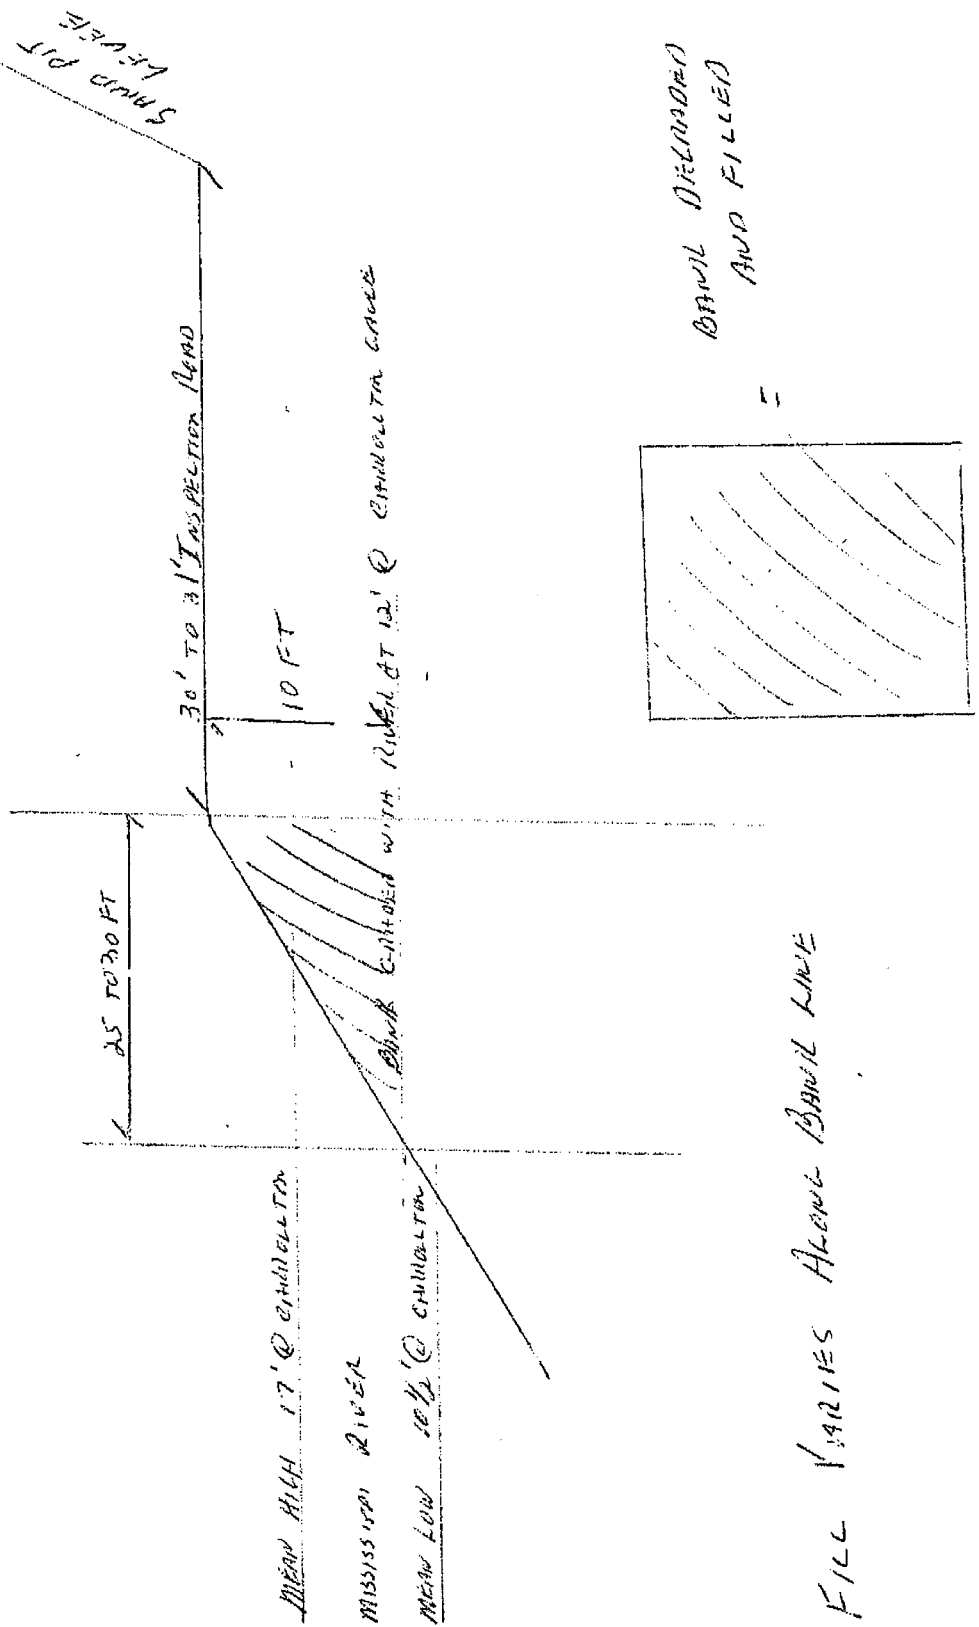
Cross Section of Bank Line Repair

Fill Varies Above Bank Line

ESTIMATED FILL AND GRADED MATERIAL 3 FEET TO 10 FEET OVER 2100 FEET OF BANK

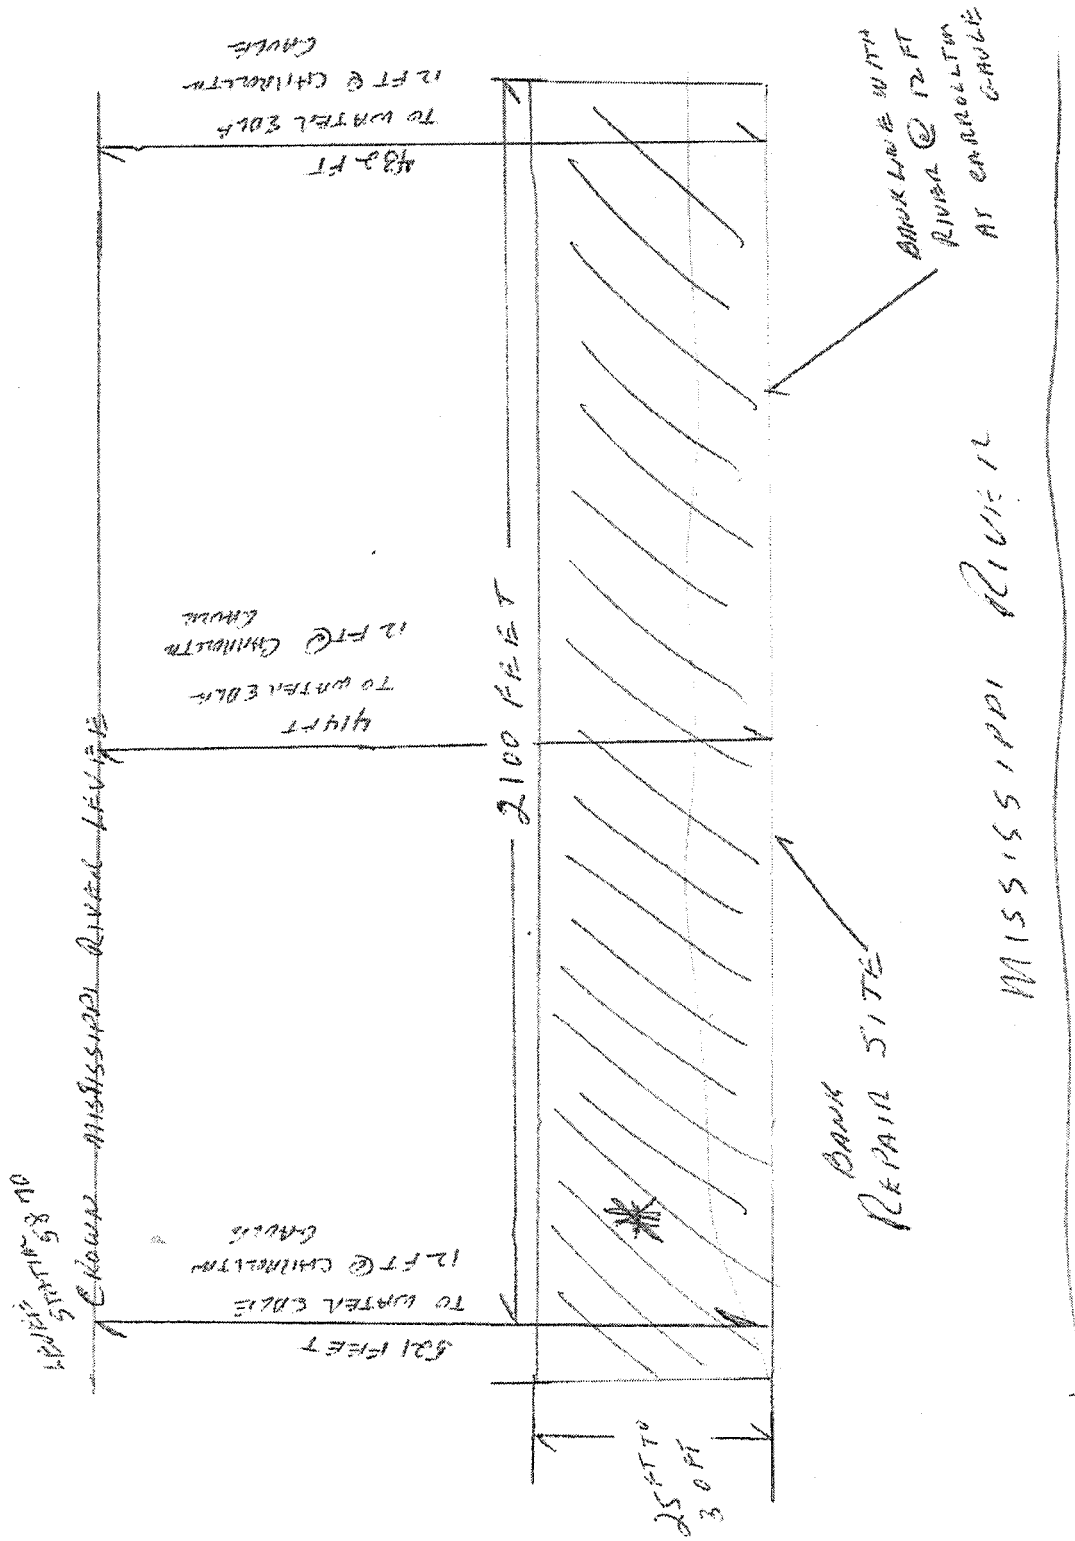
- 15,000 cu yds CONCRETE
- 25,000 cu yds of FILL in CLAY AND DELTAIC SAND
