PVC Pipe Testing After UV Exposure

by: *Gordon Lefort, P.Eng.*
IPEX Inc. – Langley, BC

The following is a summary of testing conducted on 15 year old PVC Pressure Pipe that has been continually exposed to sunlight. The pipe was returned to its plant of origin at IPEX Inc. in Edmonton, AB for testing and evaluation.

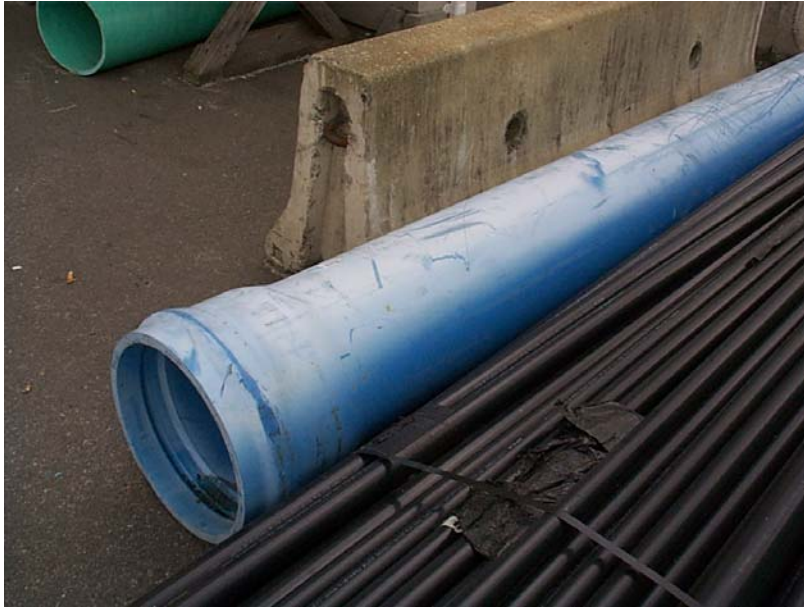
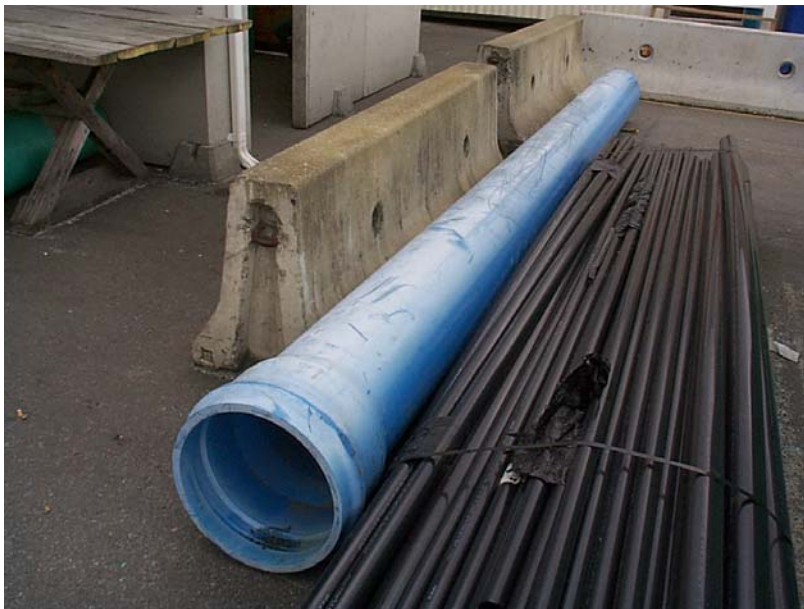
- 350 mm PVC DR18 PR235 psi
- Pipe certified to CSA B137.3
- Trade name - “Scepter”
- Date of manufacture - May 23, 1986
- Pipe severely faded to a maximum depth of .002 inches for approximately 180 degrees of the exterior surface

Photos of faded 350 mm DR18 AWWA C905 before testing.
