Test according A.S.T.M Standard D 5778-12

Project : **Site Investigation**

Location: **Paterson St - Wellington**

CPT no. : **32**      **4/14**

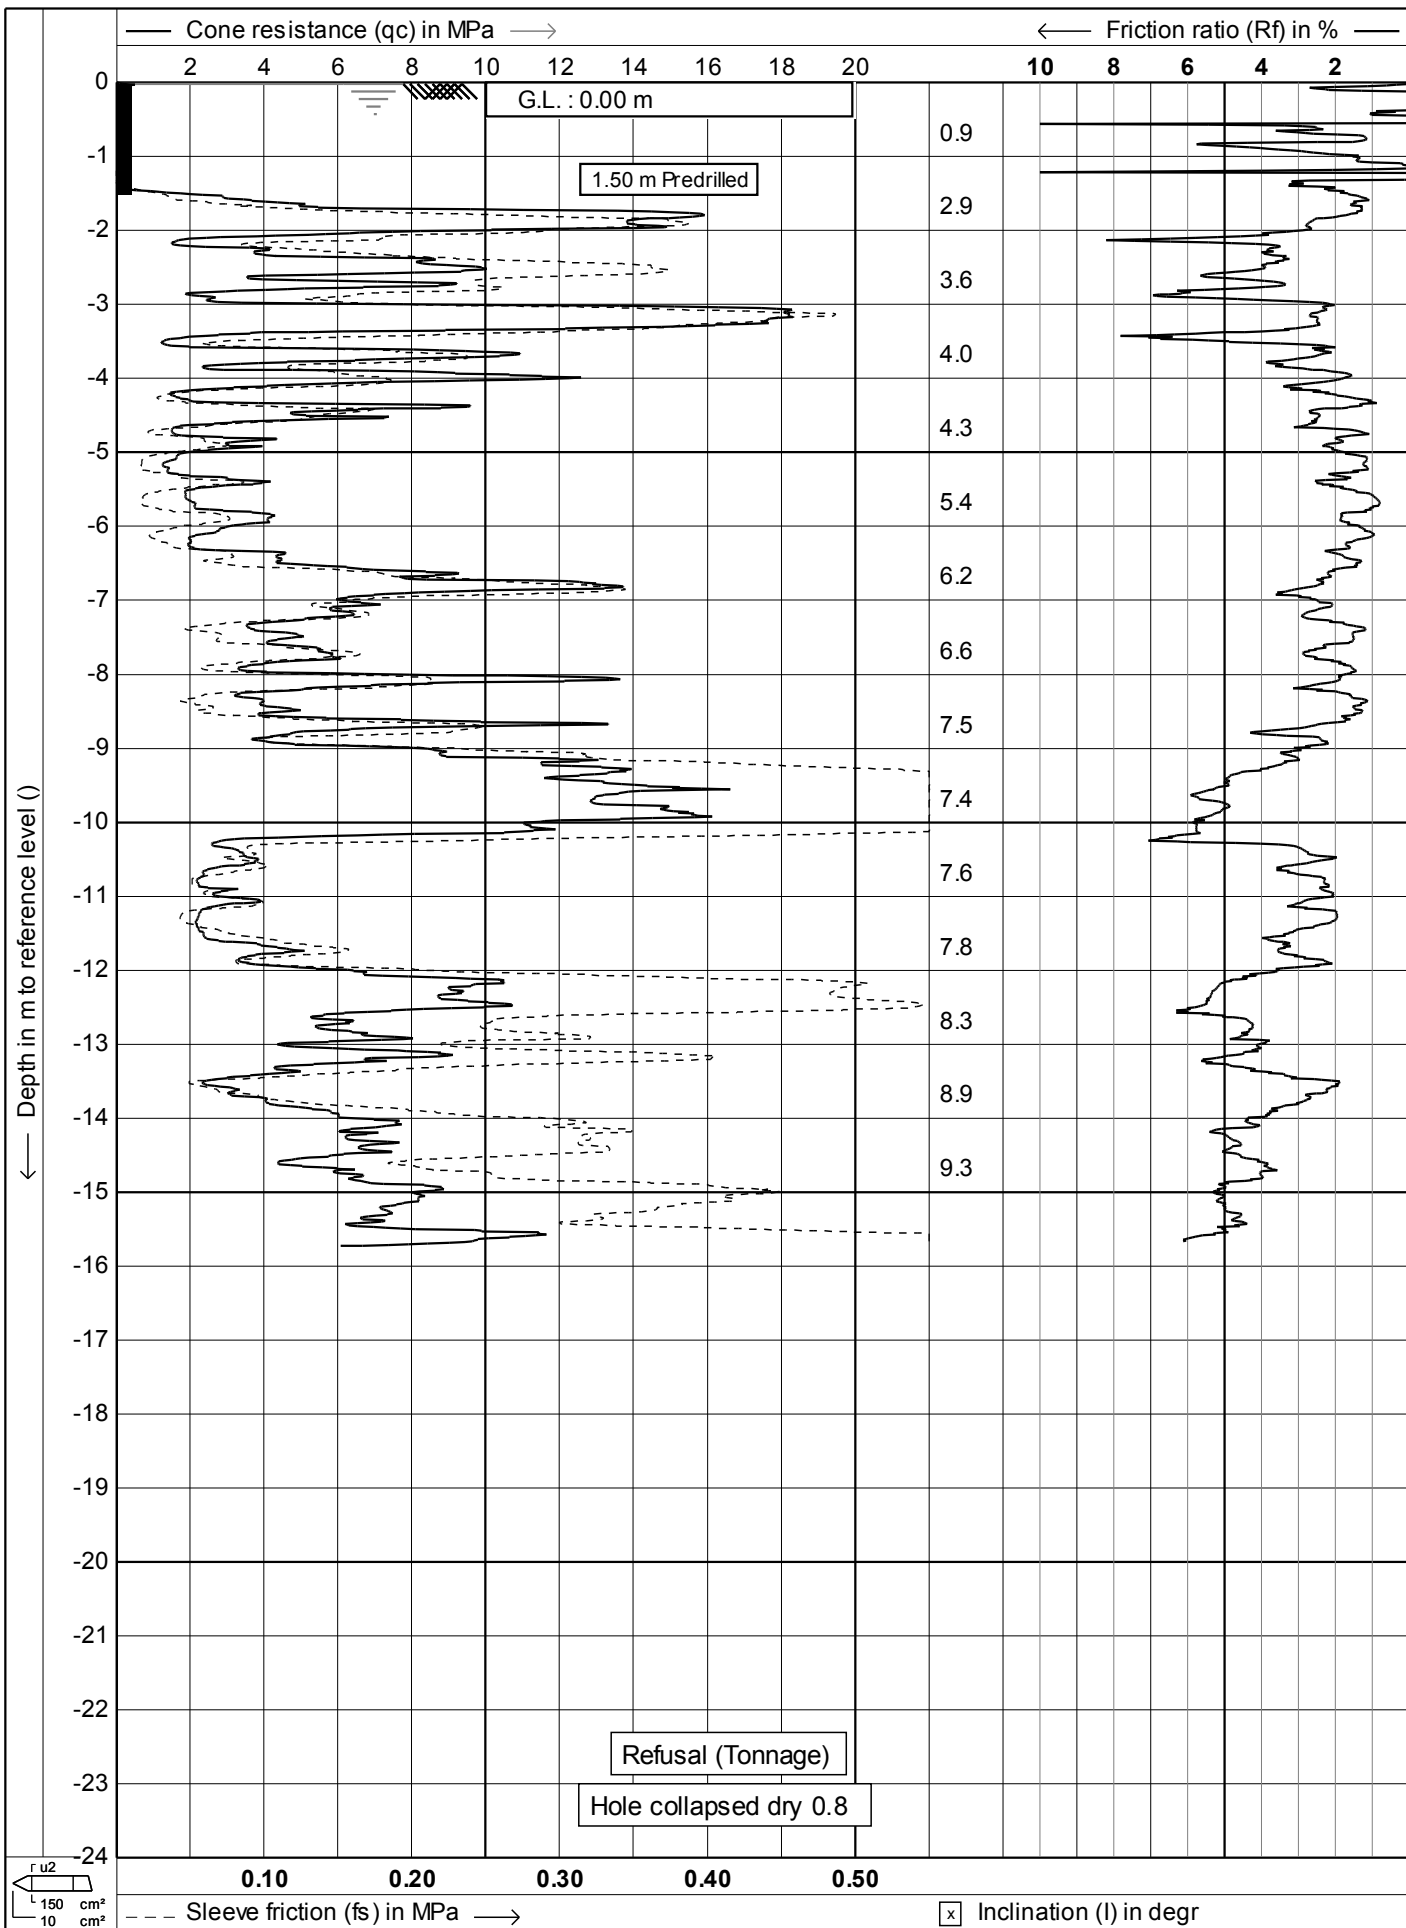
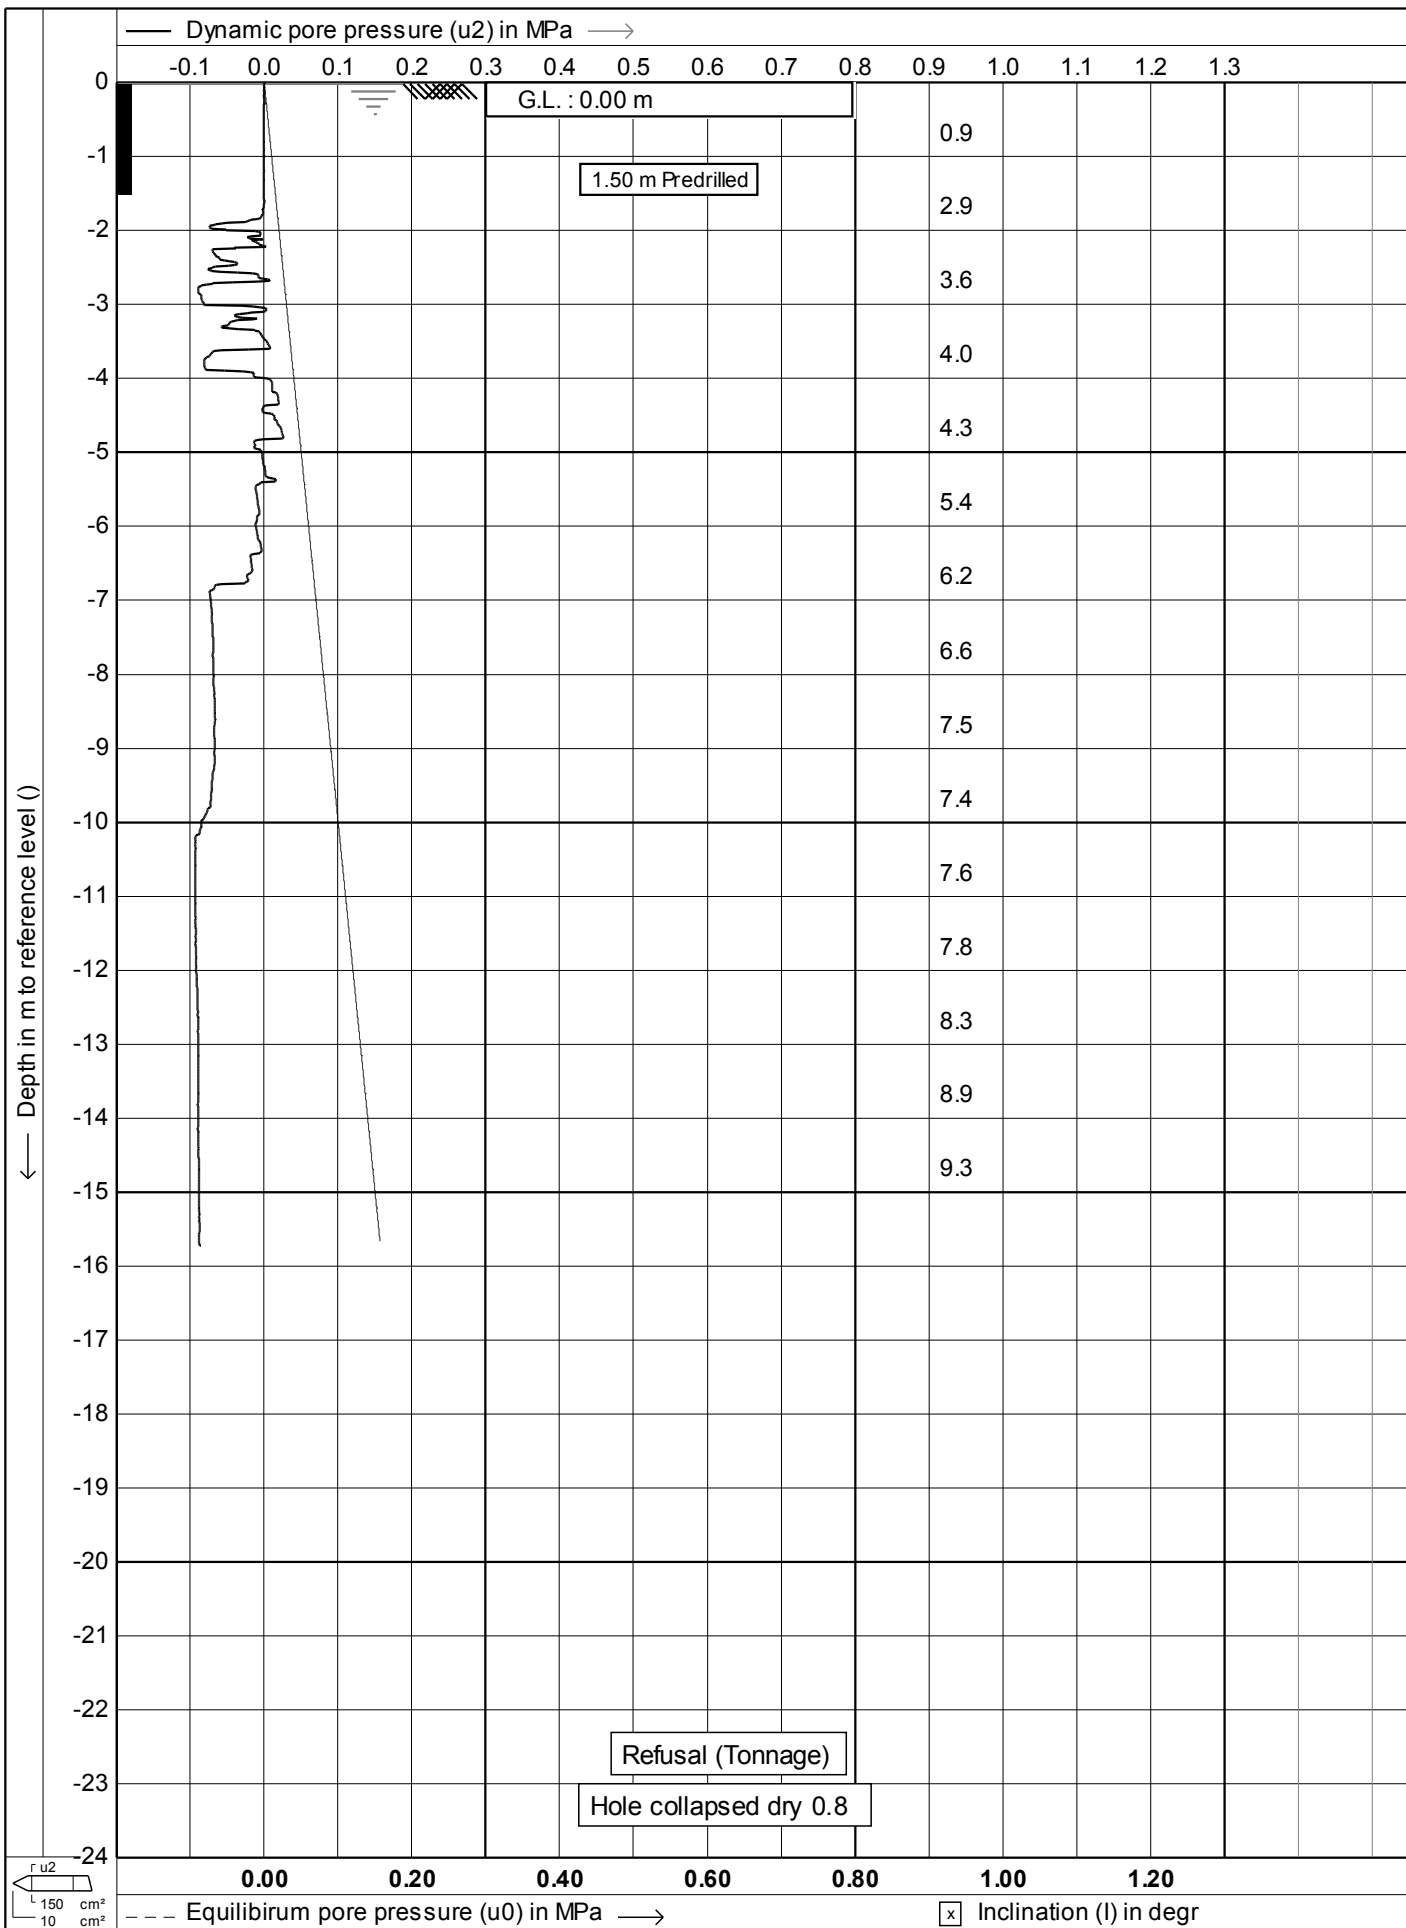
Test according A.S.T.M Standard D 5778-12		Date : 30-1-2013
Project : Site Investigation		Cone no. : C10CFIP.F04
Location: Paterson St - Wellington		Project no. : 02TT1
		CPT no. : 32
		2/14
