## **HAZARDOUS MATERIALS ASSESSMENT REPORT**

**Client:** Cape Cod Australia Pty. Limited

**Job details:** Owner: Mrs. L. Dodd  
Location: 760A Forest Road, Peakhurst NSW

**Date of assessment:** 16<sup>th</sup> December 2015

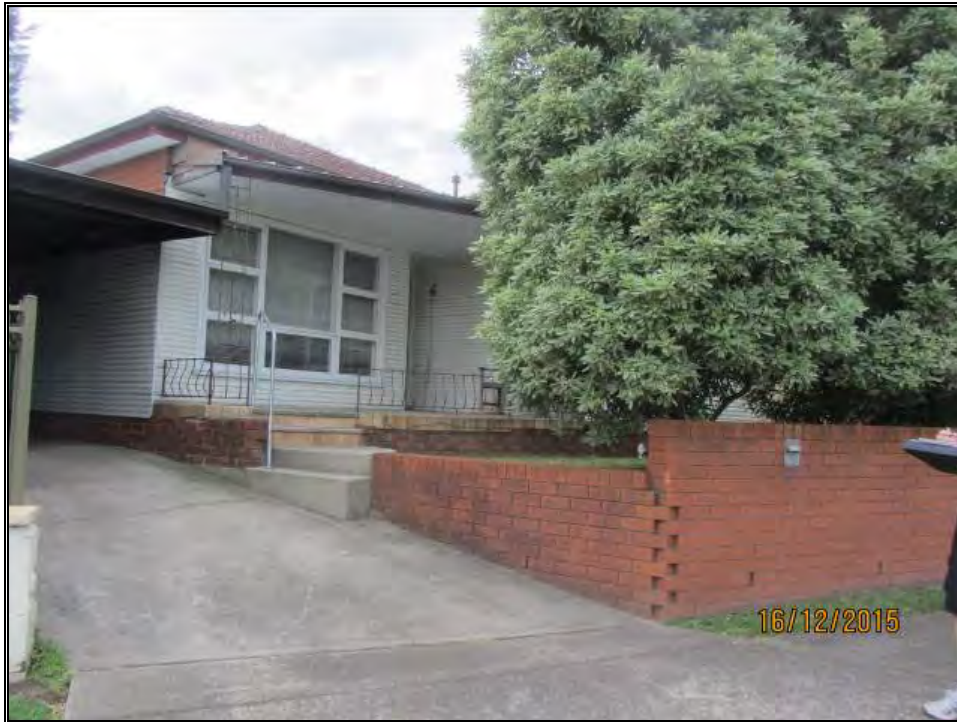
Front south eastern elevation of the residence

<b>Estimated age:</b>	Circa 1920 -1930
<b>Type of construction:</b>	Freestanding single storey timber framed and timber weatherboard clad residence on brick footings with a suspended timber floor system.
<b>External cladding:</b>	Profiled timber weatherboards
<b>Roof:</b>	Traditional cut and pitched hipped and valley roof structure with terra cotta roofing tiles.
