## **HAZARDOUS MATERIALS ASSESSMENT REPORT**

**Job details:** Owner: Mr. T. Vallis.  
Location: 9 Hilda Road, Baulkham Hills. NSW.

**Our reference:** HM05241016

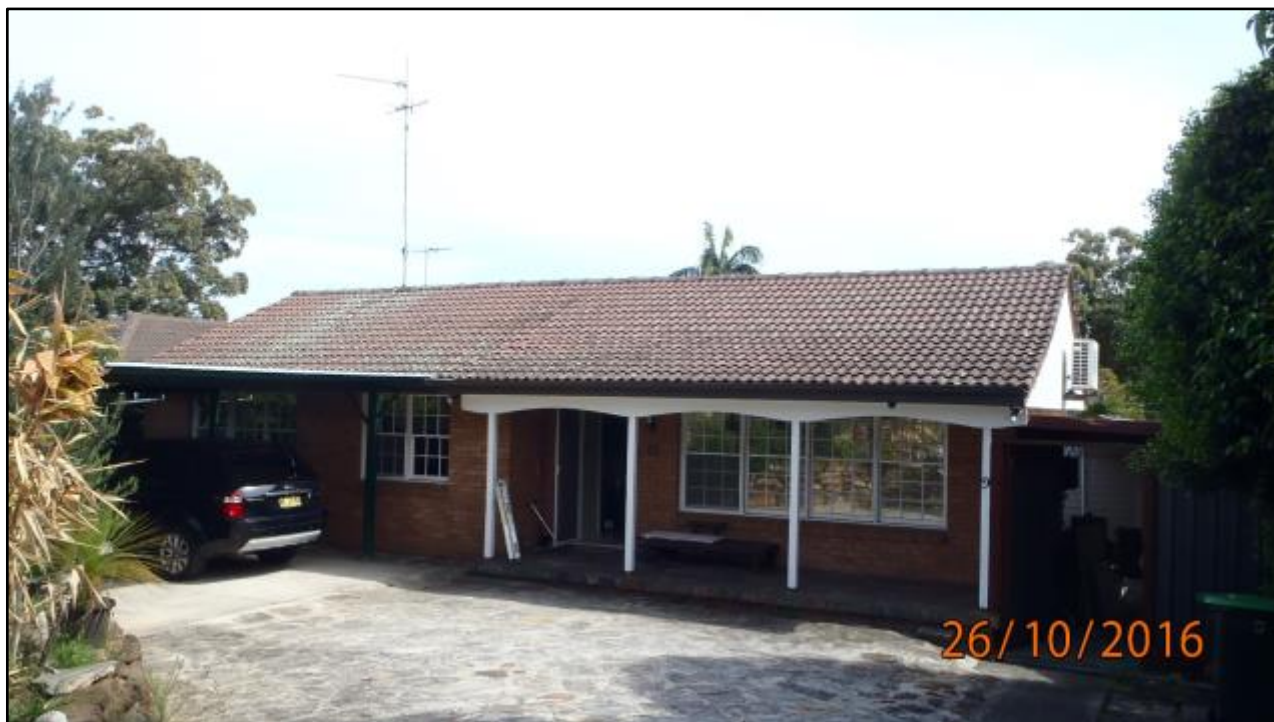
Front southern elevation of the residence

Estimated age:	Circa 1970 - 1980
Type of construction:	Freestanding single storey brick veneer construction built on brick piers and riser walls supporting a suspended hardwood timber flooring system.
External cladding:	Clay masonry brickwork.
Roof:	Traditional cut and pitched, gable ended roof structure with concrete roofing tiles.
