Rejuvenation of Guru ka Taal, Agra: Issues, Challenges and Strategy

^{1,2,3,4,5,6,7}Civil Engineering Department, Dayalbagh Educational Institute Agra, 282005, Uttar Pradesh, India

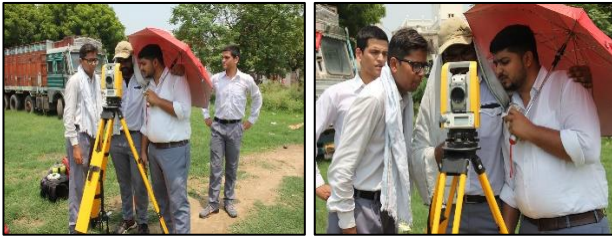
Fig. 2 Team conducting survey at the site

A lot of challenges came across while conducting the site survey as the site had excessive vegetation, and some points were inaccessible to approach to get the points for the total station. Still, the team managed to take almost all the points successfully and contour the site showing the present elevation condition of various points in the taal.

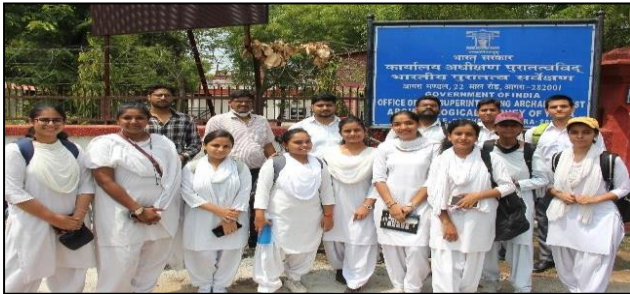
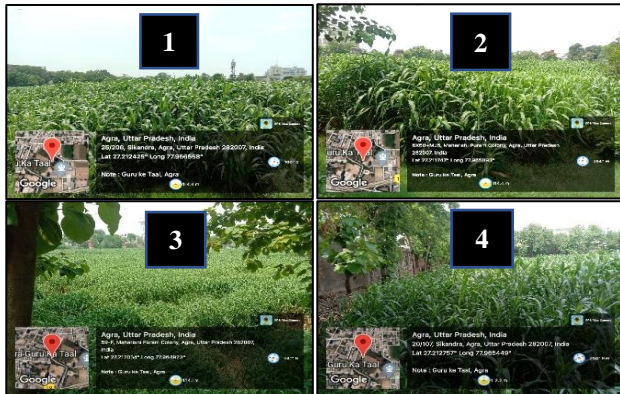
Fig. 3 Geo-tagging of the points of the taal.

The team visited the site, did a survey, and analyzed the current site condition. The geo-tagging of the waterbody with its latitude and longitude has been done. The water body is in a lost condition. A lot of vegetation is present at the site in the current scenario. Also, the team conducted a total station survey at the site and drew the site's contour. From the contour map, it can be inferred that the ground

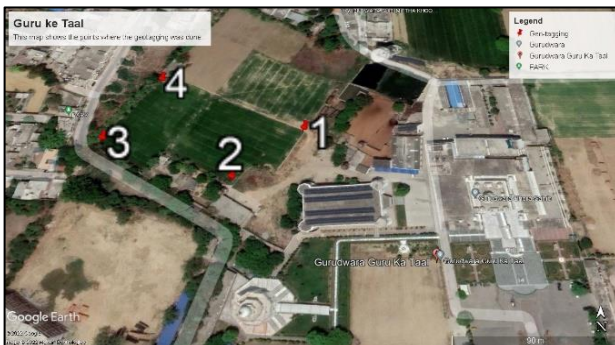
Fig. 4 Google Earth Images of the waterbody showing the positions of the geo-tagged location.

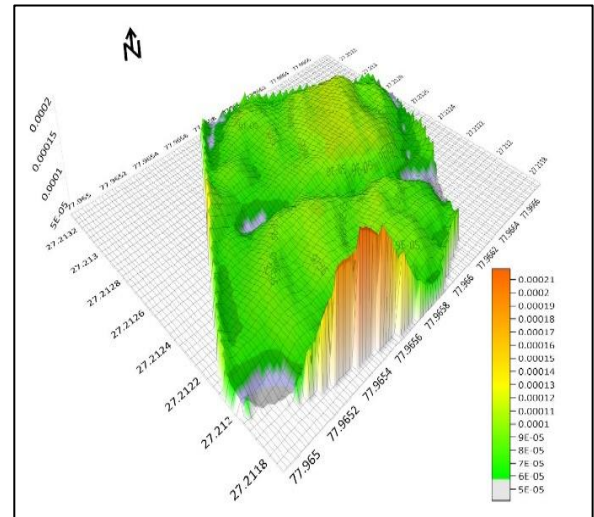
Fig. 5 Contour Map of Guru ka Taal

surface is uneven and de-silting and levelling off the ground needs to be done as the first step in rejuvenating the guru ka taal.

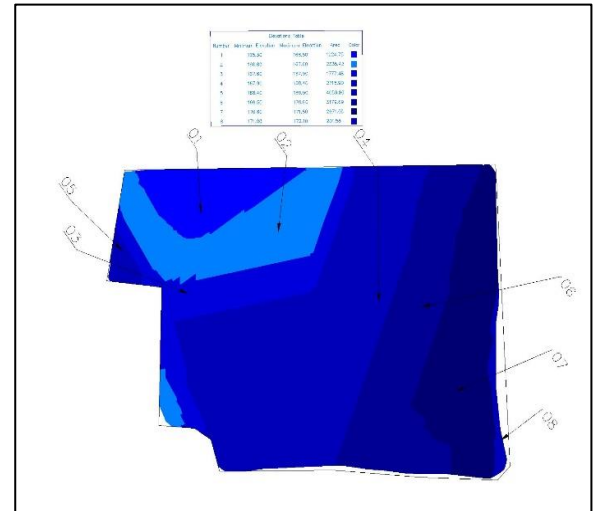
Fig. 6 Elevation profile of taal

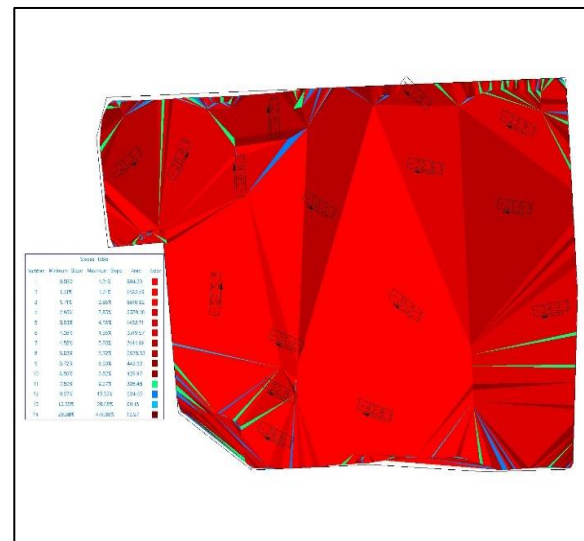
Fig. 7 Slope profile of taal

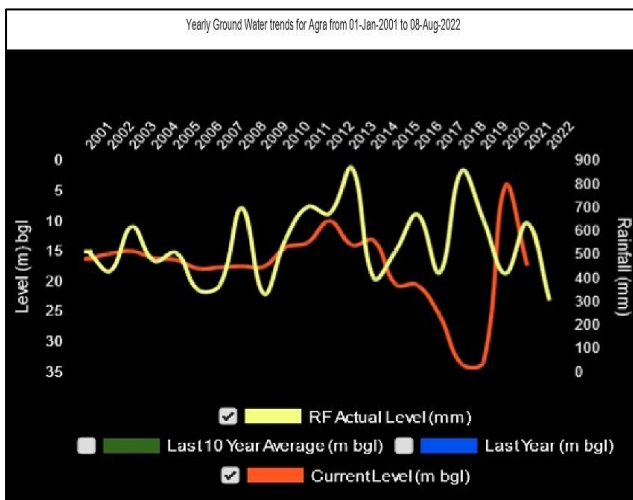
Fig. 8 Last 22 years' groundwater table data

The chart showing the groundwater table level for the last 22 years is shown:

Groundwater is playing a vital role in the fulfilment of drinking, irrigational and industrial needs of the area, as it is a highly dependable, safe and replenishable natural resource. But, It has been observed that the ground water table is declining gradually, which means the water table below the ground level is increasing yearly.

The issues a, b and c were found at the investigation site (guru ka taal). The techniques that have been proposed on the basis of groundwater table data are the following:

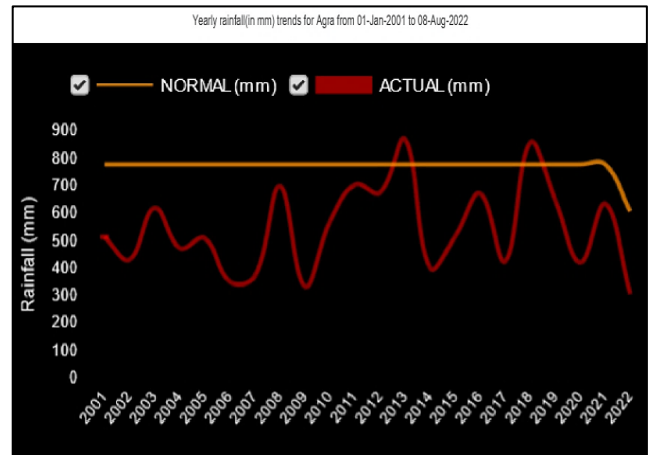
The normal annual rainfall of Agra is 751.37 mm. The chart of Rainfall data for the last 22 years is shown:

Fig. 9 Last 22 years' rainfall data

The reports of the Central Water Ground Body (CGWB) indicate that the major problem of rainfall or monsoon water in Agra is that most of the rainfall water in Agra is drained out as surface runoff by different rivers and suffers evaporation losses. This loss is almost 80% of the total rainfall. It means only 20% of the rainwater is recharging the sub-surface aquifers.

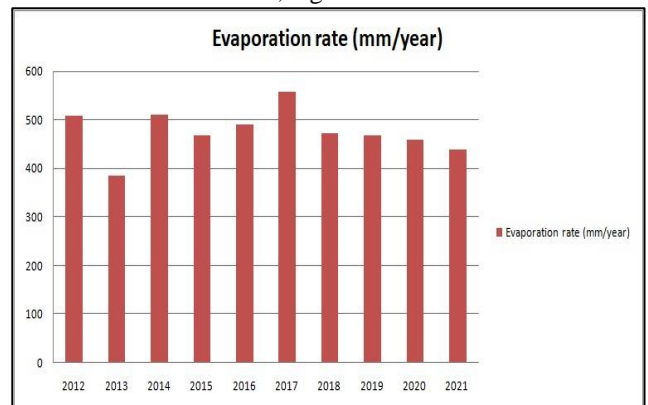
Also, the evaporation data chart has been incorporated to show the yearly variation of evaporation loss at Gurudwara Guru ka Taal, Agra.

Fig. 10 Last 10 years' evaporation rate data

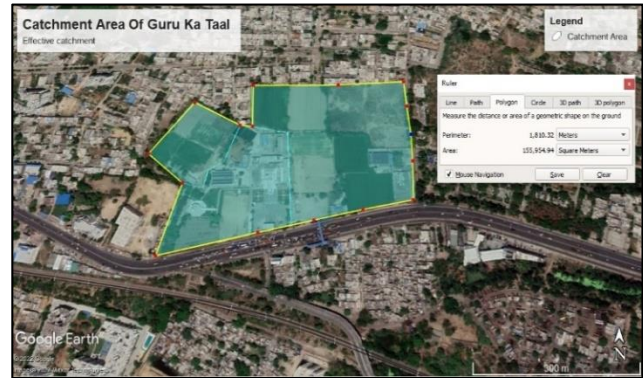
The catchment area to collect all the rainwater or stormwater has been taken from the property of Gurudwara itself. The catchment area has been marked on the google earth image.

Fig. 11 Catchment area of Guru ka Taal

Although the actual rainfall intensity is less in Agra, some rainwater will collect in the catchment area, and due to the slope, it will directly lead to the taal.
