NGA ROW Scoping Document

V4.0

2/179 MCLEOD RD

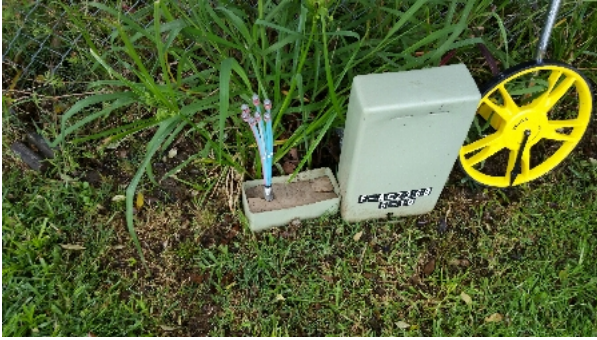
Appendix 1
11/25/16 2:42 PM

| Question | Response | Details |
|---|--|---|
| Drop off located? | Yes | |
| Take photo(s) of drop off clearly showing number of tubes & location relative to ROW landmarks. | | |

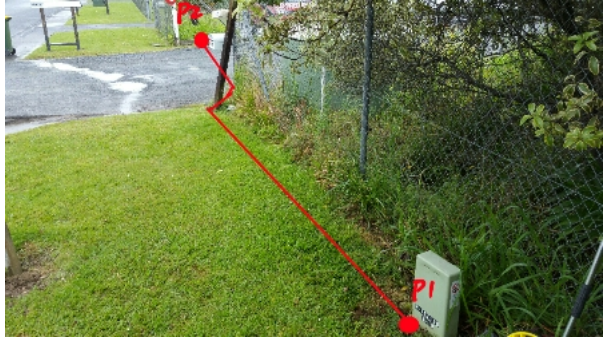
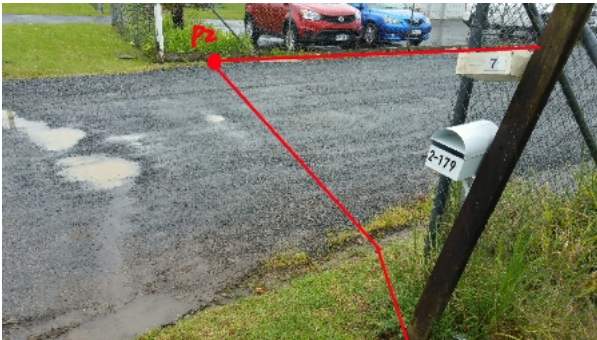
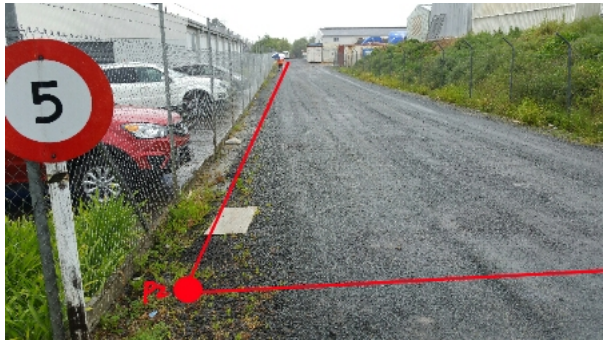
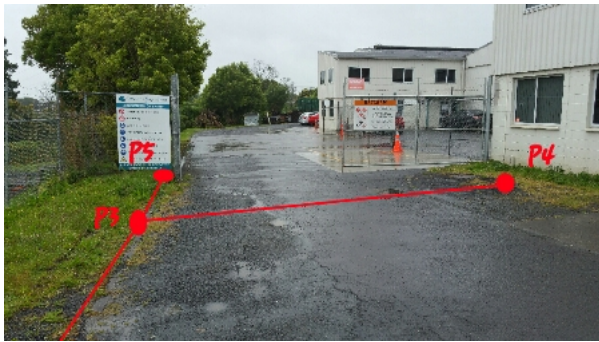
| Question | Response | Details |
|---|--|---|
| Step by step description of build. Format Px-Py, activity, distance, infrastructure; e.g. P1-2, T in grass 5m, 3xR Key: MT - microtrench; T - trench; H - haul; LL - lift & lay; R - ruggedized; D - duct; C - concrete | P1 Connect 2xR to d/off in pedestal P1-P2 T in grass 8m. T in gravel hard surface 7m 2xR. P2-P3 T in gravel hard surface 155m lay 2xR. P3-P4 MT in seal 10m 1xR P4 leave d/off for 2/179 (Req). P3-P5 T in grass 3m 1xReq P5 leave d/off | |
| Add aerial & photos for design. Blue - existing; Red - build; Purple - future or for provisioning. | | |

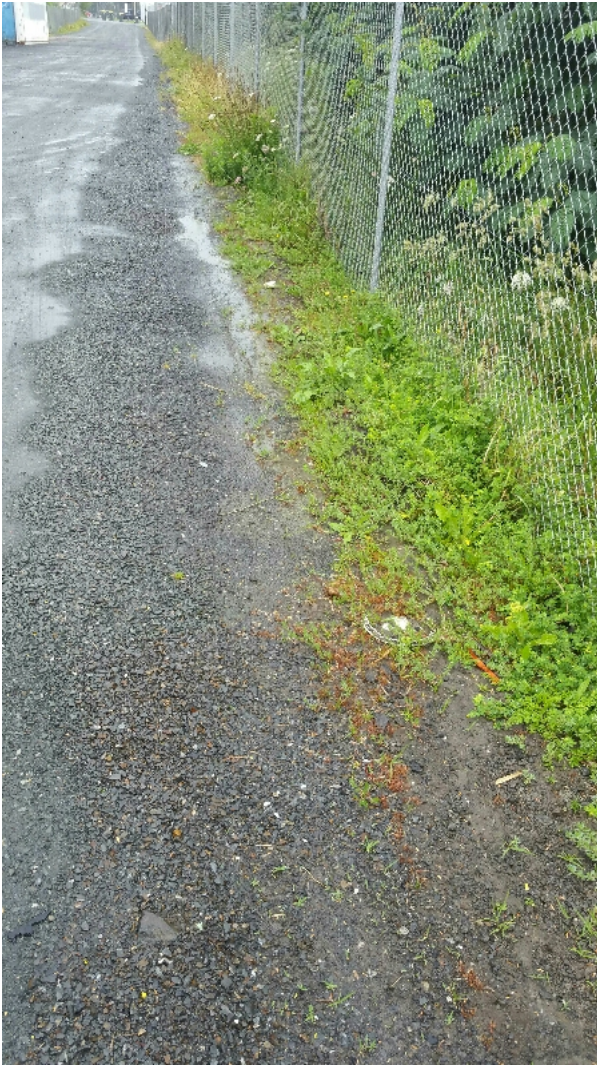
Appendix 7
11/25/16 3:08 PM

| Select Main ROW Build Methodology | Hard Surface Trench - Standard Reinstatement: N-ROW7 | |
| Explain why? Are there any surface mount options available? Why were they not used? Are the transitions between surfaces possible, can the bending radius be maintained etc. | No fence available for s/mount and surface is only loose gravel. | |
| Take photo(s) clearly showing any surface or route expected to mount infrastructure on or build including transition points, e.g. Retaining walls, fences, existing pits, BDDs duct entry & exits etc. Or any other picture as required to support photos already in scoping section. | | |
