Tracking California's Trash Project

Evaluation of Street Sweeping and Curb Inlet Screens as Measures to Control Trash in Stormwater

State Water Resources Control Board Grant Agreement No. 12-420-550

December 2016

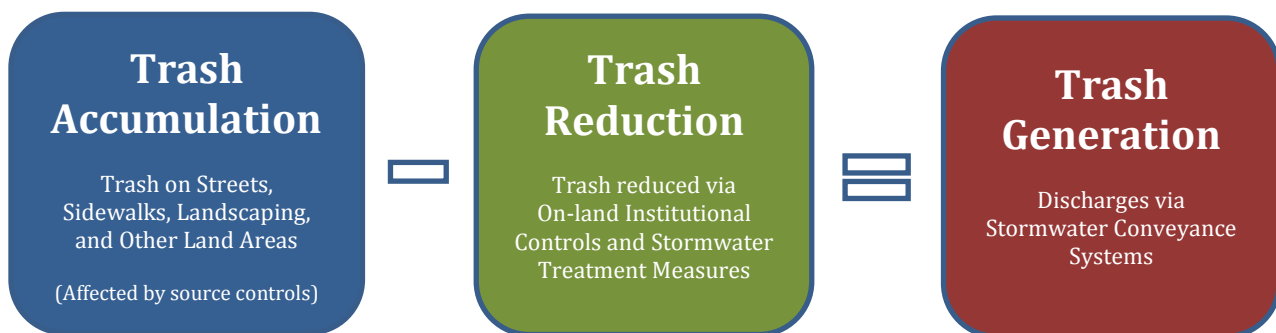
Figure 1.1. Relationship between trash accumulation, reduction and generation.

Reductions in amount of trash generated (i.e., discharged) via stormwater conveyances is the ultimate goal of the trash reduction requirements summarized in the previous section. Reductions in the amount of trash that accumulates onto land areas, is transported to storm drain inlets, and/or is discharged from the stormwater conveyance system can assist municipalities and other public agencies in addressing these requirements. Figure 1.1 illustrates the relationship between trash accumulation, control measure implementation, and trash generation.

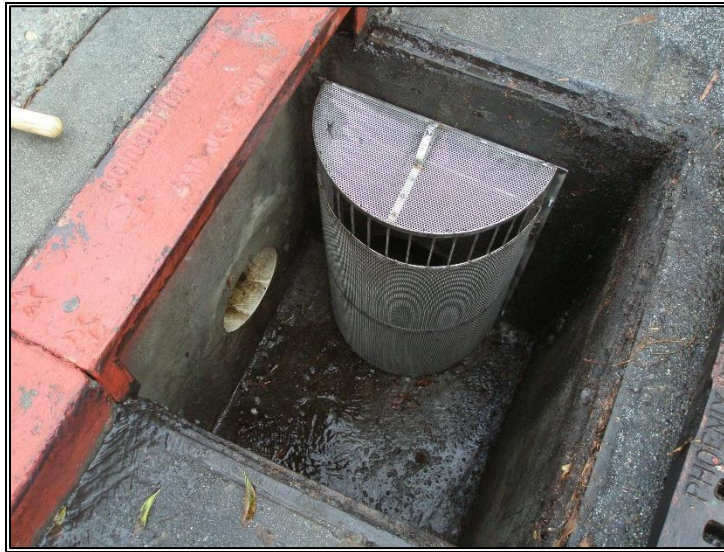
Figure 1.2. Example small full-capture device used as a monitoring site.

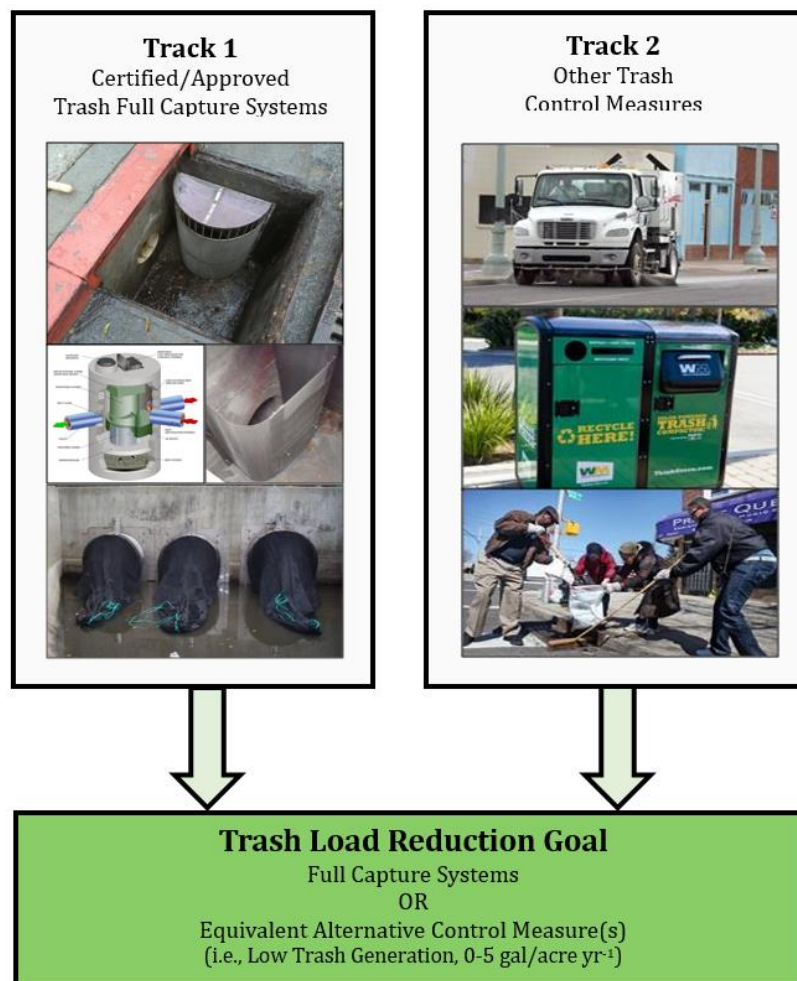
Figure 1.3. Compliance tracks outlined in the State Water Board's Trash Amendments and the trash load reduction goal for municipal stormwater in the the San Francisco Bay Area.

Figure 1.3 illustrates the compliance tracks (i.e., Track 1 and 2) outlined in the State Water Board's Trash Amendments and the methods described in NPDES municipal stormwater permit for the San Francisco Bay region that municipalities currently utilize to determine the load reduction benefit of alternative trash control measures. Figure 1.3 also presents the trash reduction goals outlined in the Bay Area permit – trash full capture systems or equivalent alternative controls, or low trash generation (0-5 gallons/acre yr-1).

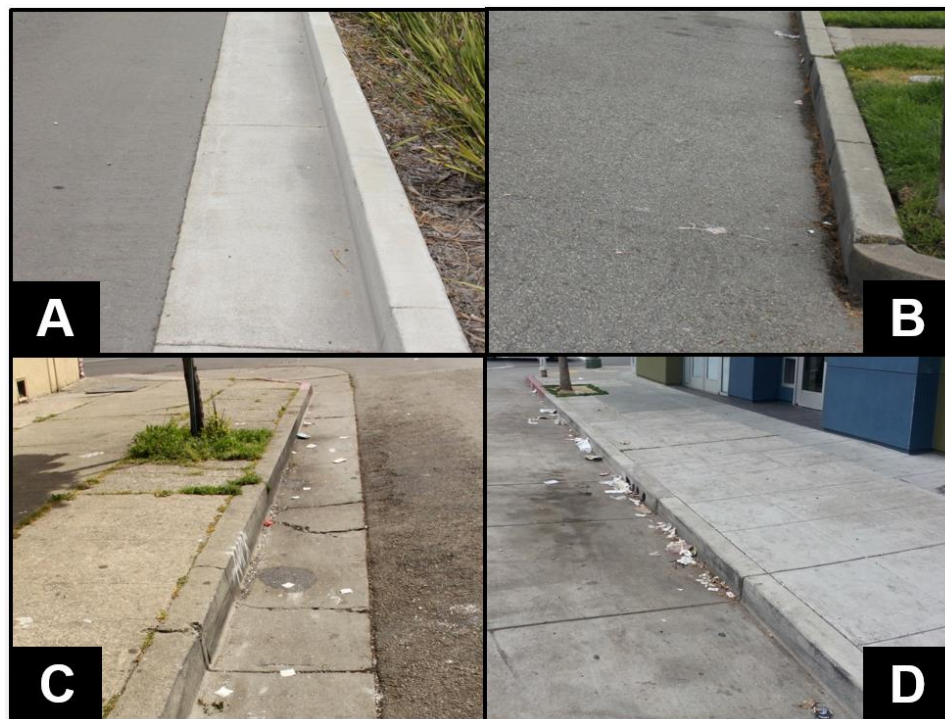
Figure 2.1. Example photos of On-land Visual Trash Assessment scores.
