DrainDomain.Com

Pitch Fibre Pipe Work

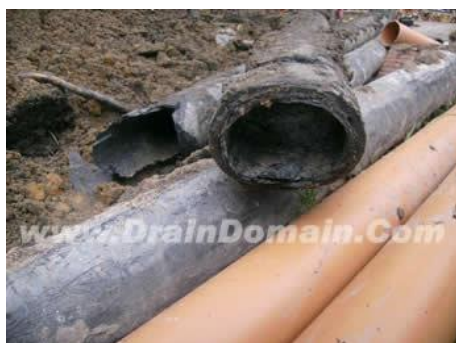
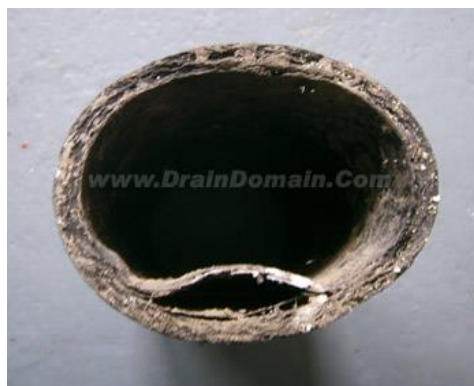
The image above shows a cross section of a 100mm pitch fibre drain we excavated and you will note the large blister in the base of the pipe where the internal layers of the pipe wall have delaminated, you can also clearly see how the pipe has lost its shape and therefore its structural integrity

It will get you both ways, it collapses and becomes misshaped when under any kind of external pressure and as usual there was little specification for pipe bedding when it was installed so it relies on the sub-soil for external support.

The internal wall blisters and de-laminates when it come into prolonged contact with water, which with hindsight is not the kind of product that we should have been giving a british standard mark too for the purpose of transferring waste and water from one point to another.
