## When Pitch Trim Systems Turn Ugly

Revision -C- 27 June 2007

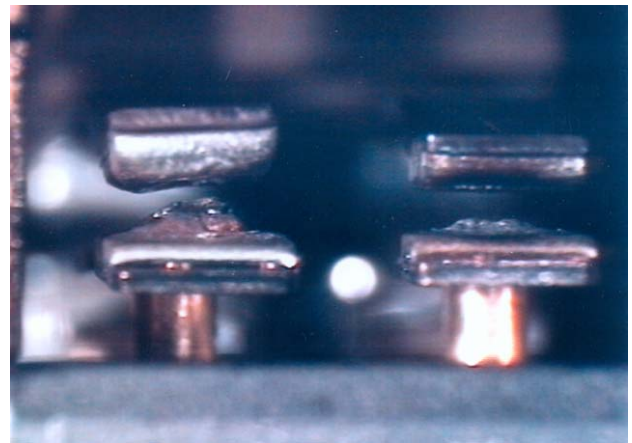
Let's examine the phrase "**no evidence of electrical arcing or other damage**". This photo is of a set of contacts for a relay used in a bizjet trim system. These contacts were subjected to a standard test protocols for

reliability. Such testing is accomplished periodically on production parts to verify continued compliance with specifications. These contacts show severe metal transfer (due to arcing under rated load) but the relays were not

sticking nor were they damaged in a way that prevented a relay from performing as advertised.

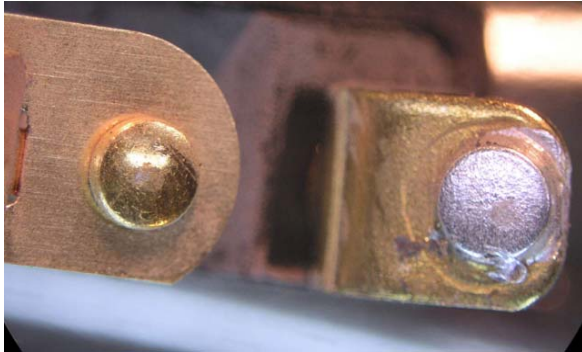
On the other hand, here are a pair of mating contacts that show only the tiniest hints of electrical stress after perhaps 2,000 cycles and they were *failing* to make connection! Visual inspection of these contacts did not reveal why an expected event didn't happen, yet the malfunctioning contacts were visually "perfect".

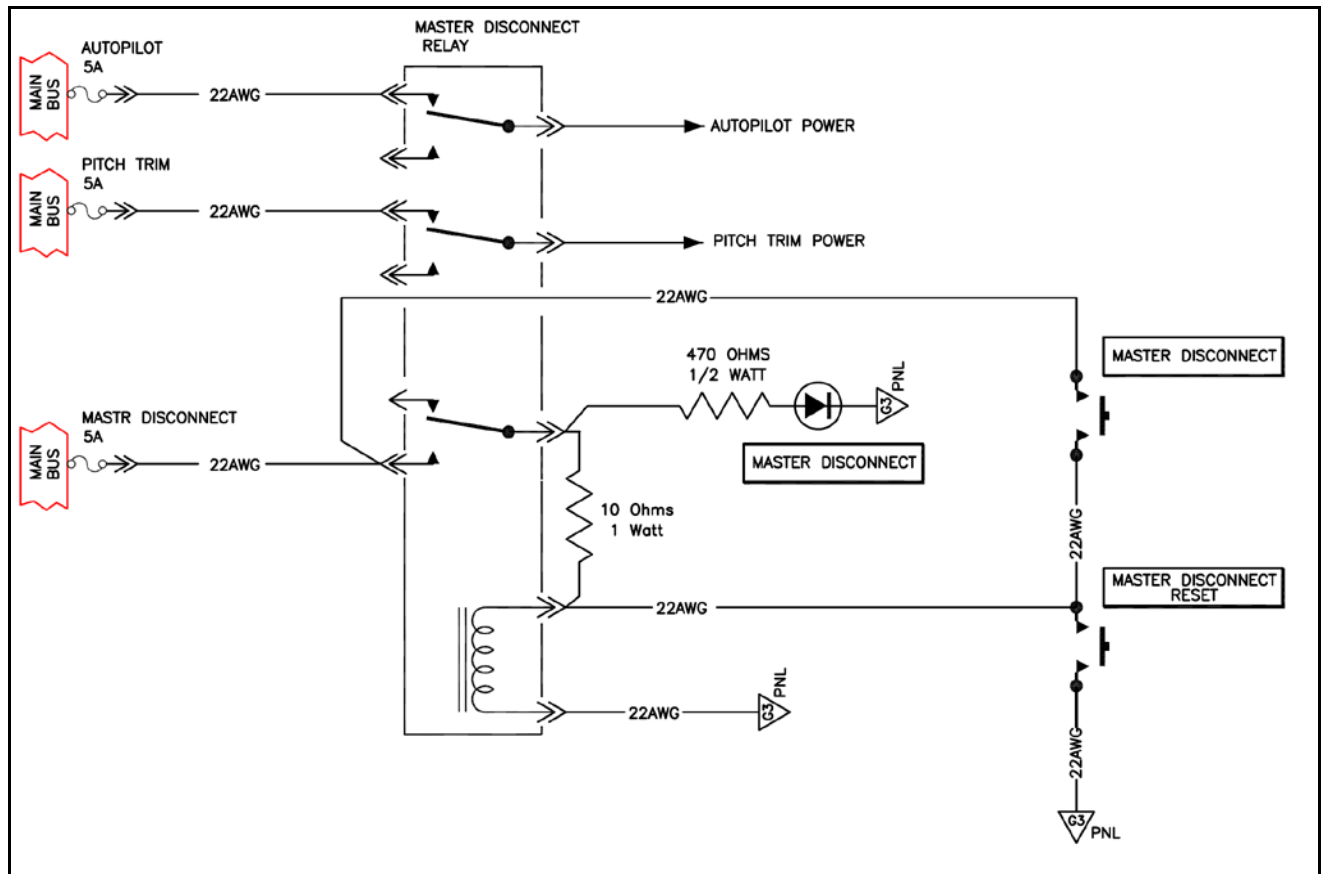
Figure 1. Master Flight Motors Disconnect System.

If you don’t want to go the **Press for Trim Enable** route, consider the equivalent of the **Wheel Master Disconnect** button. The schematic in Figure 1 describes one approach to a Master Disconnect system capable of handling any and all power paths to motor driven flight controls. The relay used needs one more pole than the number of systems being controlled. Alternatively, the relay can be a combination of 2 or more relays with the coils wired in parallel.

The goal is to provide a means by which operation of a single switch preferably on the control stick or wheel grip can be quickly operated at the first perception of a malfunctioning flight controls motor. The system is reset by a second button elsewhere . . . perhaps right next to the Master Disconnect warning light.
