geändert, changed		21/04/2023		TOR		C0148385		Replacement of the SBC: TJA1028TK from NXP is used																					
Darf nicht manuell geändert werden May not be changed manually		Datum		Date		Name		Name		TAE-Nr.		EC-No.		Änderungsbeschreibung						Change-description									
														Massstab		Scale		Dok. Nummer		Doc. number		Änd. stand		Rev. level					
														none				DOC02045309				08							
		Erstellt Drawn		09.01.2018		L. M. Tortosa								Oberfläche		Surface Coating													
		Gepr. Checked		10.01.2018		I. Ameijeiras										--				Klassifikation		Classification		Dok. typ		Doc. type			
		Norm Appr.		11.01.2018		D. Rodriguez																		PCBSTUFF					
						Leopold Kostal GmbH & Co. KG Automobil - Elektrik Luedenscheid								Allgemeintoleranz				General Tolerance											
						DIN ISO 2768 (f)																							
		Projekt-Nr. Project-No.				P07520										Halbzeug		Material Form				Variant 1		RCE basic

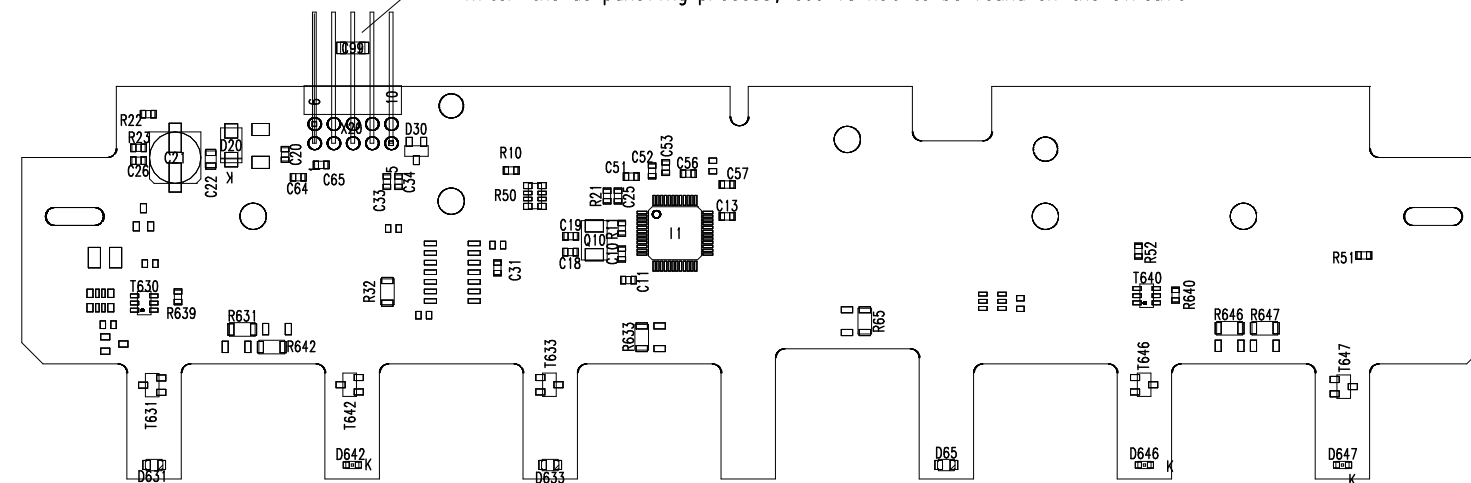
TOP

Capacitor C99 is assembled on the waste part of the panel, outside the PCB.  
Its aim is that the horizontal pins of the connector lean on it during  
the electronic assembly process, so the connector keeps its right position.  
After the de-paneling process, C99 is not to be found on the circuit
