The Heterodyne

Editor: Loren Singh, AD6YU — ad6yu@yahoo.com

Call Sign	Name	Home Location (QTH)
AD6YU	Loren	San José
AF6AR	Shawn	Sunnyvale
AF6DS	Peter	Sunnyvale
K6JCA	Jeffrey	Los Altos
K6TXD	Gerald	Sunnyvale
K6PHL	Phil	Sunnyvale
K6XOX	Nimit	San José
K9ZPY	Dale	San Francisco
KA2COB	Donald	Sunnyvale
KC6POF	William	Daly City
KD6FJI	Lloyd	San José
KG6SCE	Walter	San Francisco
KI6AZB	Ronald	Cupertino
KI6FZB	Stuart	Brisbane
KI6UH	Gordon	Brisbane
KN6LV	Gary	San Leandro
NC6D	David	San Francisco
NK6U	Robert	San José
WB6IQN	Ed	Sunnyvale

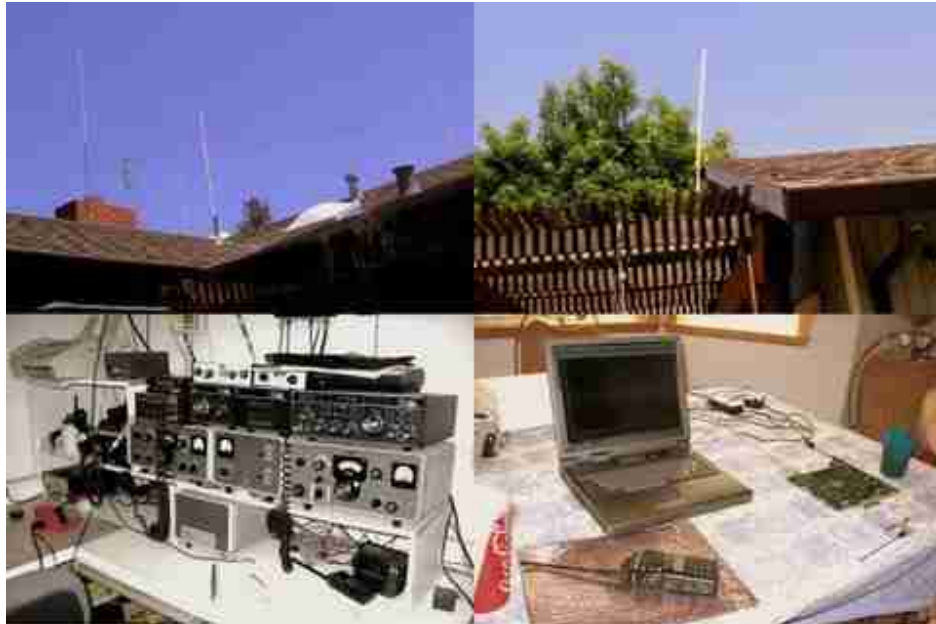
The group recently held a meeting at the home of the club's newsletter editor, Ed, WB6IQN in Sunnyvale. Ed gave a presentation on "A DC-3 GHz Spectrum Analyzer Using Time Domain Sampling." Ed was part of an engineering development team at National Semiconductor that developed a spectrum analyzer built on a printed-circuit board that plugs into a USB 2.0 port. The board measures 8 inches by 8 inches, and can be used with a laptop computer.

Cathay Amateur Radio Club (CARC), August 8, 2009 Meeting— The Cathay Amateur Radio Club (www.cathayradio.org) is a club that several WVARA members also belong to. The club holds a weekly net on Monday nights at 9 p.m. local time on a repeater located in the Oakland Hills, 146.67 (-) MHz, PL85.4. All hams are welcome to check into the net.
