SECTION DETAILS

FRANKLIN CO. ANIMAL CONTROL FACILITY

GEORGE FRALEY PARKWAY
WINCHESTER, TN 37398

A5.21

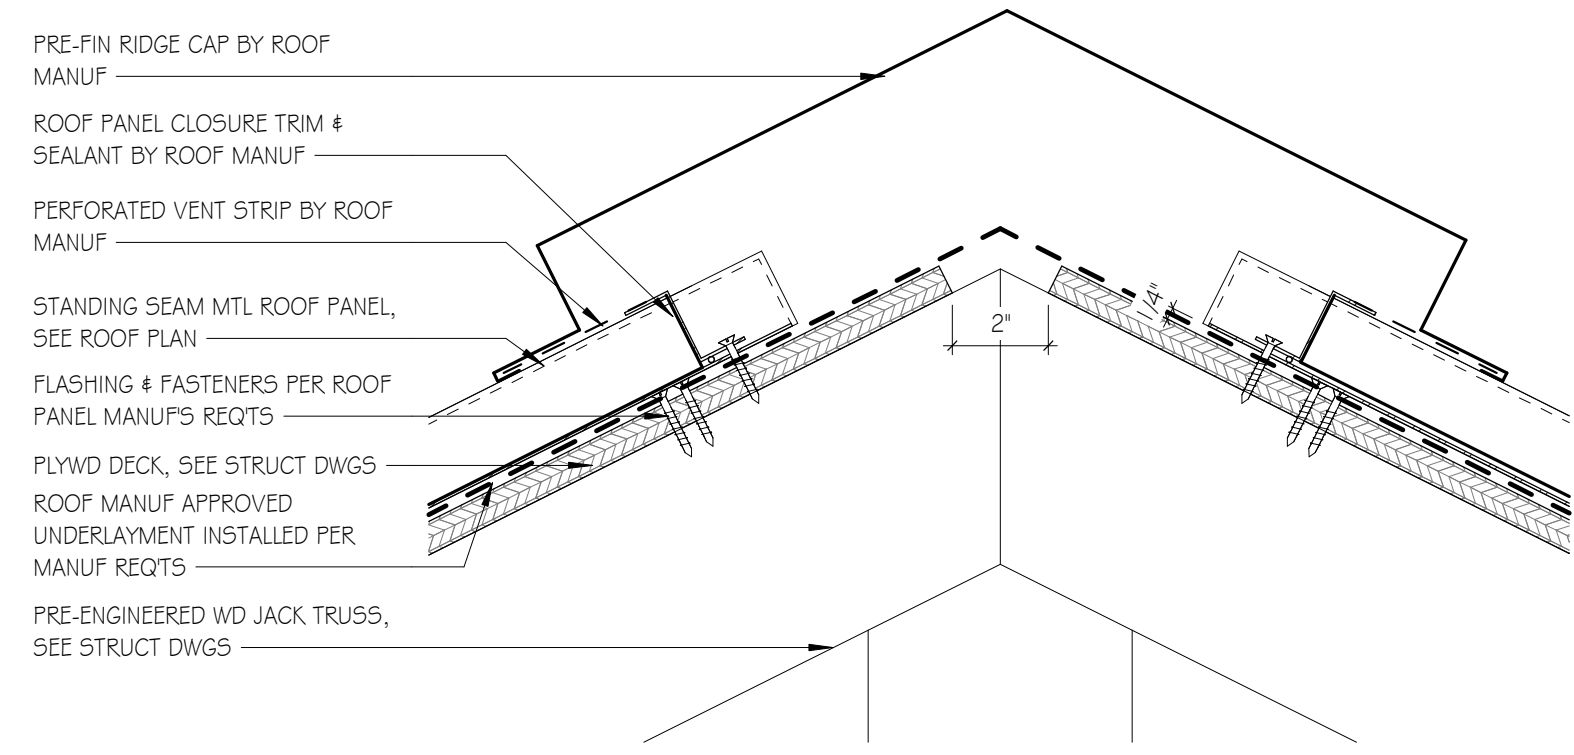
H1 RIDGE VENT CAP DETAIL
SCALE: 3" = 1'-0"

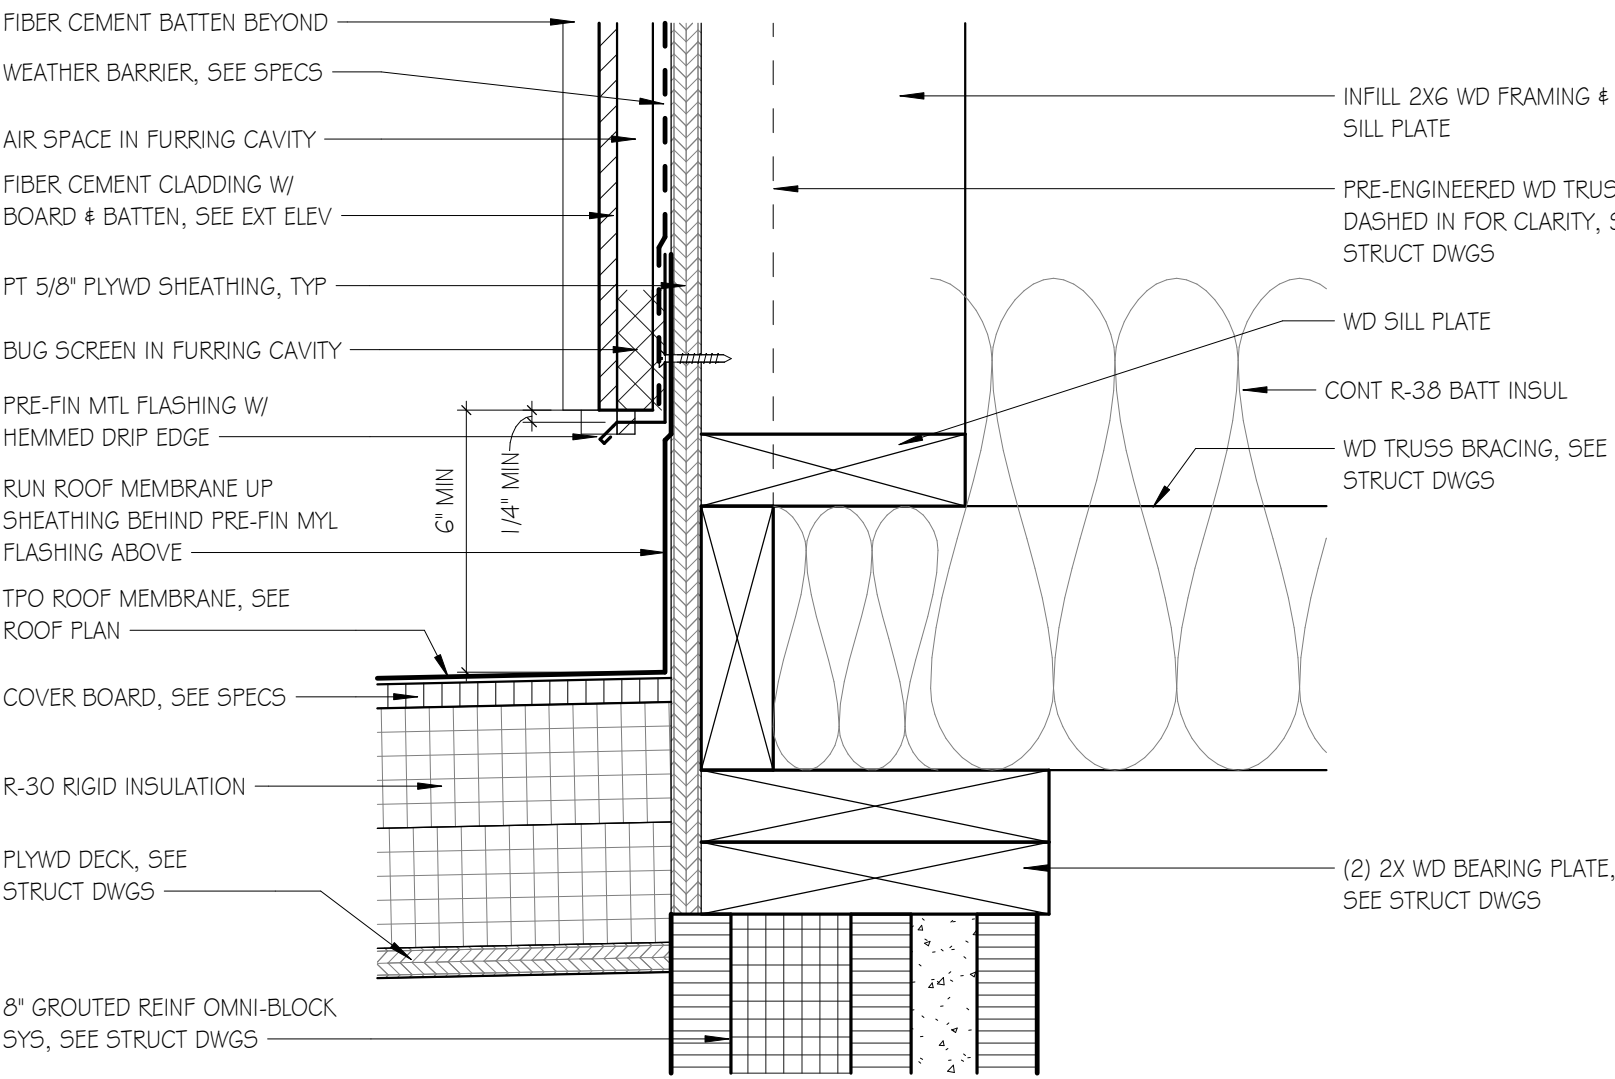
H4 ROOF TRANSITION DETAIL
SCALE: 3" = 1'-0"

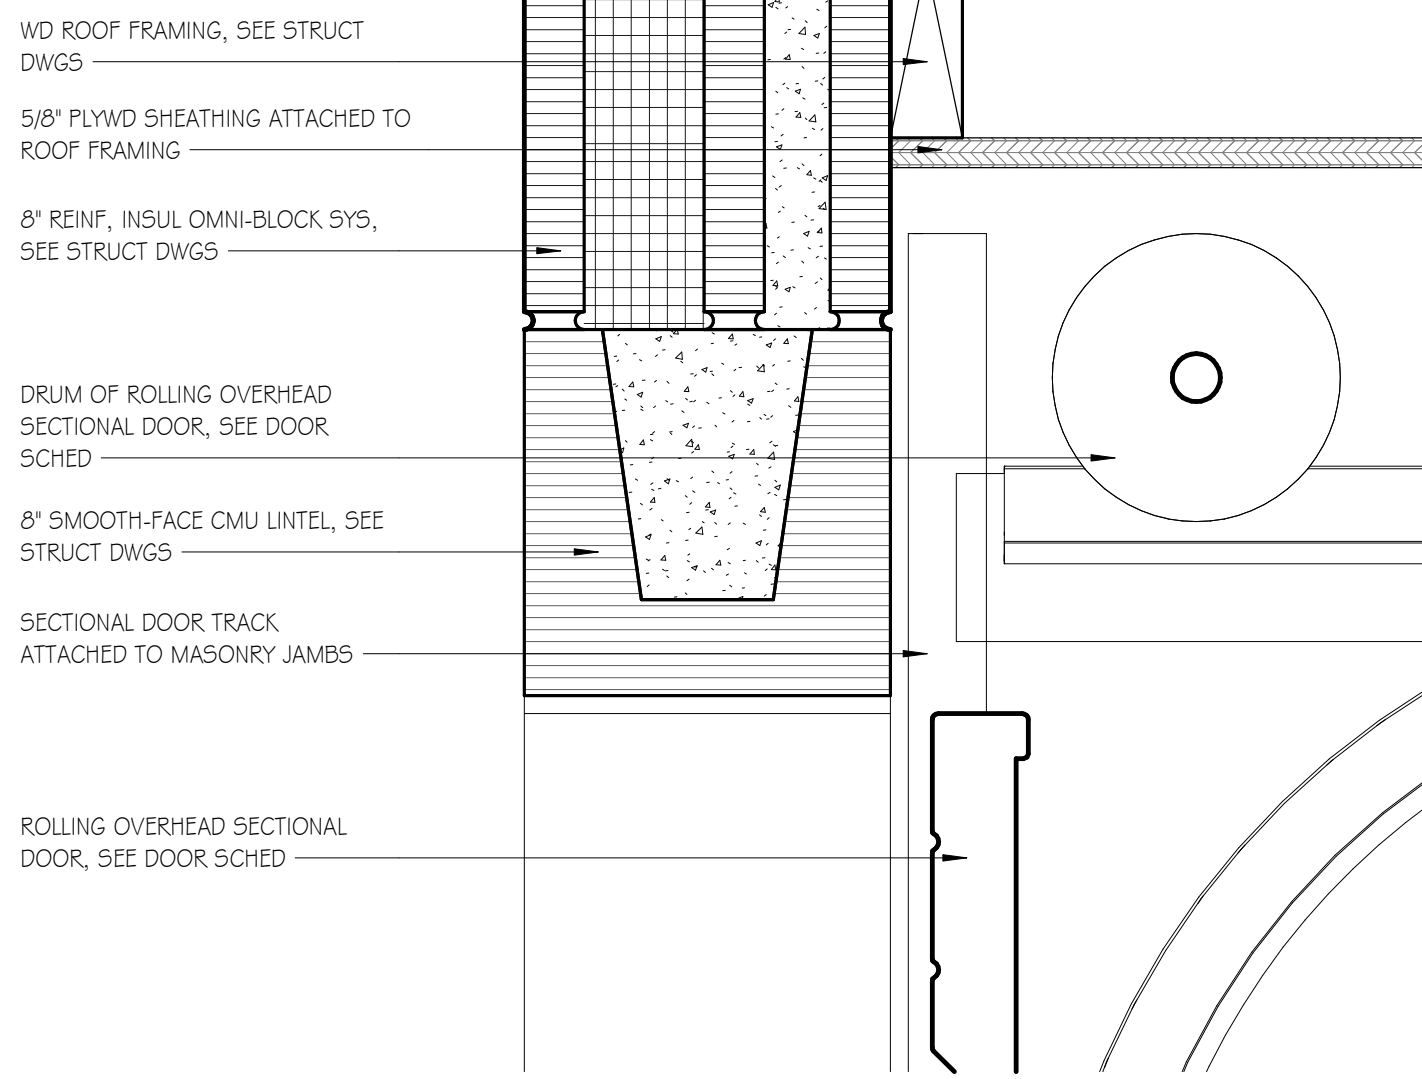
H7 DETAIL AT OVERHEAD DOOR HEADER
SCALE: 3" = 1'-0"

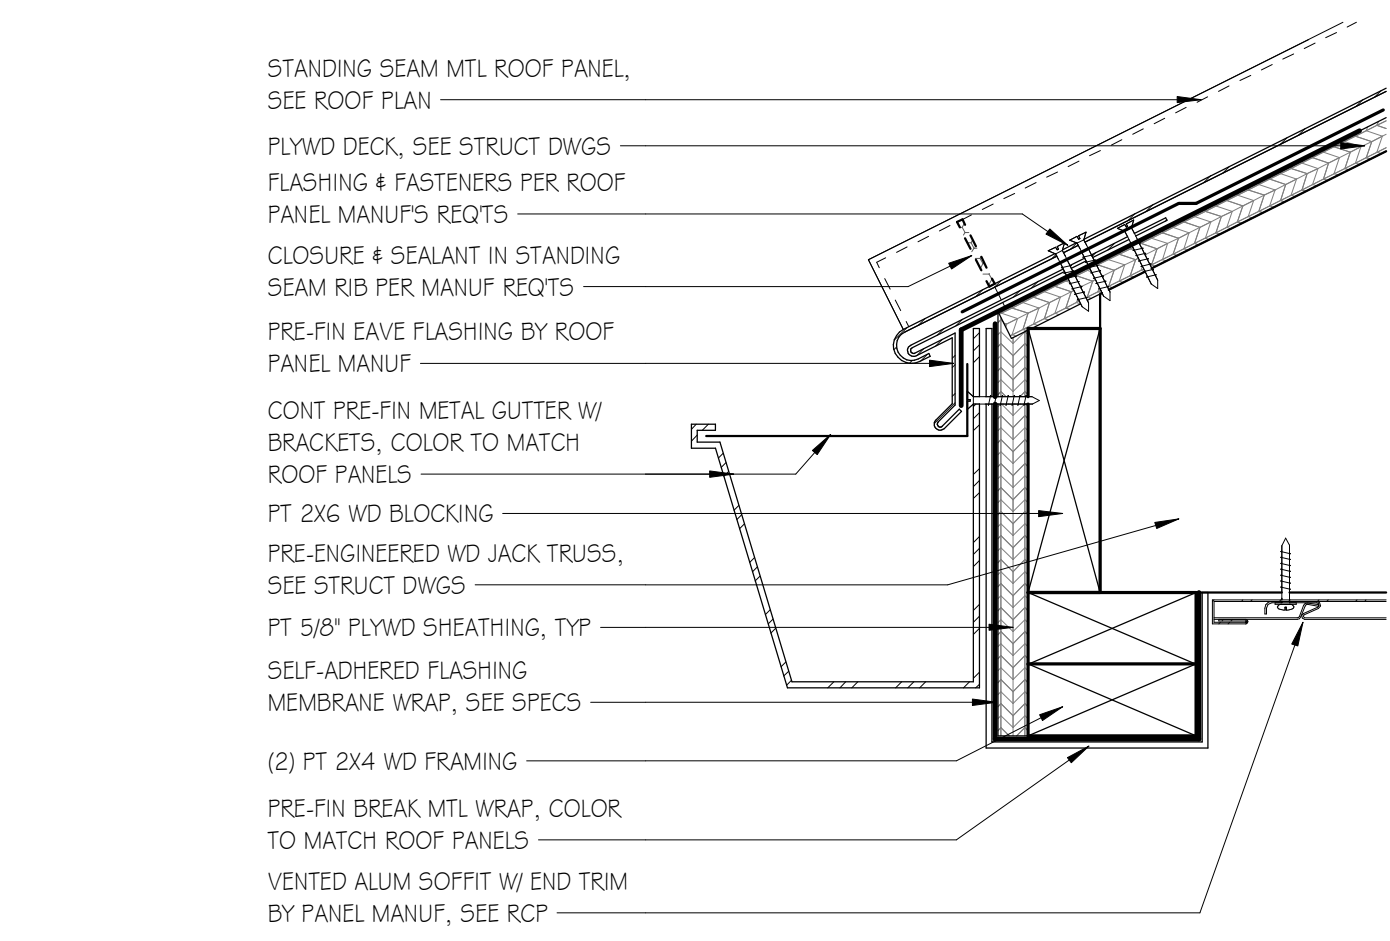
H10 SECTION DETAIL AT GUTTER
SCALE: 3" = 1'-0"

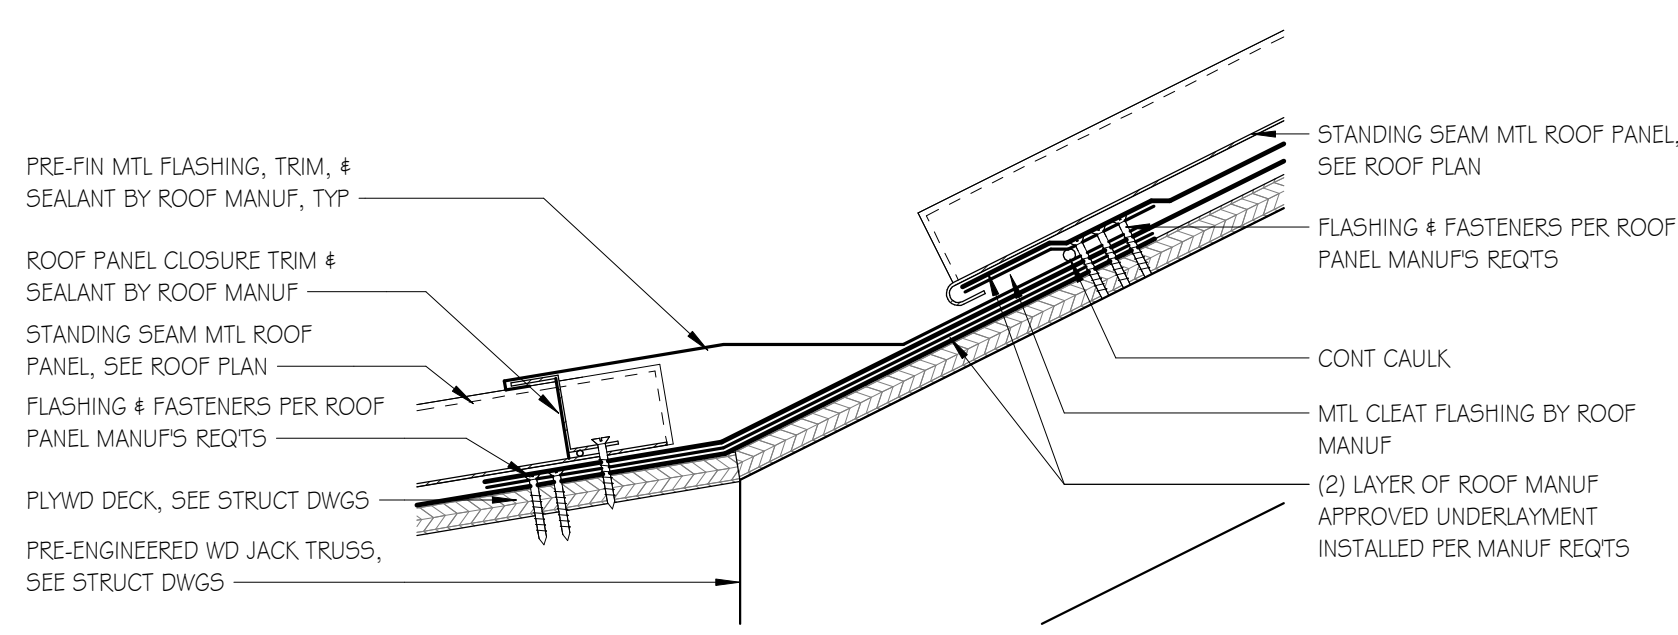
F1 ROOF SLOPE TRANSITION DETAIL
SCALE: 3" = 1'-0"

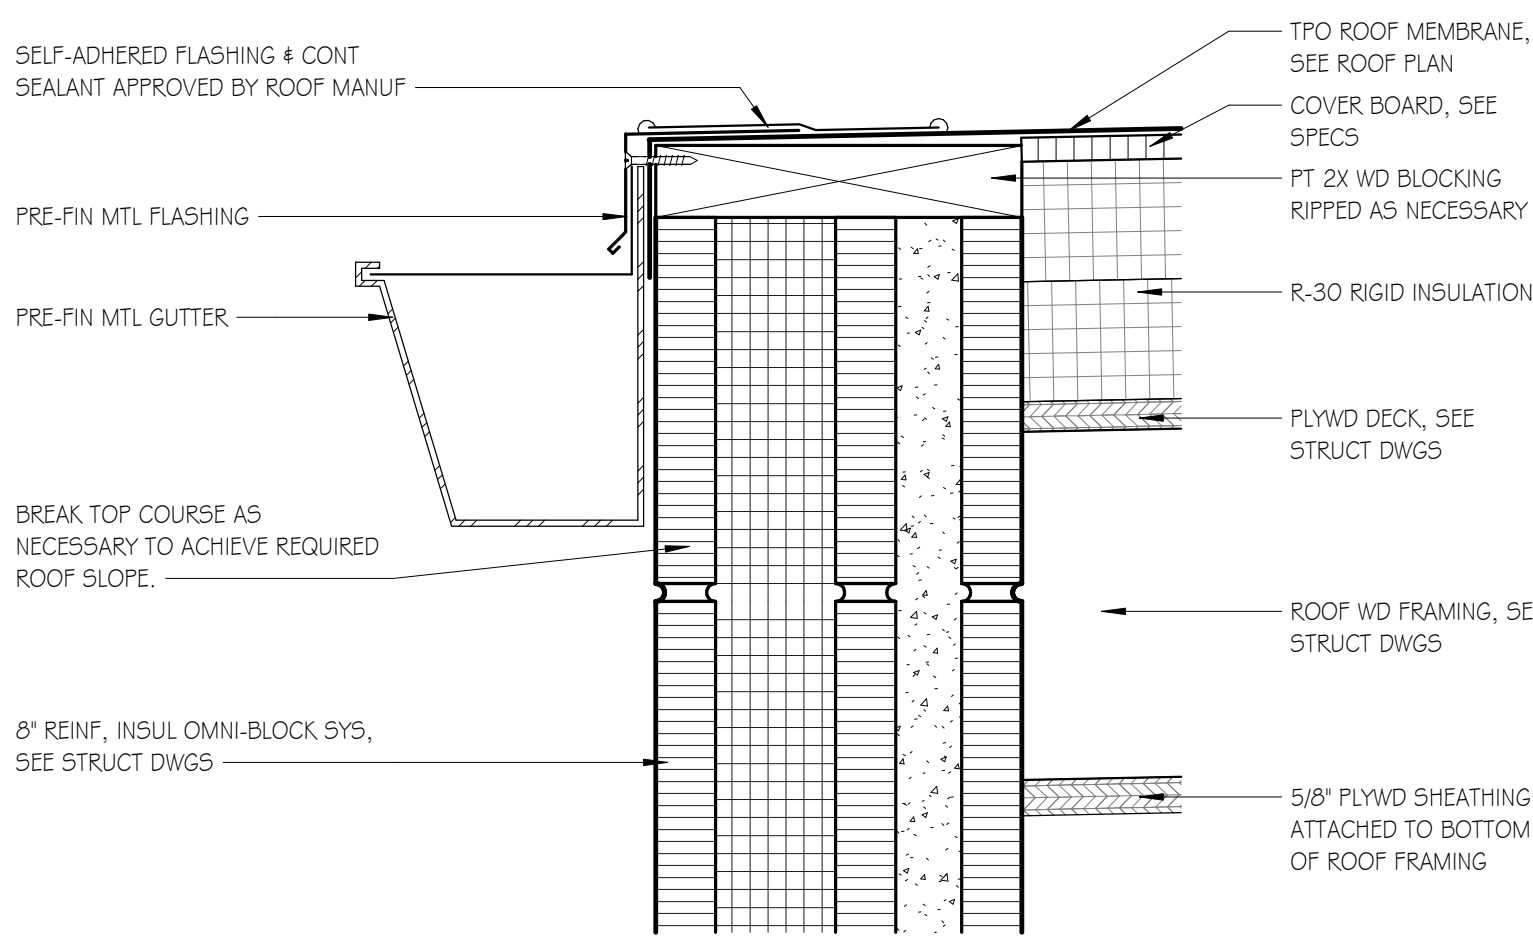
F4 SECTION DETIAL AT GUTTER
SCALE: 3" = 1'-0"

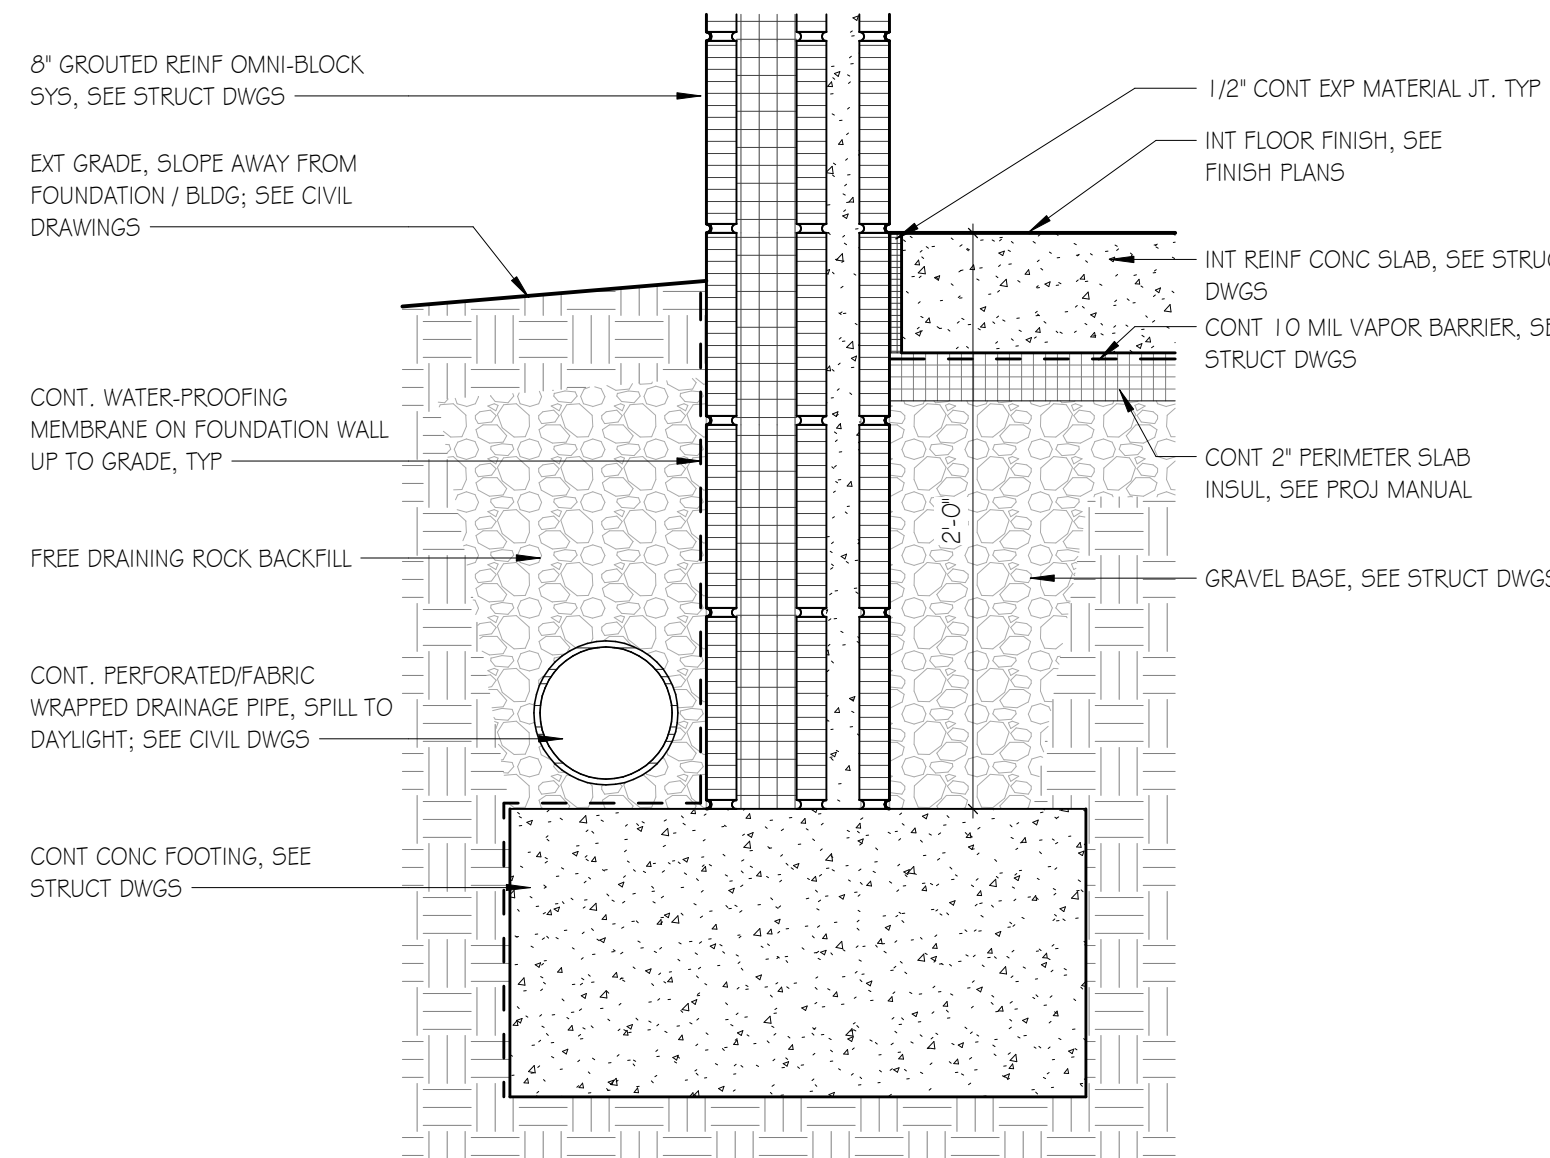
F7 FOUNDATION DETAIL
SCALE: 1 1/2" = 1'-0"

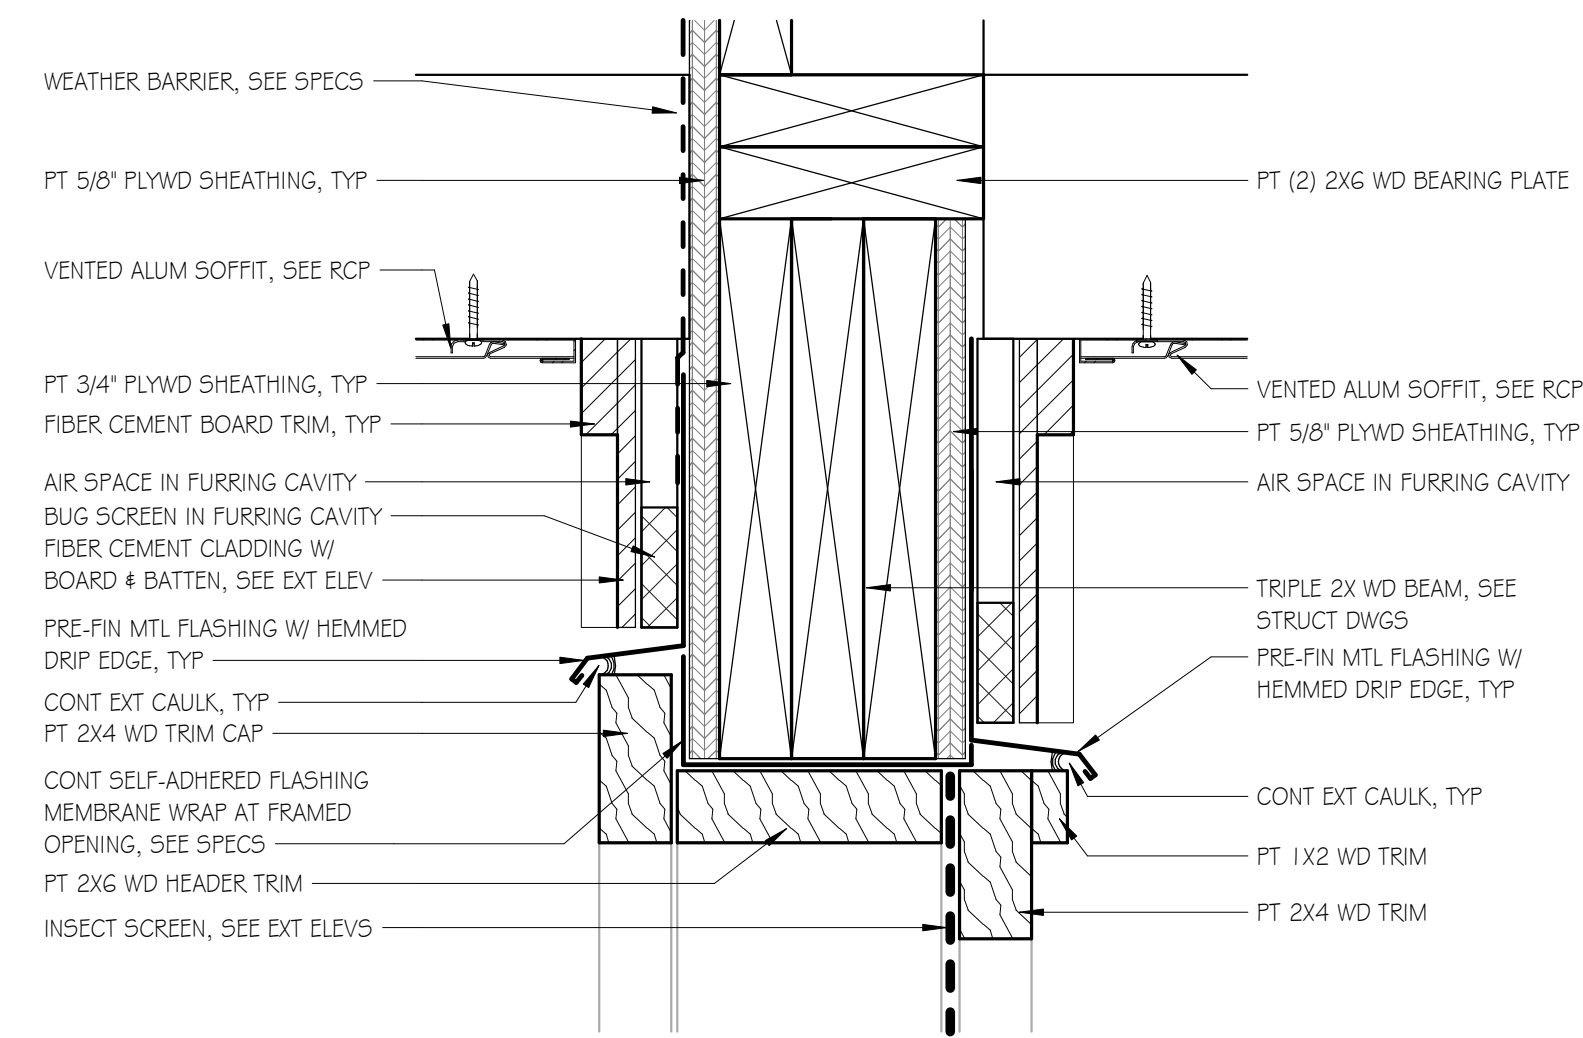
F10 SECTION DETAIL AT INSECT SCREEN
SCALE: 3" = 1'-0"

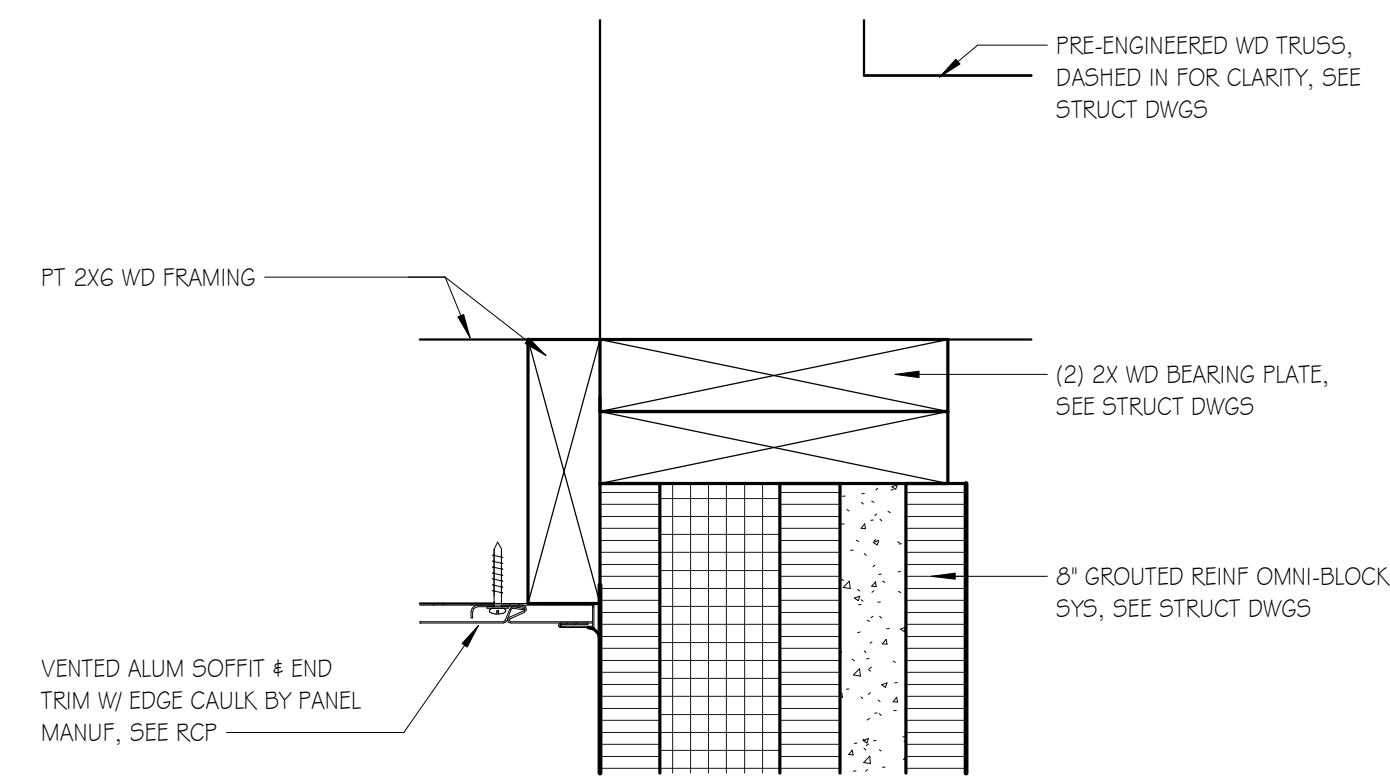
C1 TYPICAL TRUSS BEARING DETAIL
SCALE: 3" = 1'-0"

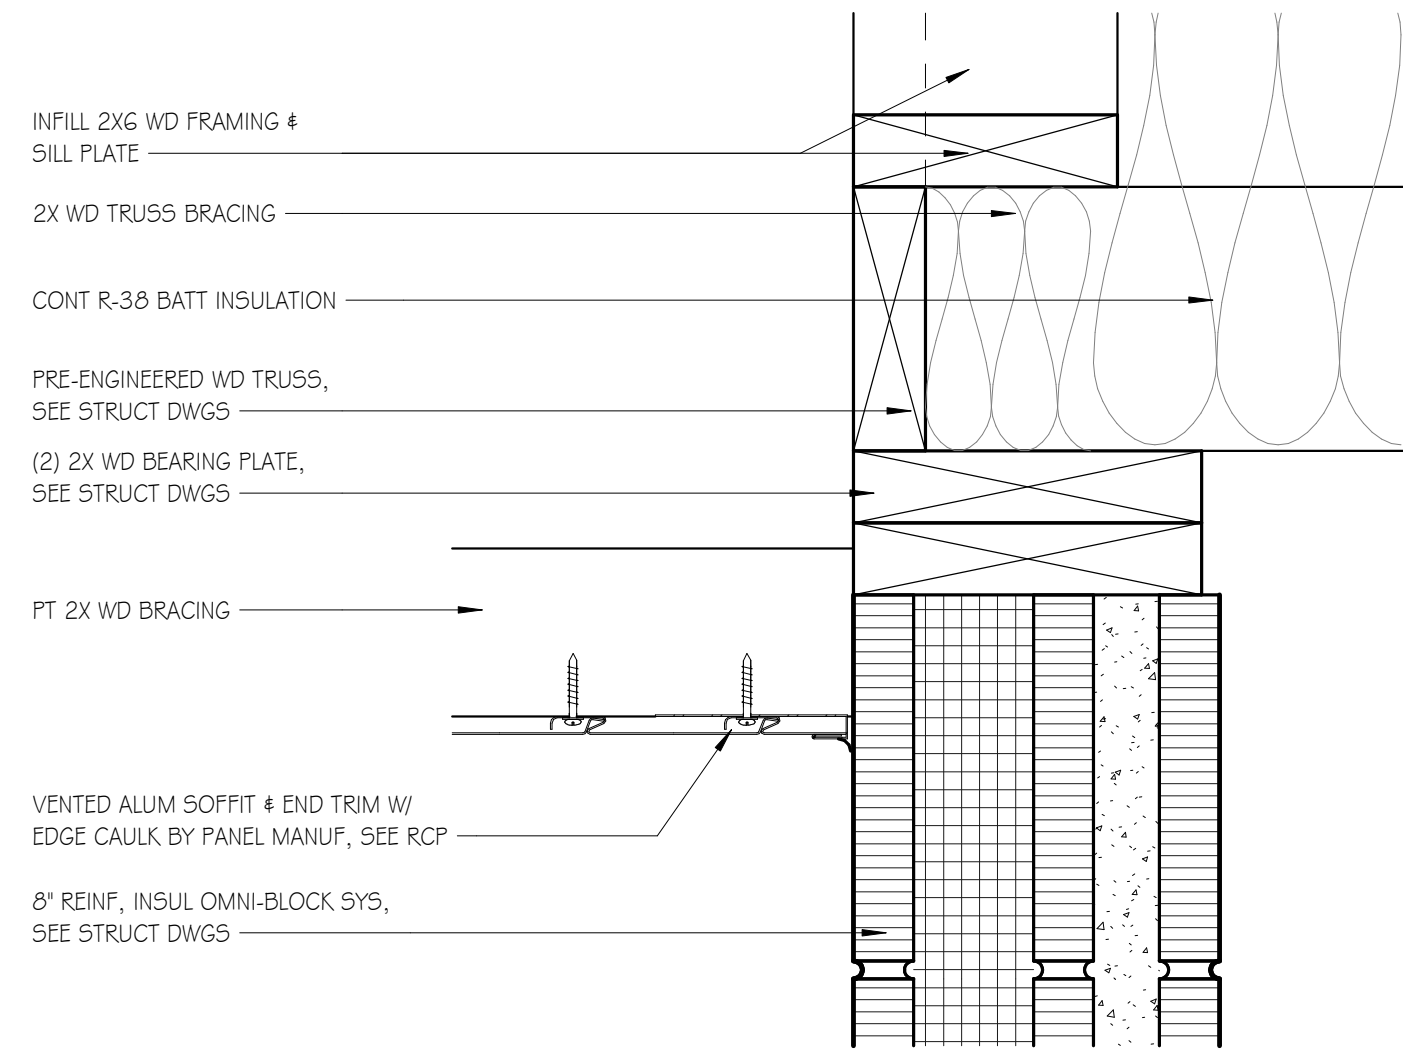
C4 SECTION DETAIL AT BEARING PLATE
SCALE: 3" = 1'-0"

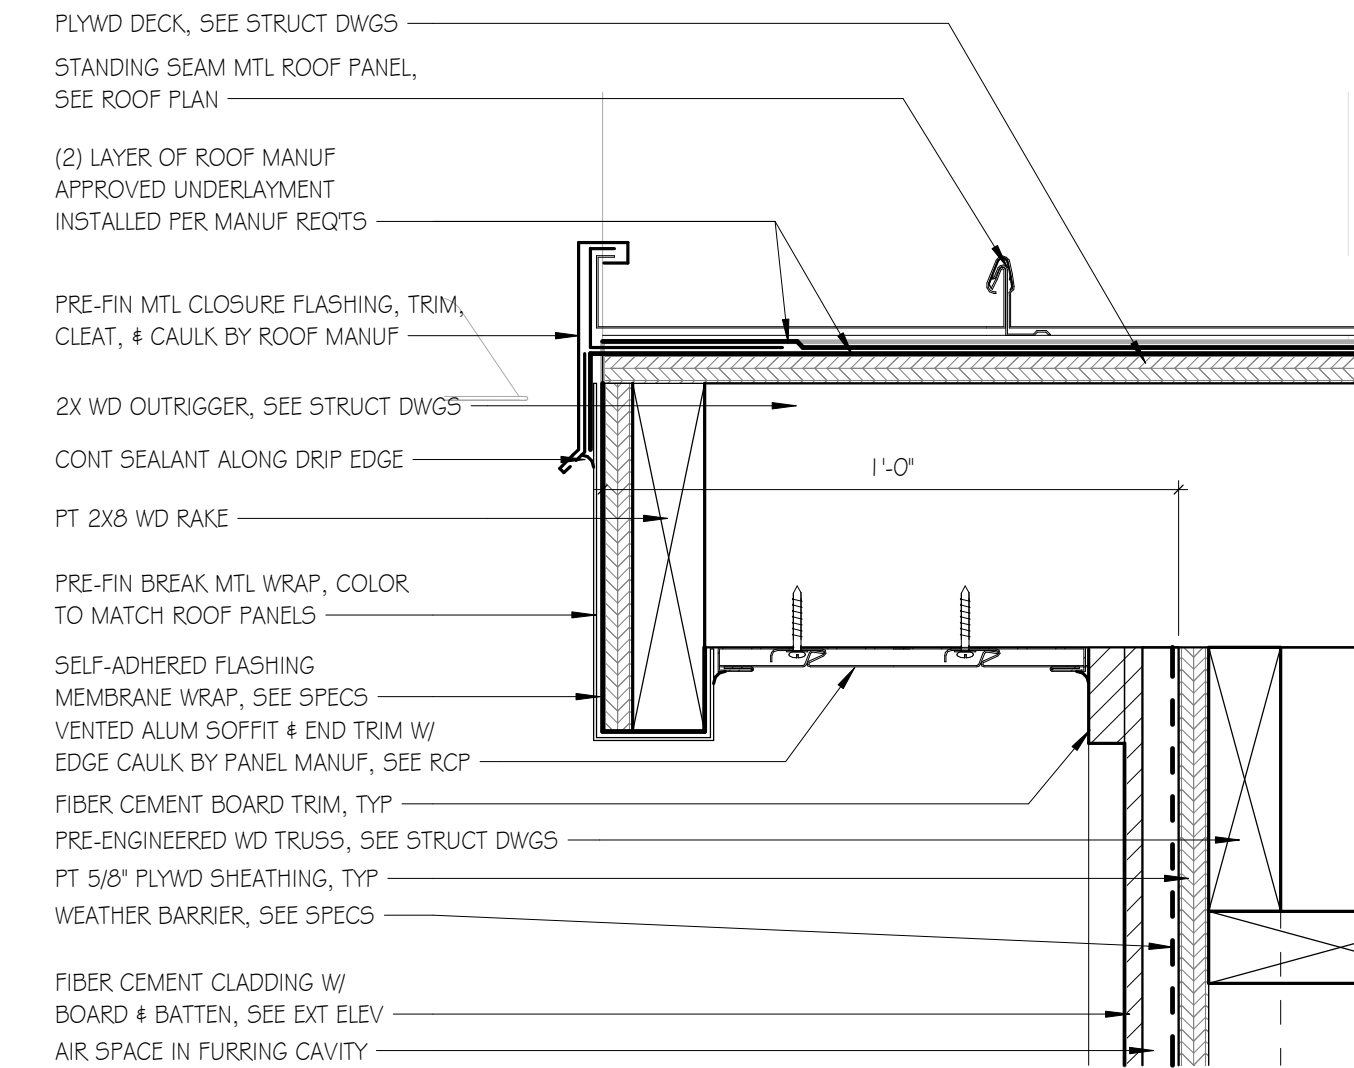
C7 DETAIL AT ROOF RAKE
SCALE: 3" = 1'-0"

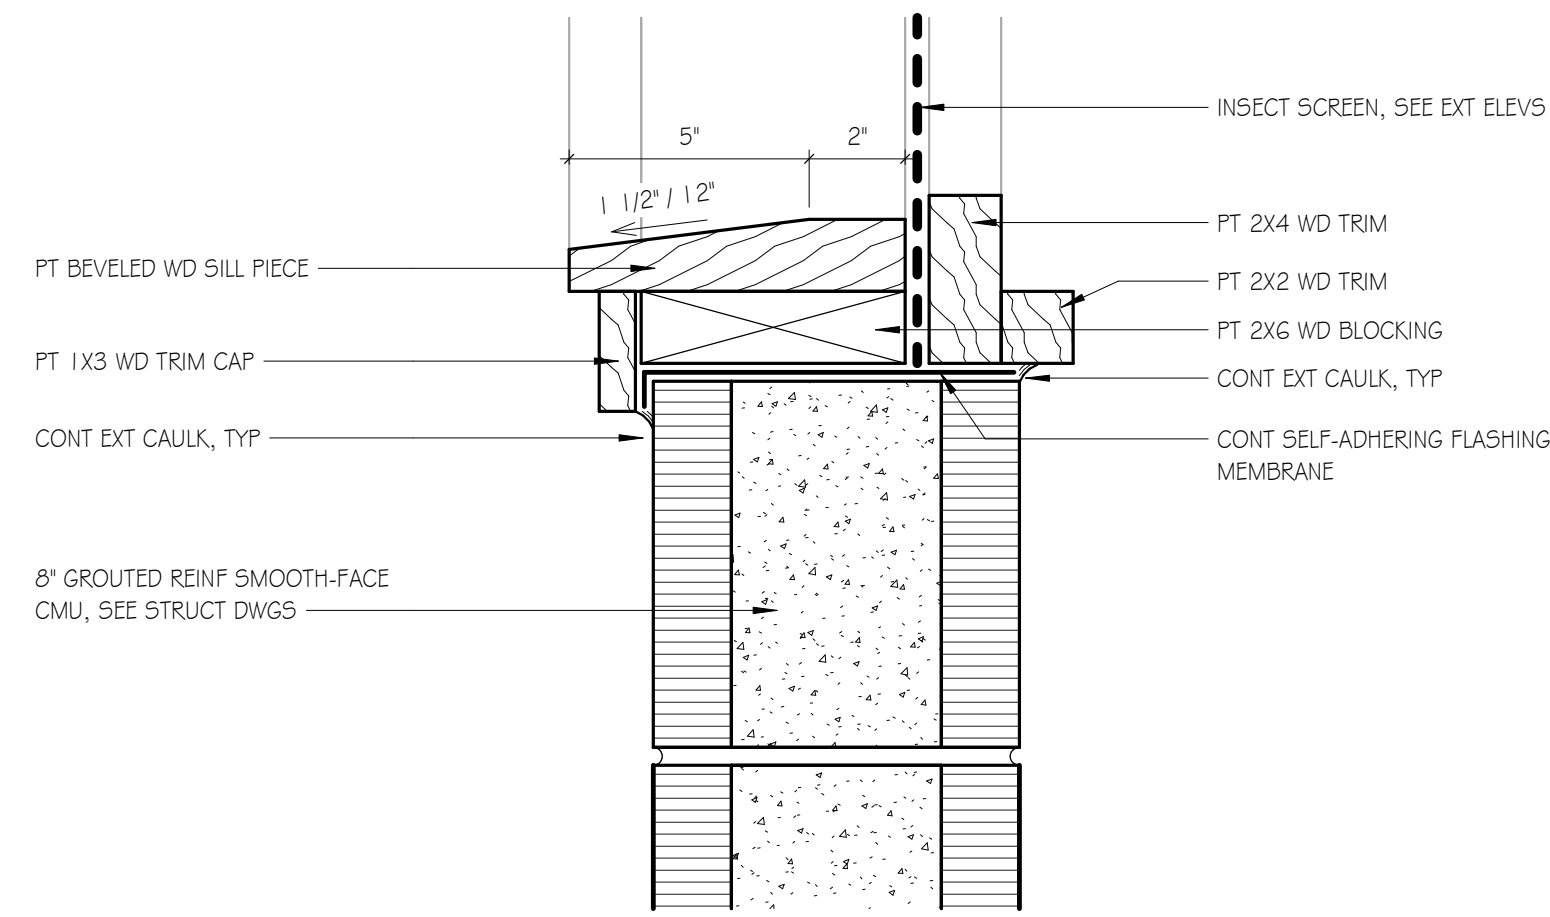
C10 SECTION DETAIL AT INSECT SCREEN
SCALE: 3" = 1'-0"

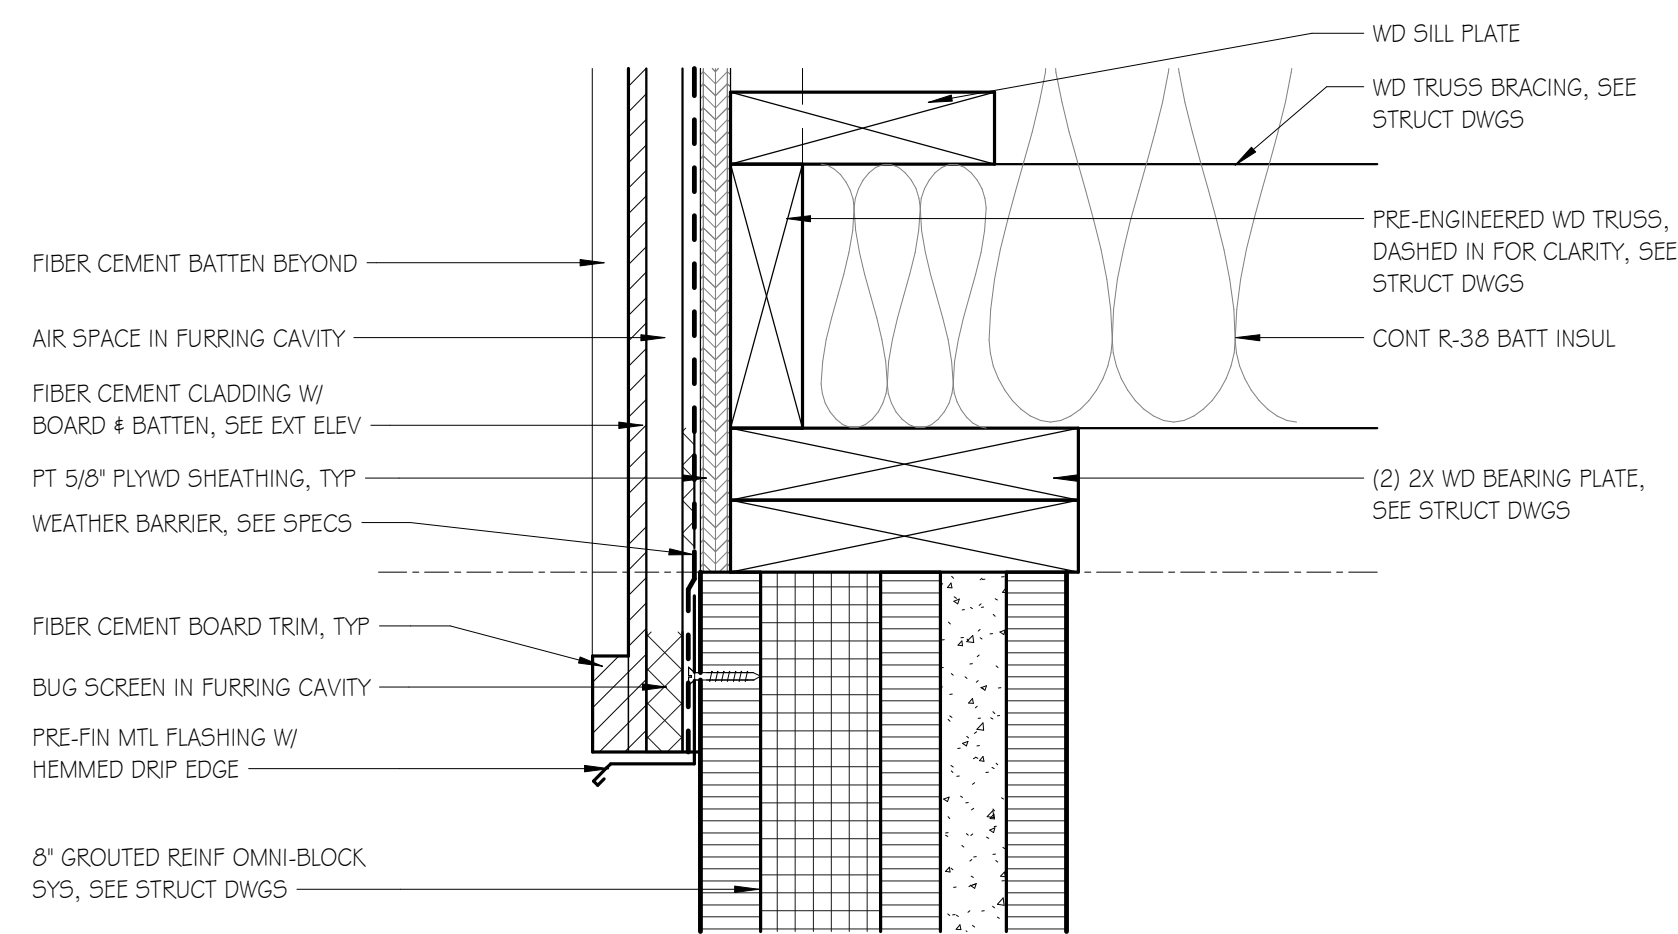
A1 FIBER CEMENT FLASHING DETAIL
SCALE: 3" = 1'-0"

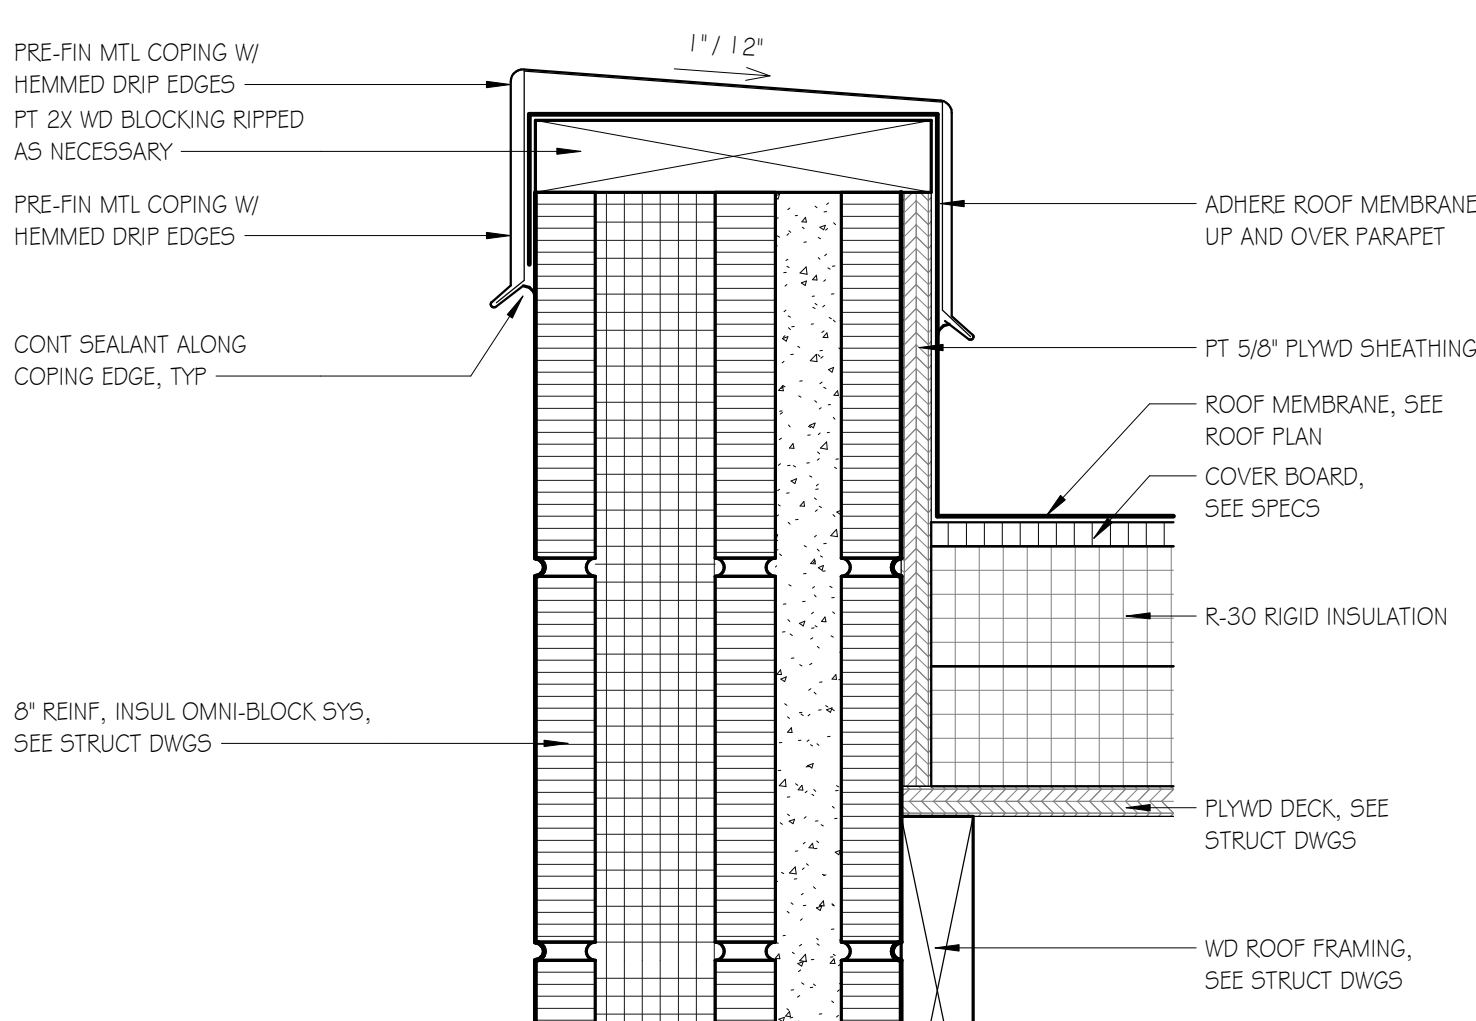
A4 SECTION DETAIL AT PARAPET
SCALE: 3" = 1'-0"

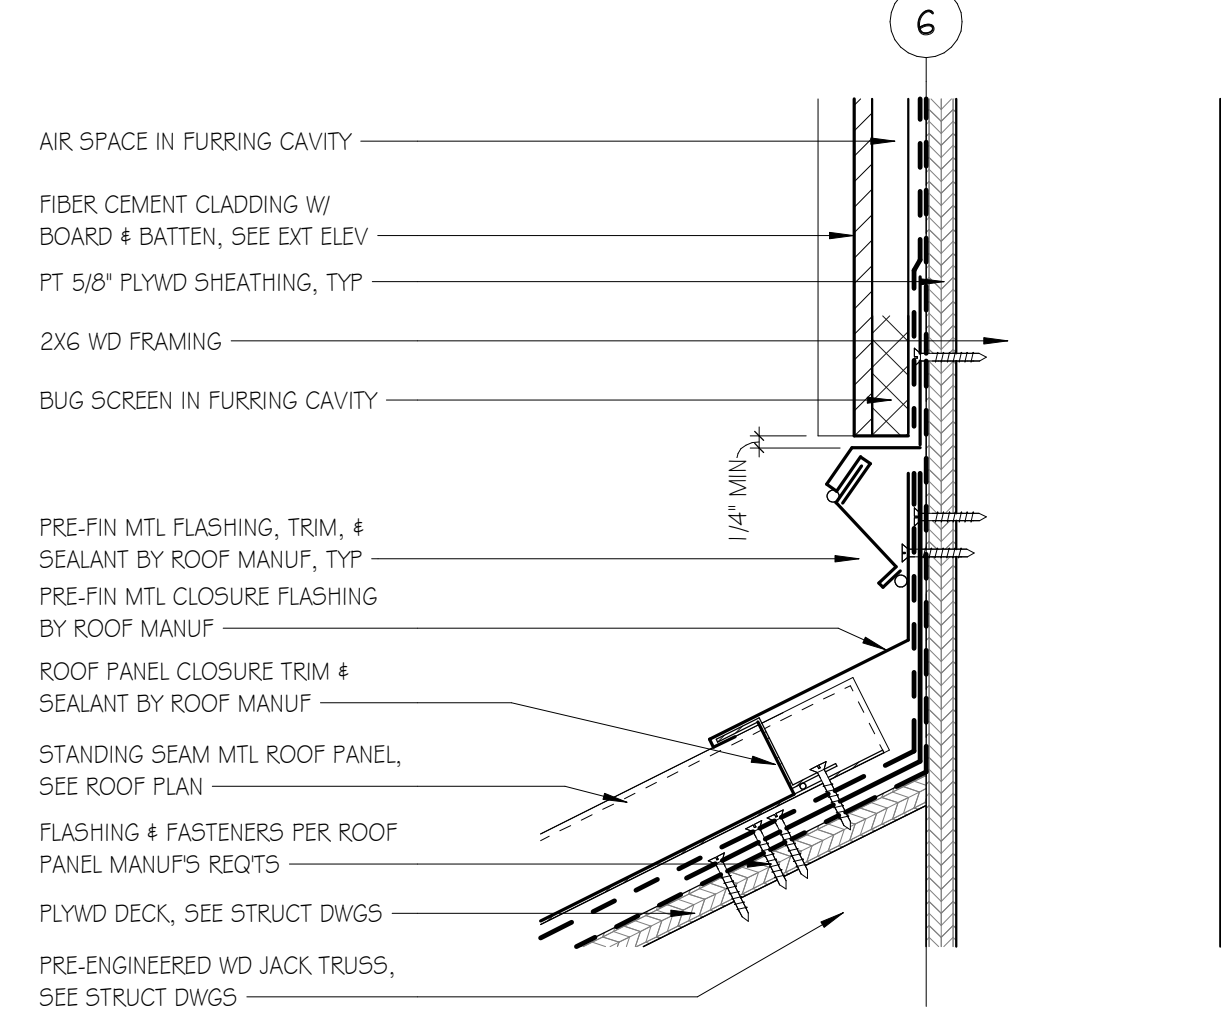
A7 ROOF TRANSITION DETAIL
SCALE: 3" = 1'-0"
