SECTION DETAILS

FRANKLIN CO. ANIMAL CONTROL FACILITY

GEORGE FRALEY PARKWAY
WINCHESTER, TN 37398

A5.21

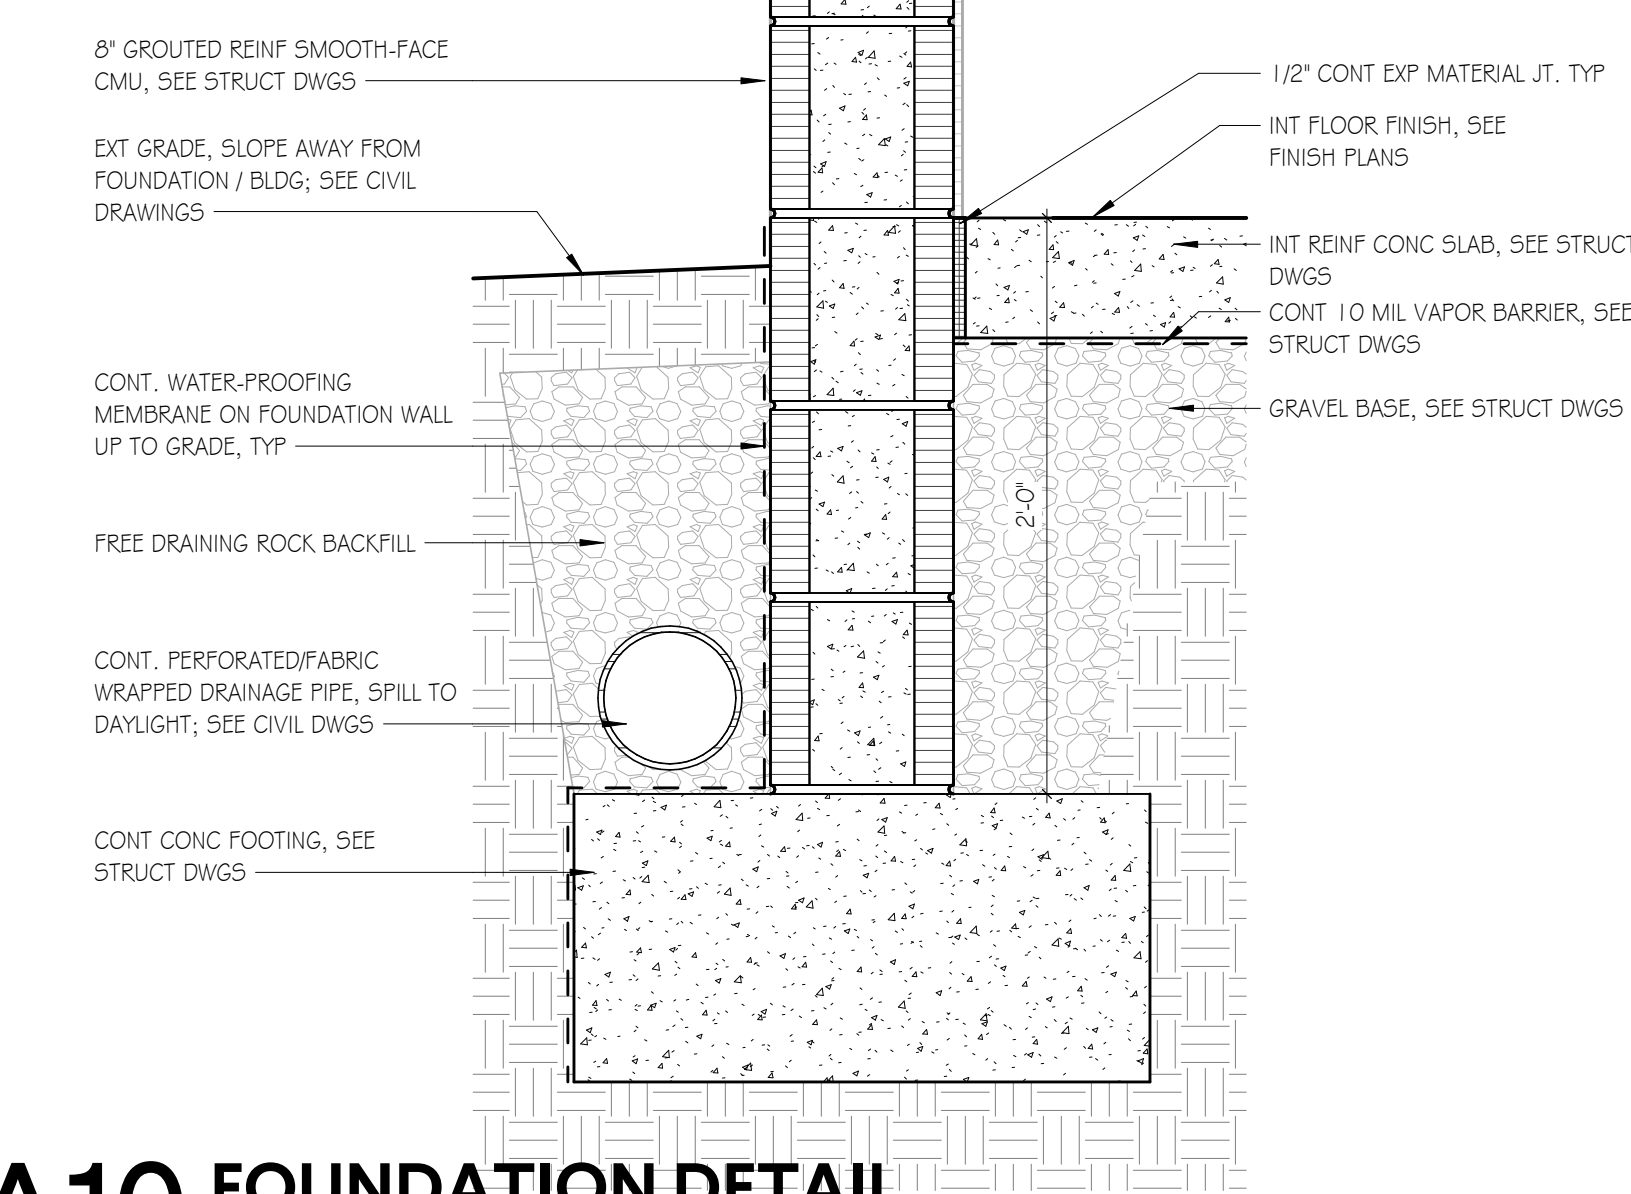
A10 FOUNDATION DETAIL
SCALE: 1 1/2" = 1'-0"
