Plant	Equipment No.	Description
P&G Home Products Pvt Ltd, Hyderabad.	1788/01 (Baroda Eq & Vessels make)	Vertical Air Receiver
Area	P&G Reference No.	Process Fluid/End Use
F & HC (utility)	HYPV-01	Compressed Air
Design Code	Capacity	Position
ASME Sec VIII Div. 1	10 m3	Vertical
Year of Manufacturing(Mfr)	Insulated	Date of Inspection
2013 (rerated on 2015)	No	15.12.2020

HYPV 01 –Reference Photos

INSPECTION REPORT

Report No:
TUV/8118475772/P&G/HYD/
F&HC/SL-16

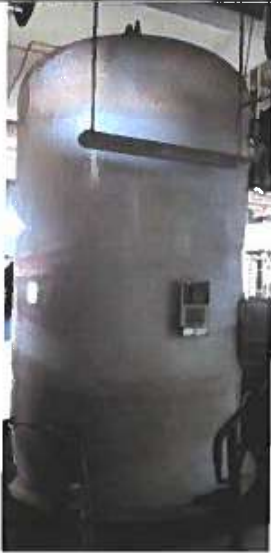
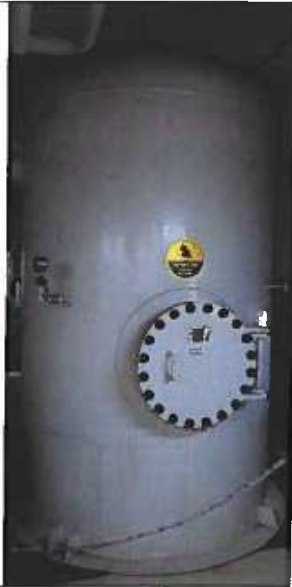
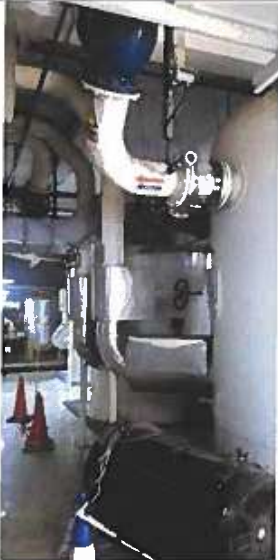
Internal Inspection	internal inspection not possible due to vessel is in service , Hence Manhole not opened.					
External Inspection	Visual inspection conducted & found all around vessel surface is painted & in good condition. No surface imperfections observed / No corrosion spots observed. Weld joints visually inspected on painted surface & found no surface defects. Thickness verified at various locations on vessel (CML) & recorded below.					
Thickness recorded on 2020	Location	Shell			Top Dish	Bottom Dish
	1	12.3			14.2	14.2
	2	12.3			14.4	14.3
	3	12.3			14.3	14.2
	4	12.4			14.4	14.4
	5	12.4				
	6	12.3				
	7	12.3				
	8	12.3				
	9	12.3				
	10	12.5				
	11	12.3				
	12	12.4

Eqpt Visual	Eqpt Visual

Based on the above inspection findings, the above vessel can be operated safely in specified operating conditions mentioned in Section-I of this report subject periodic inspection as specified in Section-II of this report.
