ADA Curb Ramp New Construction Inspection Form (Perpendicular)

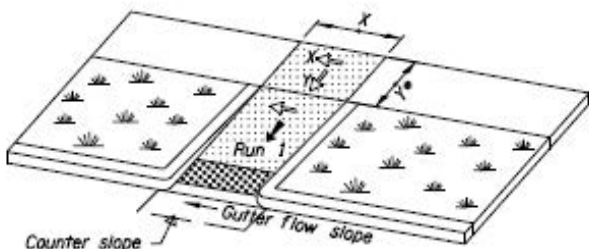
PERPENDICULAR RAMP (PR)

Pedestrian Access Route (to measure Clear Width)

Detectable Warning Surface

Cross Slope (2.0% max.)

Running Slope (8.3% max.)

Counter Slope (5.0% max.)

Turning Space (X & Y) (2.0% max. / 4' x 4' min.)*

* If constrained at back of walk, min. Y length is 5'.

Gutter Flow Slope (as directed)
