## ***DAMAGE CHART (DENT & BUCKLE)***

***Learjet 60***

***Aircraft registration: FAC-1216***

***Aircraft Serial number: 317***

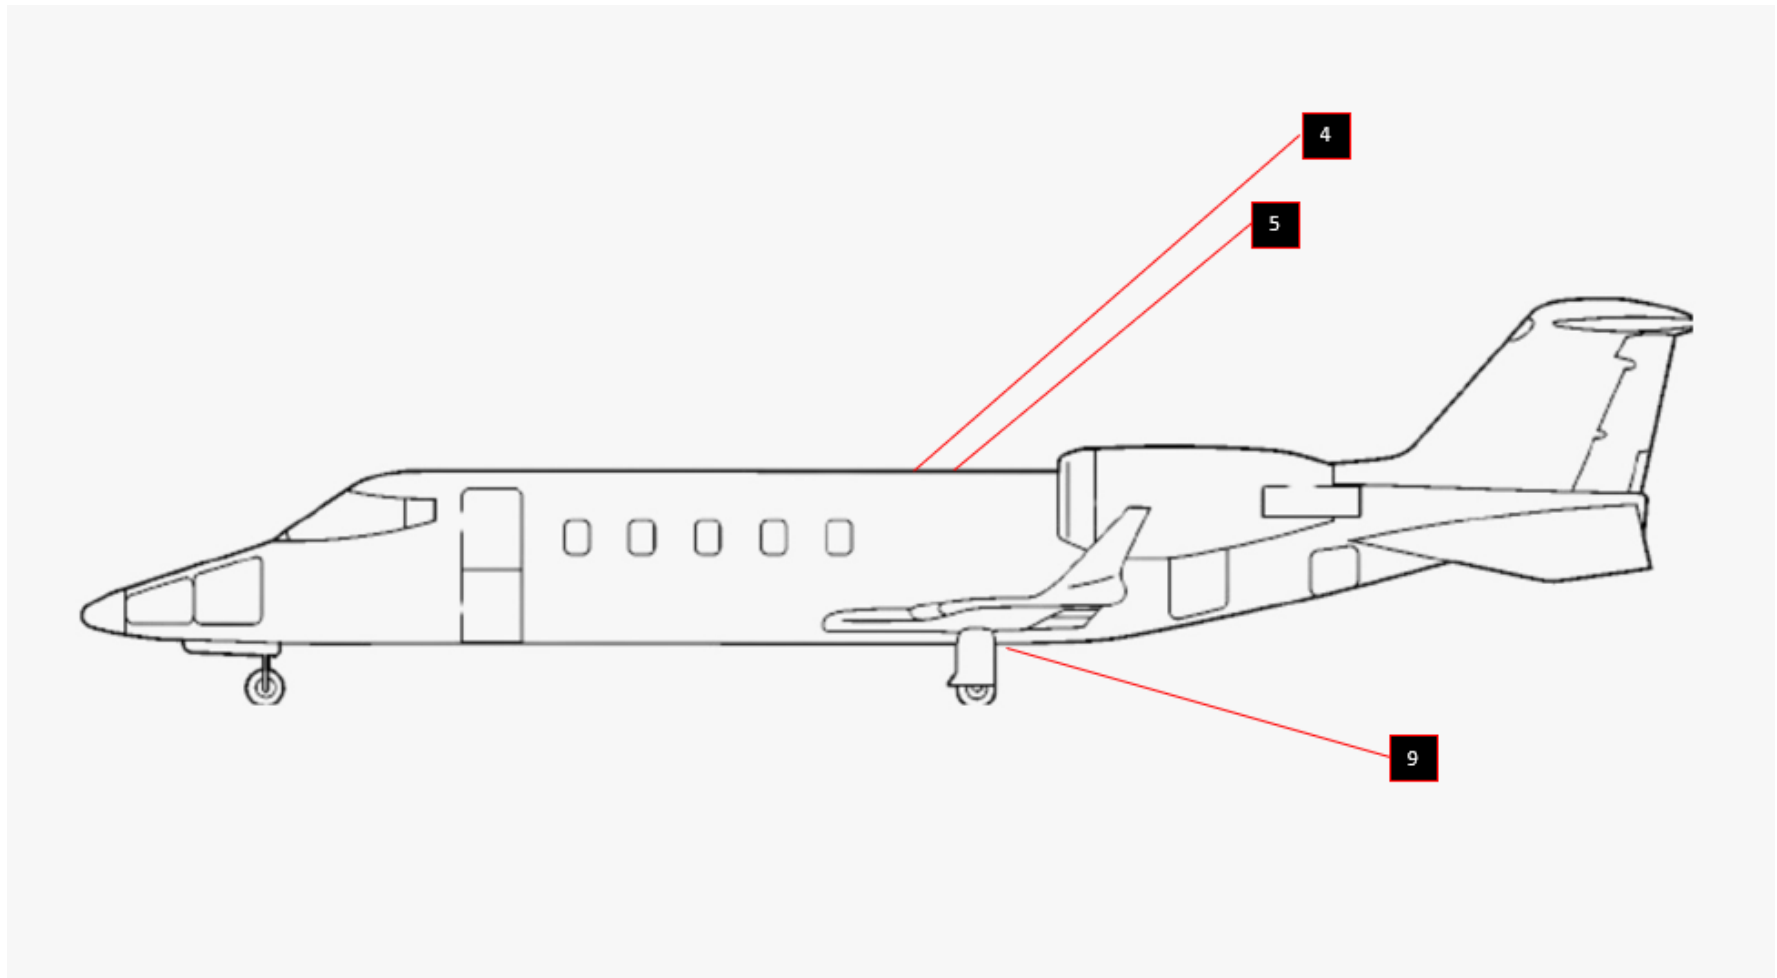
*Figure 1. Left View.*

ITEM	TYPE OF DAMAGE	DESCRIPTION	LOCATION			DIMENSIONS	REFERENCE	LIMITATIONS	ACCOMPLISHMENT DATA	STATUS	NEXT DUE
			FRAME	STRINGER	OTHER						
1	DENT	Dent in Flap upper area	Flap ST (86,50-95,30)	Spar 9R	Flap	L=9,3 H=9,3 D= 0,9 DR=90	SRM 57-50-00	N/A	N/A	CLOSED	N/A
2	DENT	Dent in Flap lower area	Flap ST R (104,2)	Spar (9-10)R	Flap	L=8,1 H=7,0 D= 0,57 DR =72	SRM 57-50-00	N/A	N/A	CLOSED	N/A
3	OTHER	Missing rivet in low wing area	WS 53,040	Spar 8-7R	Wing	N/A	N/A	N/A	N/A	CLOSED	N/A
4	DENT	Upper fuselage dent in oxygen duct	FR (25-27)	STR 1R-1L	Center Fuselage	L=6,8 H=4,6 D=0,37 DR=65	SRM 53-23-00	N/A	N/A	CLOSED	N/A
5	DENT	Upper fuselage dent in oxygen duct	FR (25-27)	STR 1R-1L	Center Fuselage	L=10,4 H=6,4 D=0,69 DR=58	SRM 53-23-00	N/A	N/A	CLOSED	N/A
6	DENT	Upper fuselage dent in oxygen duct	FR (33-34)	STR 1R-1L	Center Fuselage	L=16,4 H=11,8 D=0,97 DR=30	SRM 53-23-00	N/A	N/A	CLOSED	N/A
7	DENT	Upper fuselage dent in oxygen duct	FR (33-34)	STR 1R-1L	Center Fuselage	L=7,6 H=5 D=0,23 DR=26	SRM 53-23-00	N/A	N/A	CLOSED	N/A

8	DENT	Upper fuselage dent in oxygen duct	FR (33-34)	STR 1R-1L	Center Fuselage	L= 8,9 H=7,6 D=0,47 DR=16	SRM 53-23-00	N/A	N/A	CLOSED	N/A
9	DENT	Dent in the lower fuselage area	FR (28-27)	STR 22L	Center Fuselage	L=6,4 H=5,2 D=0,8	SRM 53-23-00	N/A	N/A	CLOSED	N/A
10	DENT	Dent in Upper Flap zone	Flap ST 77,70L	Spar 9L	Flap	L=8,9 H=7,8 D=0,33 DR= 16,2	SRM 57-50-00	N/A	N/A	CLOSED	N/A
11	DENT	Dent in Bottom area of the flap	Flap ST ( 42,15-31,35)L	Spar 9L	Flap	L=10,3 H= 8,4 D=0,77 DR=11,4	SRM 57-50-00	N/A	N/A	CLOSED	N/A
12	DENT	Dent Lower Tail cone RH	FR (44-42)	Lower Zone	Tail Cone	L=4,5 H= 2,3 D=0,77 DR=220	SRM 53-33-00	N/A	N/A	CLOSED	N/A
13	DENT	Dent Lower Tail cone RH	FR (44-42)	Lower Zone	Tail Cone	L=3,9 H= 2,8 D=0,2 DR=190	SRM 53-33-00	N/A	N/A	CLOSED	N/A
14	DENT	Dent Lower Tail cone LH	FR (44-42)	Lower Zone	Tail Cone	L=2,4 H= 1,7 D=0,05 DR=220	SRM 53-33-00	N/A	N/A	CLOSED	N/A
