## Quality of surgical instruments

**INTRODUCTION** Many surgeons will have encountered the scissors that would not cut, and the artery clip that comes off in a deep difficult location, but it would be reasonable to assume that new instruments should be of assured quality. This study reports the surprising findings of a local quality control exercise for new instruments supplied to a single trust.

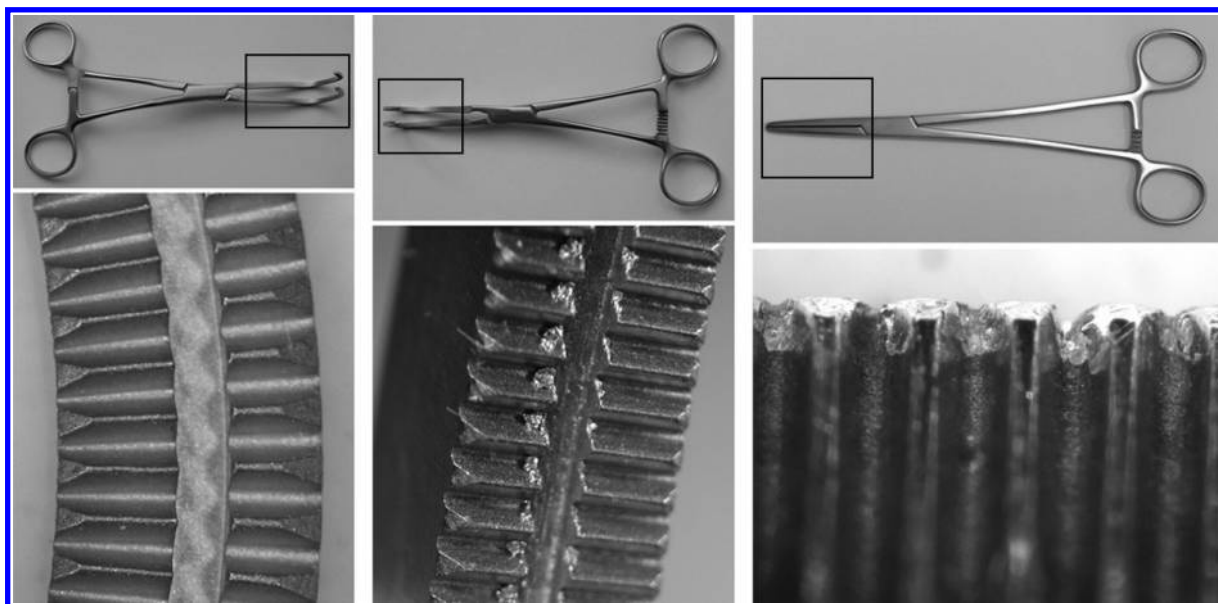
In total, 730 (15%) instruments failed the inspection. Table 1 shows the flaws that were identified. Figure 1 shows 3 views of the jaws of vascular clamps: a well-finished instrument on the left, an instrument with machining burrs in the teeth in the middle view and right views. Figure 2 shows a crack in the securing screw of scissors on the left, a crack through the end of the jaws of a needle holder in the middle view, and a major soldering fault in the surface of a wire bending forcep on the right. Figure 3 demonstrates protrusion of a sharp guide pin on gentle closure of tissue forceps.

**Figure 1** Magnified views of the jaws of vascular clamps – a well-finished example on the left, poorly finished examples in the middle and right views.

The commonest mechanical and structural fault was machining burr debris. BS states that 'all surfaces must be free from pores, crevices and grinding marks'.<sup>1</sup> The fine metallic surfaces of surgical instruments are the product of a number of engineering processes. The shapes and details are initially created by casting and pressing the metal into the required shape, but then finer detail is ground in. In modern, computer-controlled, laser-guided engineering, this should be a straightforward and reliable process, producing an extremely accurate surface, as is shown in the upper view of Figure 1. Sometimes, older methods are used but a fine finish should still be possible, as long as the surface is inspected and machine brush-polished. If this process is incomplete, metallic debris and surface imperfections will remain as shown in the middle view of Figure 1. This may be a problem in a number of ways. First, blood and tissue debris may collect in the imperfect surface. We have traditionally relied on sterilisation procedures to render such debris inert, but there are now concerns that prion disease may survive such processes.<sup>2</sup> The metallic fragments may also wear off these surfaces, and remain as microscopic debris in the wound. Sharp burrs on instrument handles may contribute to previously unexplained surgical glove punctures. Although we cannot reference any reported instance of this, BS states that 'there shall be no sharp edges other than those required by the pattern of the instrument'.<sup>1</sup>

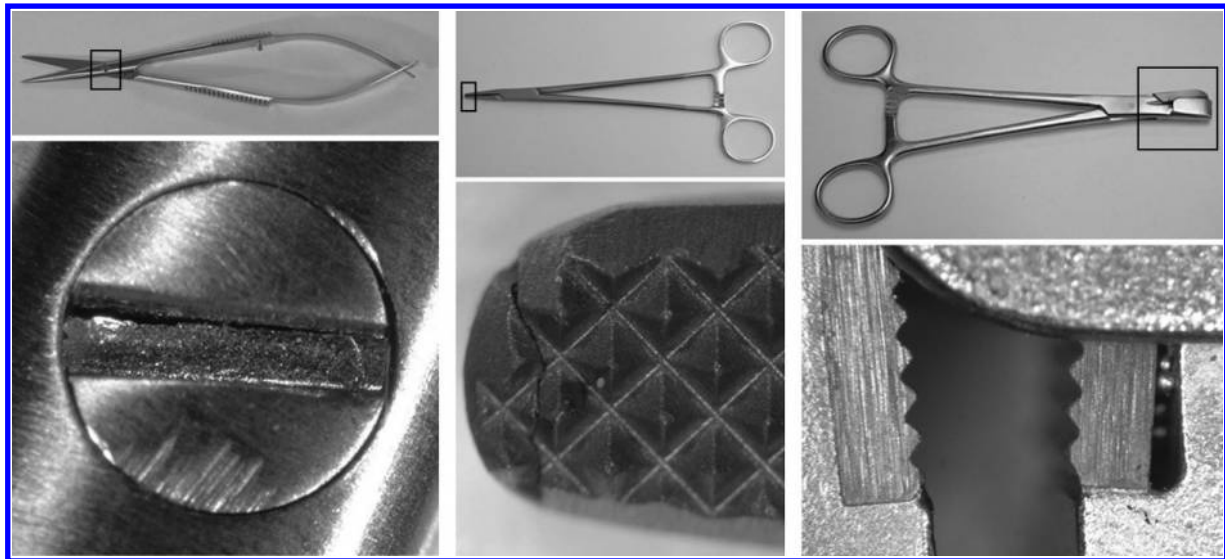
Cracks and soldering faults may also provide niches for retention of blood and tissue, and serious defects may lead to instrument failure, such as the examples shown in Figure 2.

Figure 2 Magnified views showing a crack through the screw-head of fine scissors on the left, a cracked needle holder tip in the middle, and absence of solder to secure the jaw surface insert of a wire holder on the right.

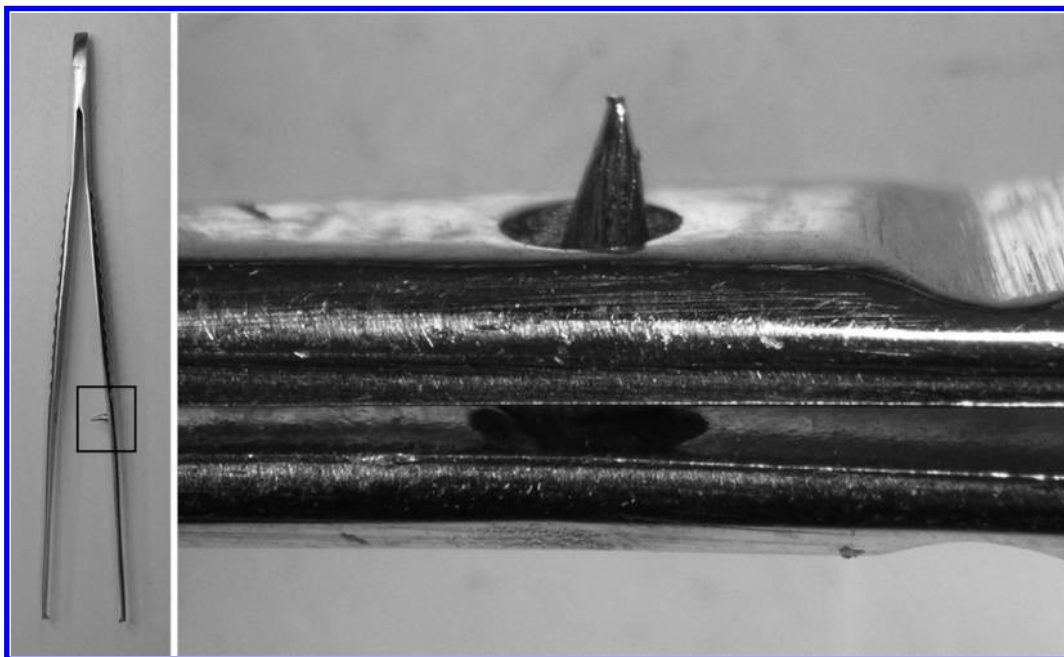
Figure 3 Protrusion of a forceps' guide pin.

Many fine tissue forceps have guide pins to re-inforce the accuracy of the jaws mating. BS states that 'if present, the guide pin shall be tapered to facilitate entry into the locating hole and shall not protrude from the hole when the jaws are closed'.<sup>1</sup> We identified 35 guide pins which protruded on light, but complete, closure of the forceps' jaws on naked eye inspection. This may be a source of glove puncture.
