Experimental Data Sharing for Structural Health Monitoring and Control

ASCE EMI Technical Committee on Structural Health
Monitoring and Control

February 24, 2022

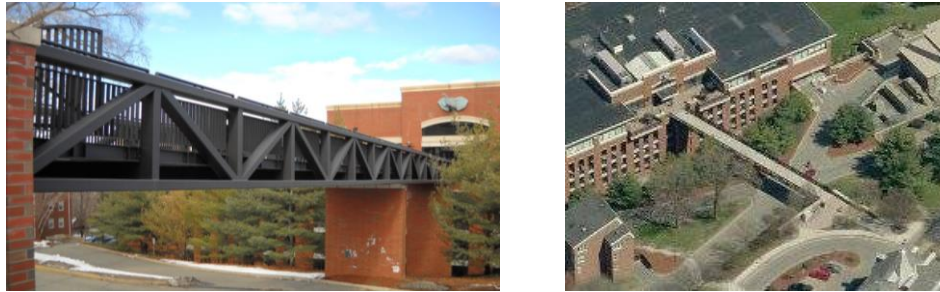
The Dowling Hall footbridge is a continuous two-span (22 m long for each span) steel frame bridge with a concrete deck (3.9 m wide) located at Tufts University campus, as shown below:

Figure 1. Dowling Hall Footbridge (photo on the right from www.maps.bing.com)

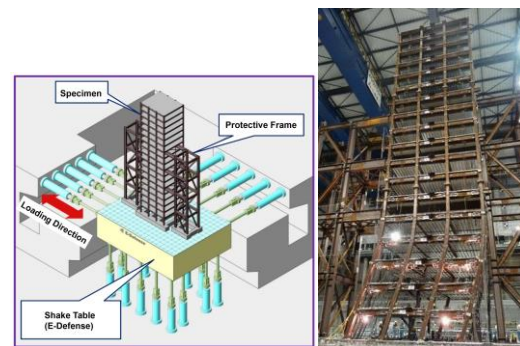
Test Structure(s) A one-third scale specimen of 18-storey steel hi-rise and a protective frame were rationally constructed and installed properly on the E-Defense shake table. The specimen represents the behavior of a typical steel high-rise and responds to earthquake as a steel moment-resisting-frame. The specimen is based on a steel high-rise constructed in 1980s to 90s where the column-to-beam strength ratio of 1.5 is provided to achieve a weak-beam strong-column mechanism. No inherent deficiencies are intentionally given.

Fig. 1 18-story specimen at the E-Defense

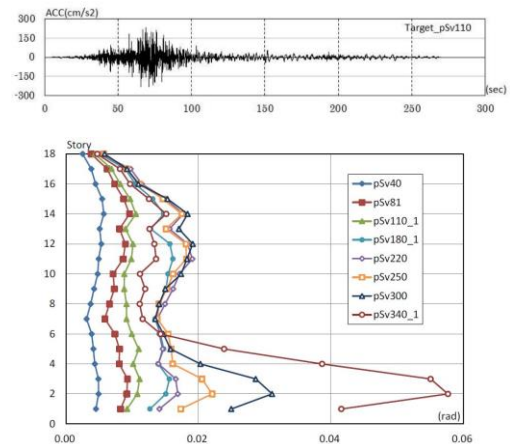
Instrumentation and Test Procedures The specimen was excited only in one direction. The input ground motion was a design synthetic ground motion with long-period characteristics for a Tokai-Tonankai-Nankai subduction-zone earthquake with the epicenter in the Nankai trough. The ground motion was synthesized assuming a building site and phase, and was processed properly for shake table use with the scaling law and a band-pass filter

Fig. 2 Input motion and story drift responses
