Experimental Data Sharing for Structural Health Monitoring and Control

ASCE EMI Technical Committee on Structural Health
Monitoring and Control

May 3, 2023

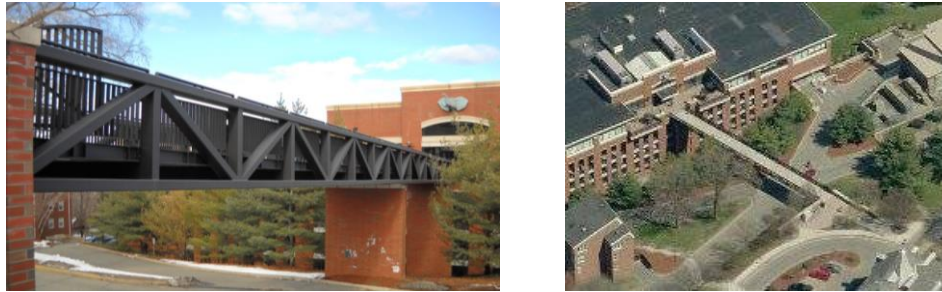
The Dowling Hall footbridge is a continuous two-span (22 m long for each span) steel frame bridge with a concrete deck (3.9 m wide) located at Tufts University campus, as shown below:

Figure 1. Dowling Hall Footbridge (photo on the right from www.maps.bing.com)

Two phases of instrumentation were deployed on the footbridge. Phase I of the monitoring system was performed in the fall of 2009, which included an array of eight accelerometers and ten thermocouples, a rugged and remotely operable data acquisition system, and a reliable communication system. The monitoring system had been running continuously from January 2010 to March 2012. At phase II, four additional accelerometers and four strain gages were added on the bridge.

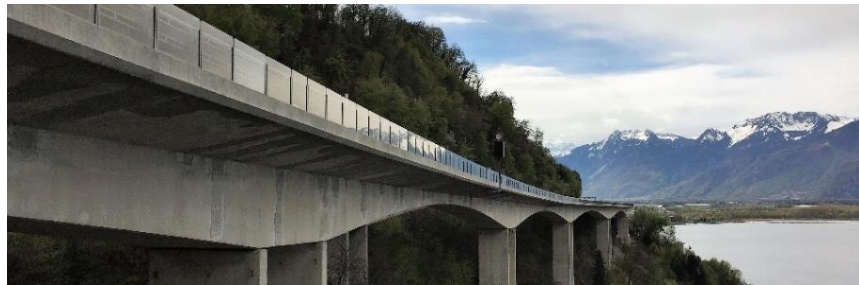
Test Structure. Constructed in 1969, the Chillon viaducts were strengthened in 2015 via a layer of Ultra High Performance Fiber Reinforced Cement-based Composite (UHPFRC) cast atop their decks. In order to assess the efficacy of this rehabilitation solution, and further evaluate its long-term performance, a Structural Health Monitoring (SHM) campaign was implemented by ETH Zurich. Three months of monitoring data have been shared with the community, with more to follow, allowing to study the influence of Operational and Environmental Conditions on the modal parameters and to further infer Performance Indicators (PIs) for assessing structural behavior [1].

Data Description A span of 98 m, in the central portion of the viaduct, has been instrumented with 11 accelerometers distributed along the span, as well as four strain gauges and environmental sensors (measuring temperature and humidity) installed at mid-span. The strain gauges were located directly on the rebar, aiming to capture fatigue effects in both the longitudinal and transverse direction.

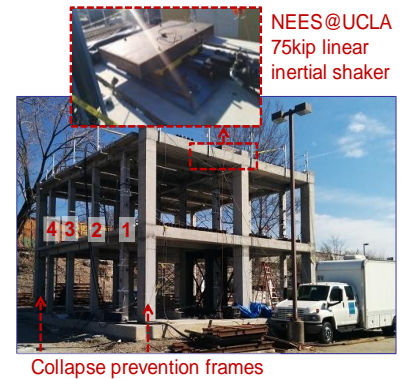
Test Structure Four identical concrete test frames were built at full scale outside the Structural Engineering and Materials Laboratory on Georgia Tech campus (Fig. 1). The frames are individually separate from each, with a gap between every two neighboring frames. Each frame consists of two bays and two stories and was meant to be representative of non-ductile reinforced concrete office buildings in the central and eastern United States built in the 1950s-1970s[1]. Frame #1 is an as-built bare frame as the reference structure, while different seismic retrofit measures are applied to the other three frames for comparison. This data sharing is for testing results from Frame #1.

Fig. 1. Full-scale frames and the 75-kip shaker on Frame #1 under test

Instrumentation and Test Procedures A 75-kip hydraulic linear inertial shaker provided by NEES@UCLA is mounted on the second elevated slab, i.e. roof top. Tens of shaker excitations were applied, with gradually increasing amplitude and causing damage to the concrete frame. The frame is first installed with 42 Kinometrics cabled accelerometers on columns and girders to capture the acceleration responses (Fig. 2a). Most of the cabled measurements are uniaxial, while a few are bi-axial or tri-axial; they provide a total number of 60 acceleration channels. To increase spatial resolution of the instrumentation, a total of 66 wireless accelerometers are interspersed between cabled accelerometers (Fig. 2b).

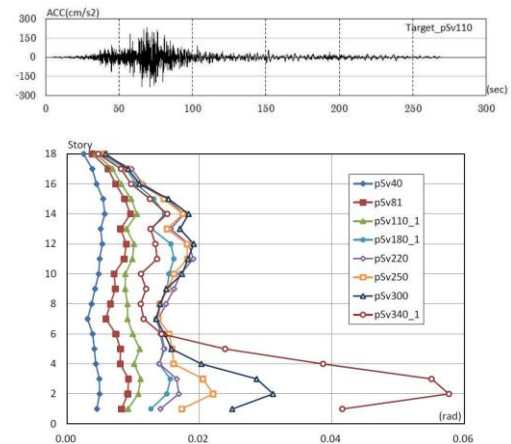
Instrumentation and Test Procedures The specimen was excited only in one direction. The input ground motion was a design synthetic ground motion with long-period characteristics for a Tokai-Tonankai-Nankai subduction-zone earthquake with the epicenter in the Nankai trough. The ground motion was synthesized assuming a building site and phase, and was processed properly for shake table use with the scaling law and a band-pass filter

Fig. 2 Input motion and story drift responses

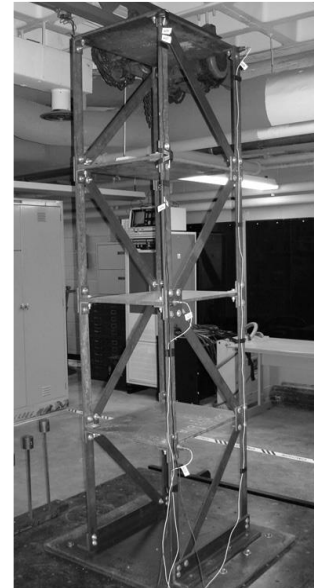
Test Structure Experimental data stems from a four-story structural steel model (Fig. 1), mounted on a uniaxial hydraulic shake table. The structure consists of four stories, with an interstory height of 533 mm and floor dimensions of 610 mm by 457 mm. The structure is braced to make it preferentially flexible in the direction of excitation, allowing for a clear spectrum of bending modes in this direction. All structural connections are bolted. The direction of excitation is referred to as the *weak* bending direction and the direction normal to excitation is referred to as the *strong* bending direction of the structure [1,2].

Fig. 1 Structural model on shake table

Instrumentation and Test Procedures The model is instrumented with piezoelectric accelerometers, with seven channels response on the structural model and one reference channel on the shake table's platform. The sensors are attached magnetically to the column connection plates at each floor.
