Effects of Traffic Calming Measures on Pedestrian and Motorist Behavior

Herman F. Huang and Michael J. Cynecki

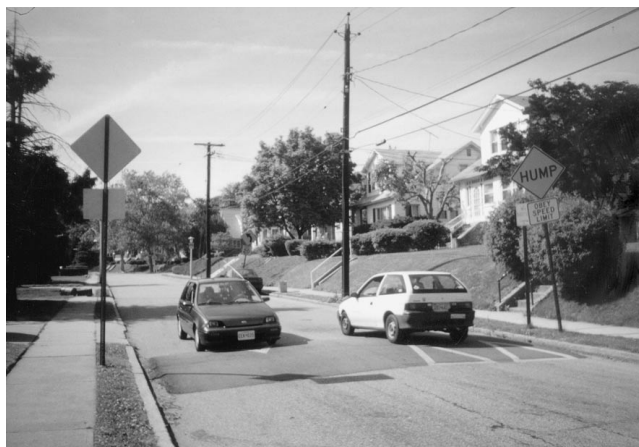
FIGURE 1 Two vehicles slow down as they pass over speed hump.

Also known as road humps, undulations, or “sleeping policemen,” speed humps have the purpose of promoting the smooth flow of traffic at speeds of about 32 to 40 km/h (20 to 25 mph). The speed hump is an elongated bump with a circular arc cross-section (round top) or flat top, rising to a height of 76 mm (3 in) above the normal pavement surface and having a length of 3.7 m to 6.7 m (12 ft to 22 ft) in the direction of vehicular travel (Figure 1). Speed humps usually extend the full width of the road, excluding the gutter to allow for drainage (1).

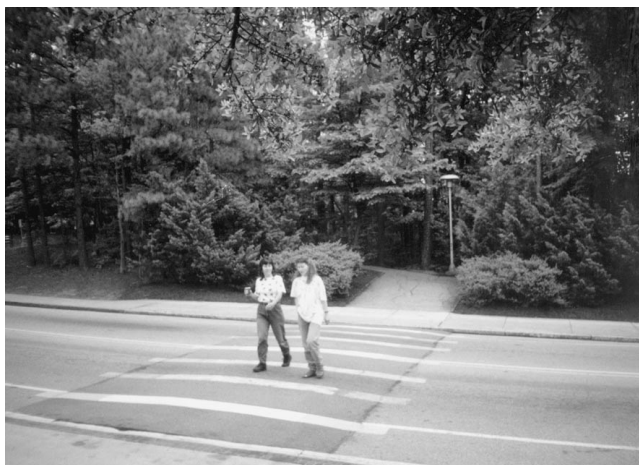
FIGURE 2 Two pedestrians using raised crosswalk.

Raised crosswalks are flat-top speed humps with crosswalk markings painted on the top (Figure 2). Raised crosswalks elevate pedestrians above the surface of the roadway and can make them more visible to motorists. Raised crosswalks cause motorists to slow at the most critical location, where pedestrians cross, and they are generally designed to keep pedestrians at one level so that there is no need for curb ramps. Drainage is accommodated by pipes along the gutter or other design features. Speed humps have been evaluated in many cities. The following paragraphs summarize some of those studies.

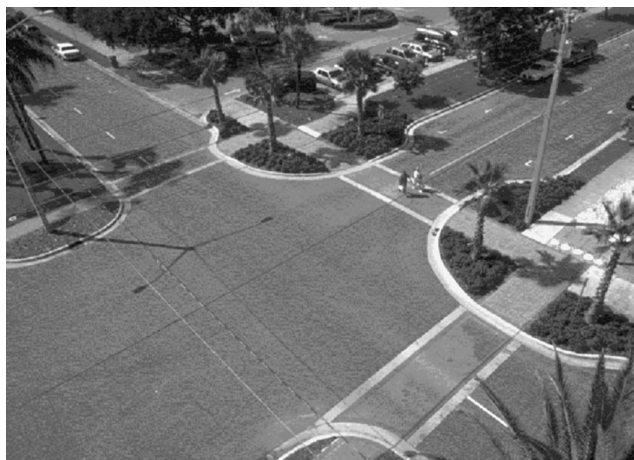
FIGURE 3 Bulbouts shorten crossing distances for pedestrians, improve sight distances, and may slow vehicle speeds.

The purpose of a bulbout (also known as a choker, curb bulb, neck-down, nub, or gateway) is reduction of the width of vehicle travel way at an intersection or a mid-block pedestrian crossing. Bulbouts shorten the street crossing distance for pedestrians, may slow vehicle speeds, and provide pedestrians and motorists with an improved view of one another, thereby reducing the risk of a motor vehicle–pedestrian collision (Figure 3).

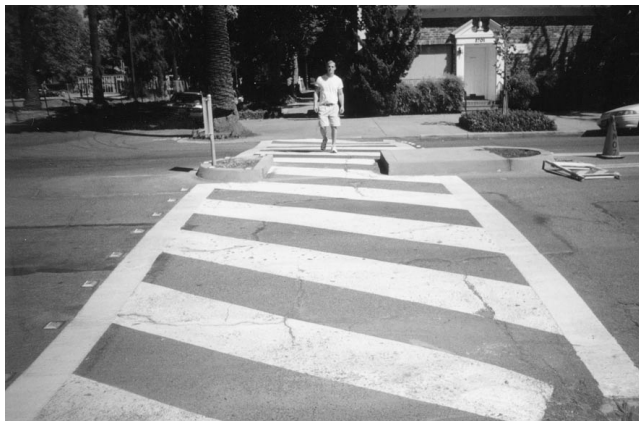
FIGURE 4 Pedestrian in crosswalk with refuge island, Sacramento, California.

The chi-square statistic was used to compare the percentages of pedestrians who crossed in the crosswalk (Figure 4) in the before and after periods. As Table 3 shows, the raised intersection in Cambridge and the refuge islands in Sacramento had statistically significant effects: that is, more pedestrians crossed in the crosswalk in the after period than in the before period. The effects of the Cambridge bulbouts and the refuge island in Corvallis were in the desired direction but were not statistically significant, not even at the 0.10 level. The results for the bulbouts in Seattle were statistically significant, but in the undesired direction—more pedestrians crossed in the crosswalk before the bulbouts were installed than after they were installed.
