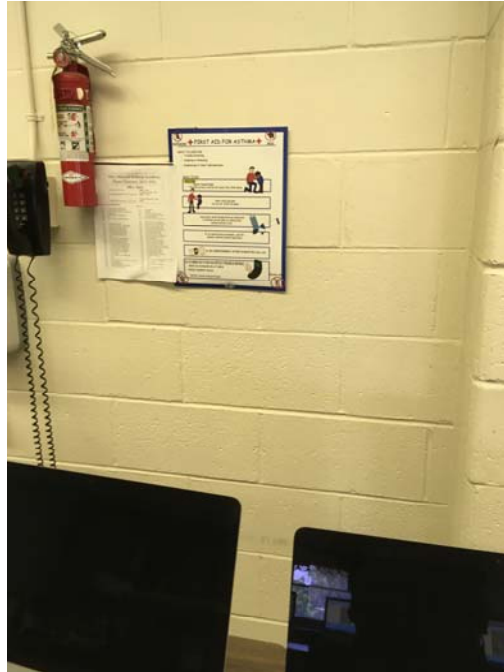
Photo 13 – Room 200  
The asthma first aid poster was posted in this room.

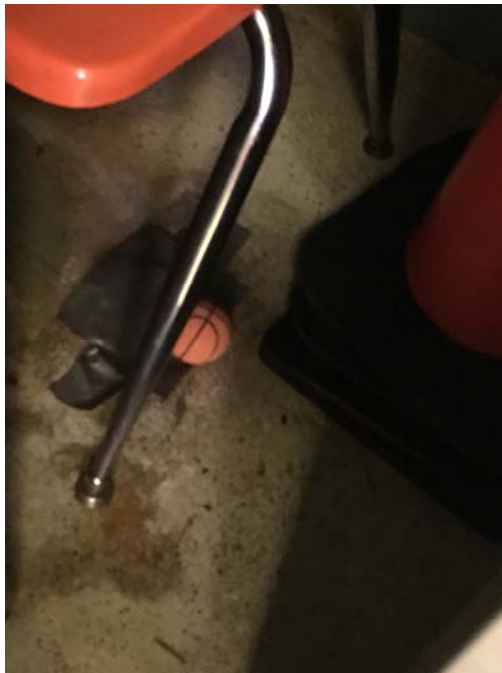
Photo 34 – Gymnasium Office Restroom  
The floor drain was covered with duct tape to prevent odors.

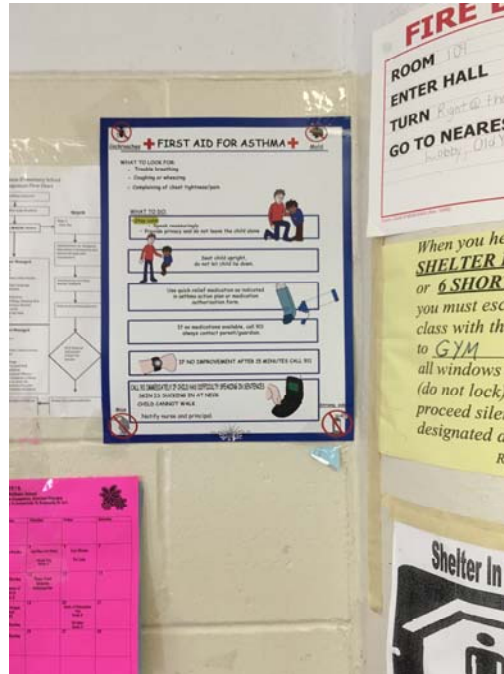
Photo 53 – Room 104  
The first aid asthma poster was noted in this room.

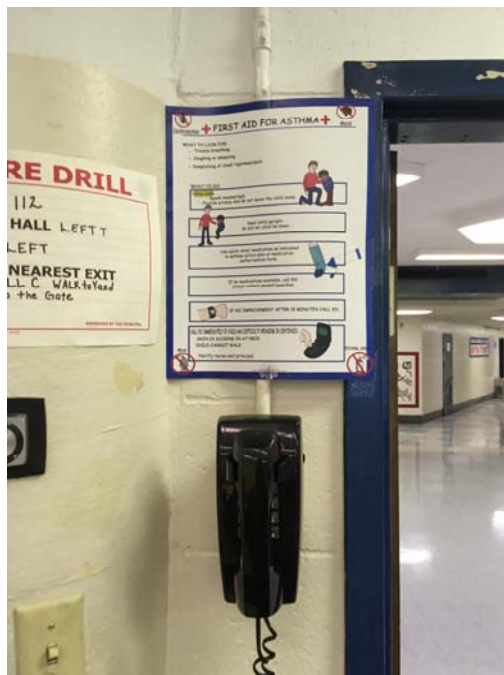
Photo 70 – Room 112  
The first aid asthma poster was observed in this room.

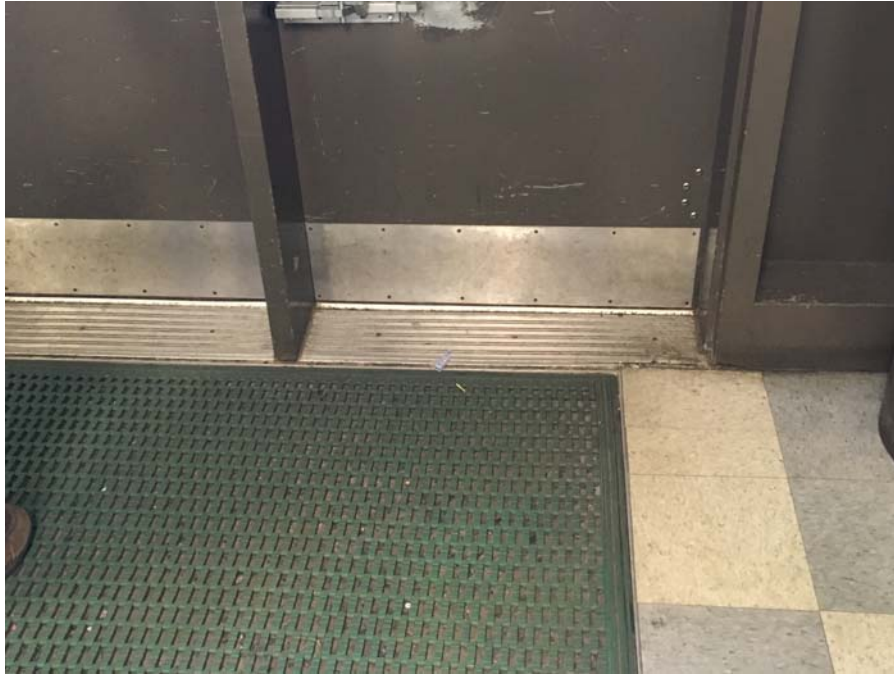
Photo 71 – Main Entrance  
The door seals at this location were tight.
