Tunnel Principal Inspection Report

Islington Tunnel

Regents Canal

RE-007-005

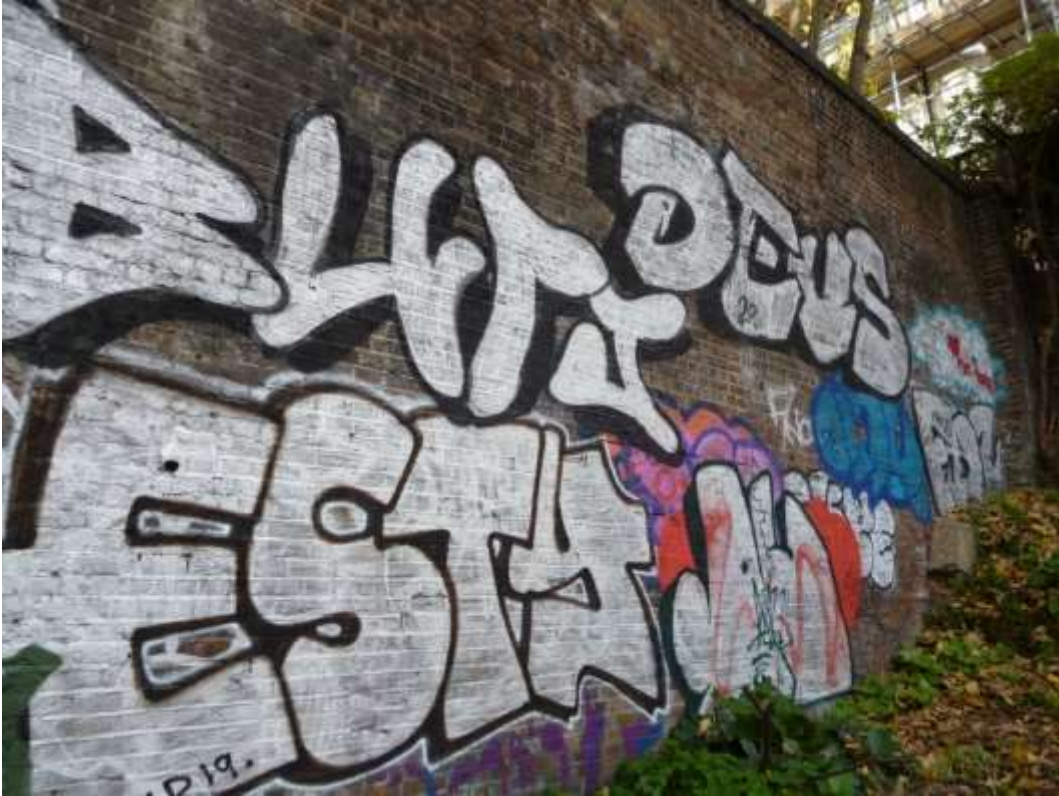
East Portal – North wingwall

There are vertical cracks in both wing walls to the East Portal with further cracks in the parapet above the tunnel. The cracks are all noted on a Portal Survey dating from June 1980 and are long standing defects. The whole wall is generally leaning (estimated at 100mm horizontal movement at the top of the wall) and there are some large trees growing immediately behind the portal.

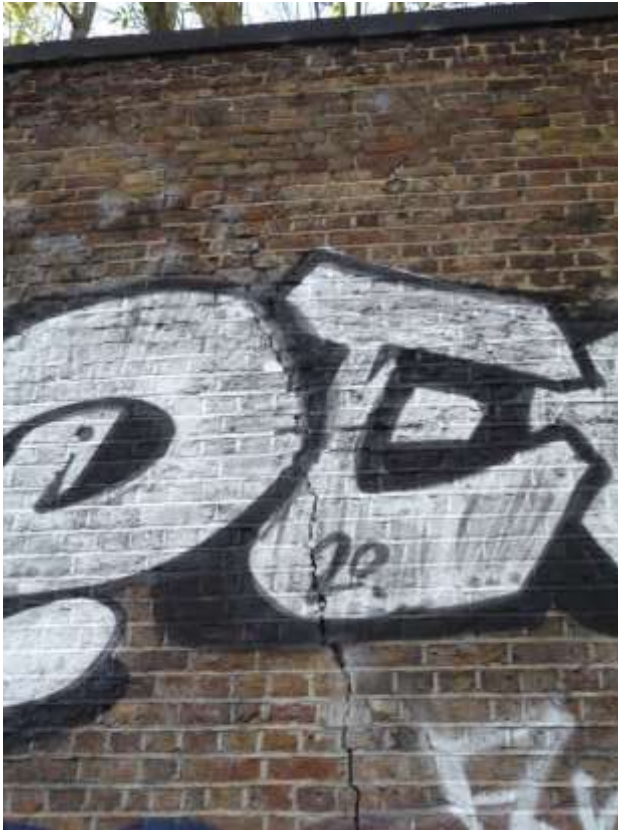
East Portal – North wingwall – Old, vertical movement crack (south crack)

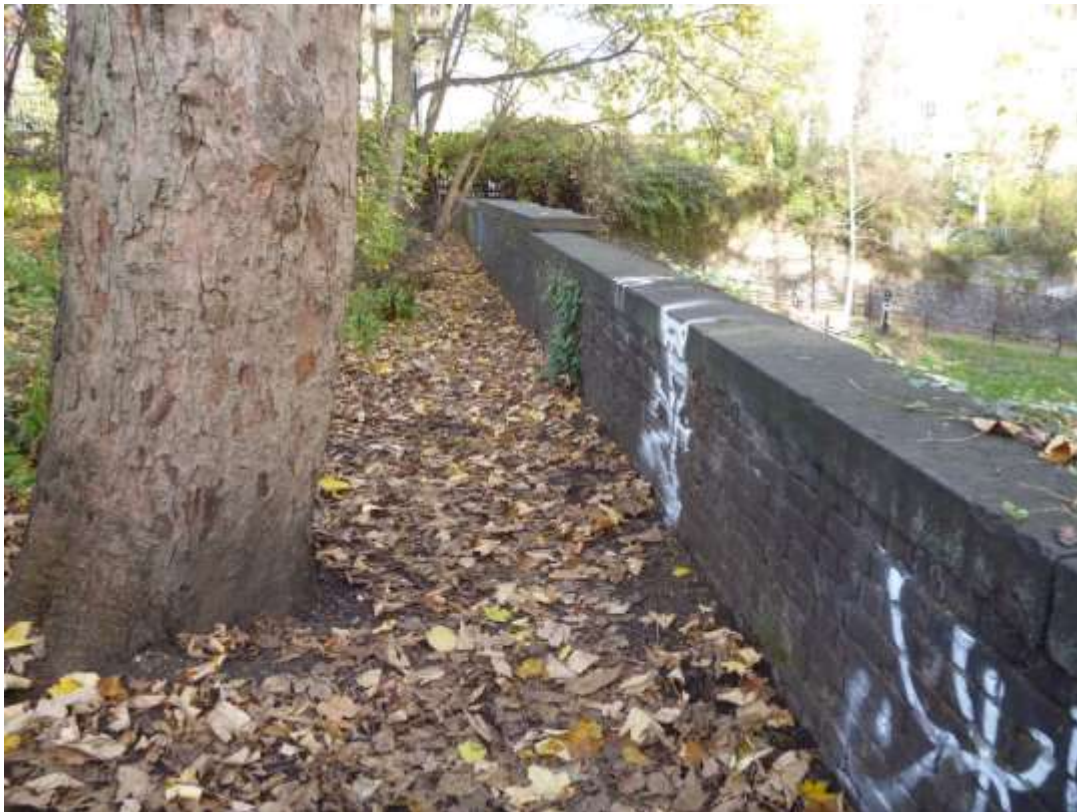
The rear of the parapet wall contains recessed mortar joints and one of the cracks in the north wing wall continues through the rear of the parapet. One section of the wall has been covered with render and there is a services cover at ground level immediately behind this section of the parapet.

East Portal – Rear of the parapet wall from the south side

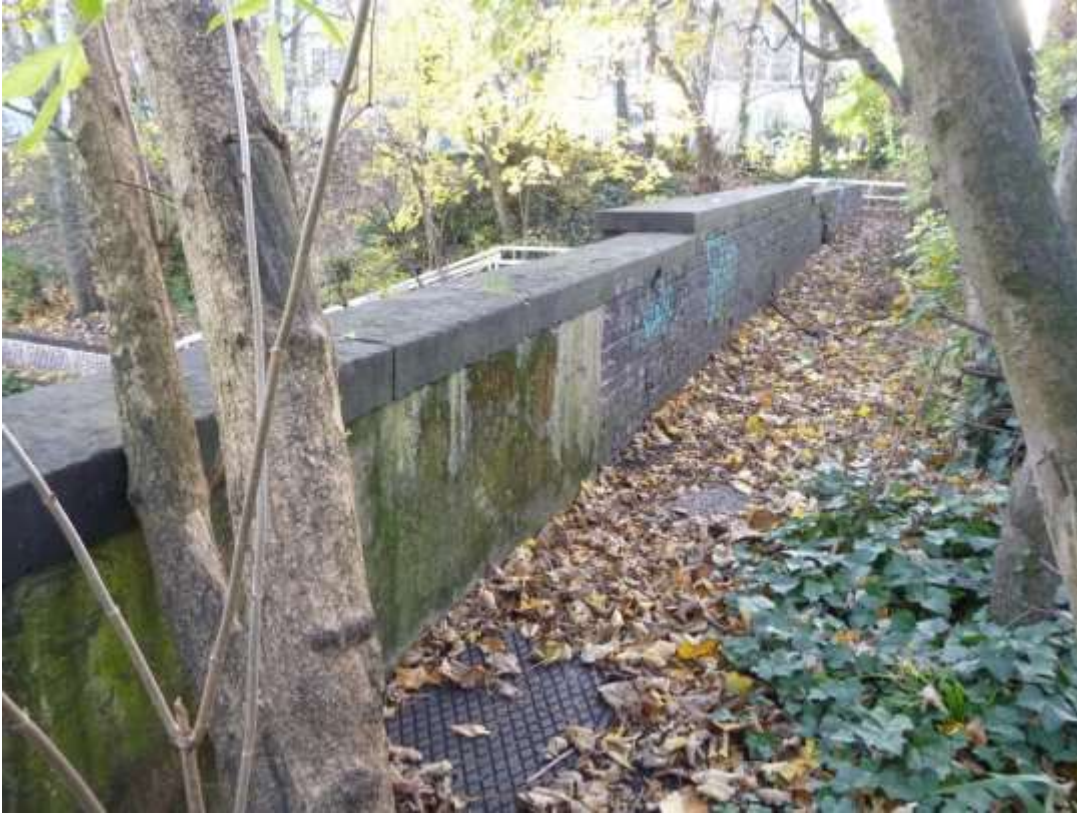
East Portal – rear of the parapet wall from the north side

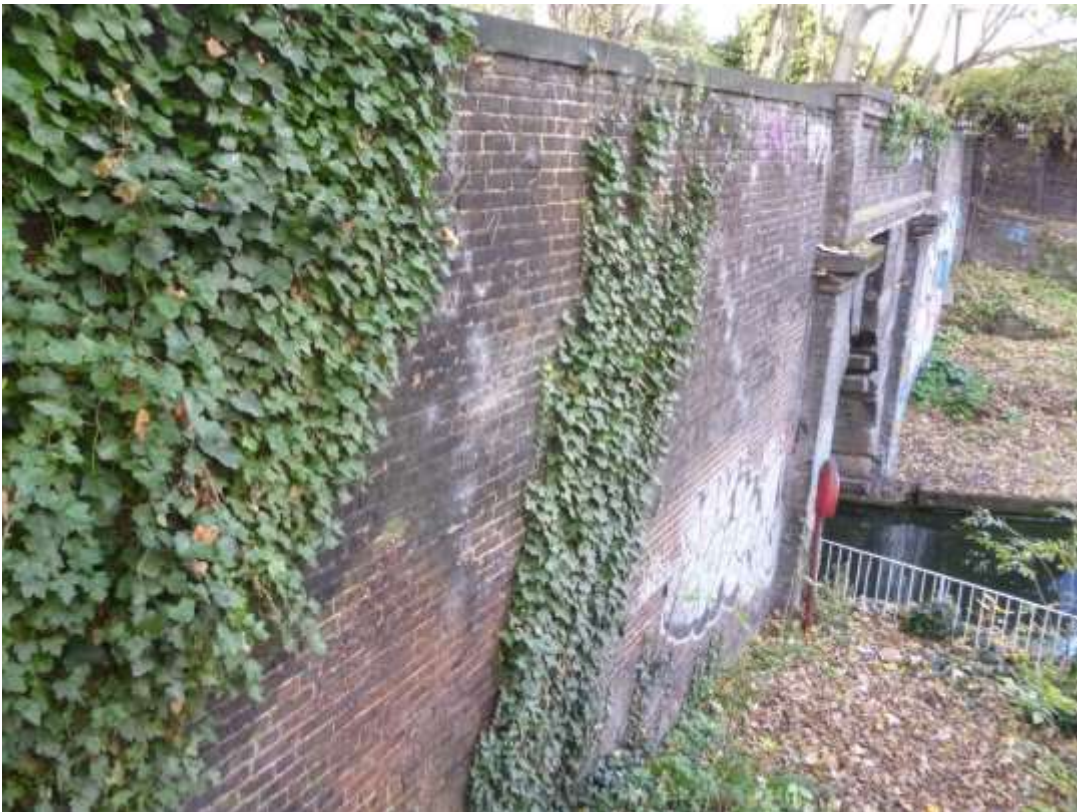
East portal from the south side – wall is leaning

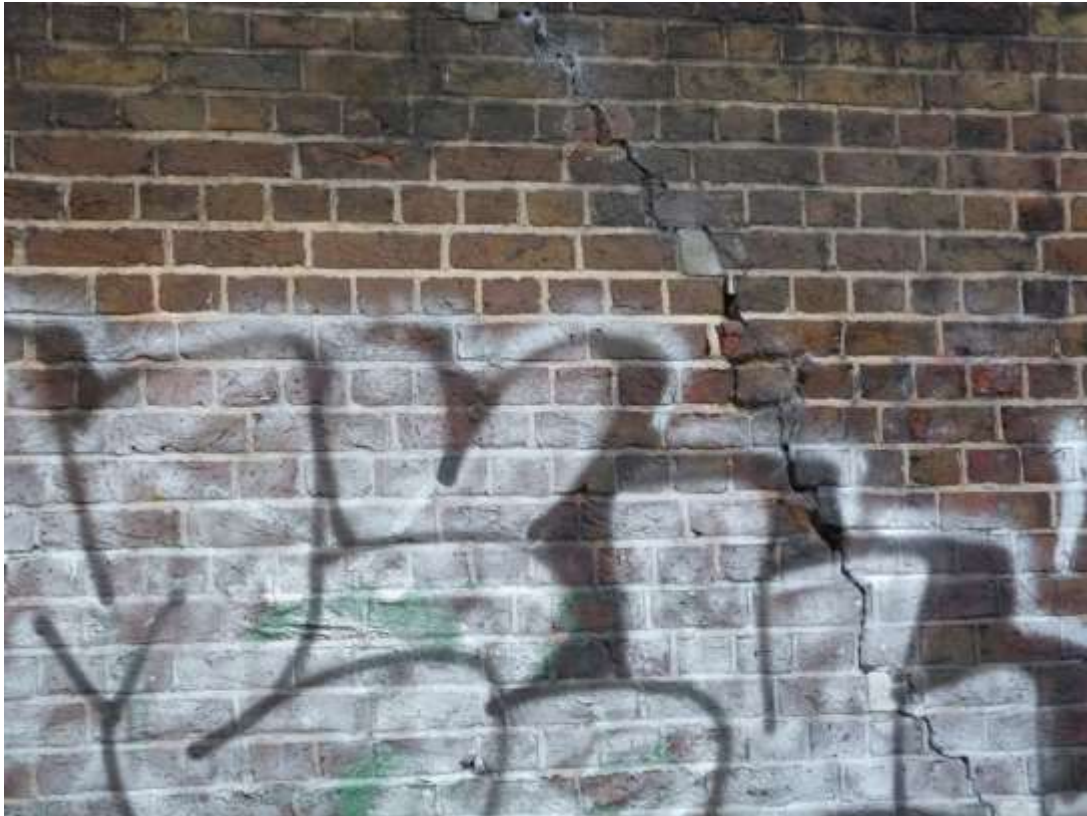
East Portal – South wingwall – Old, vertical movement crack (North crack extending up to the top of the wall, including old tell tails at mid wall height)

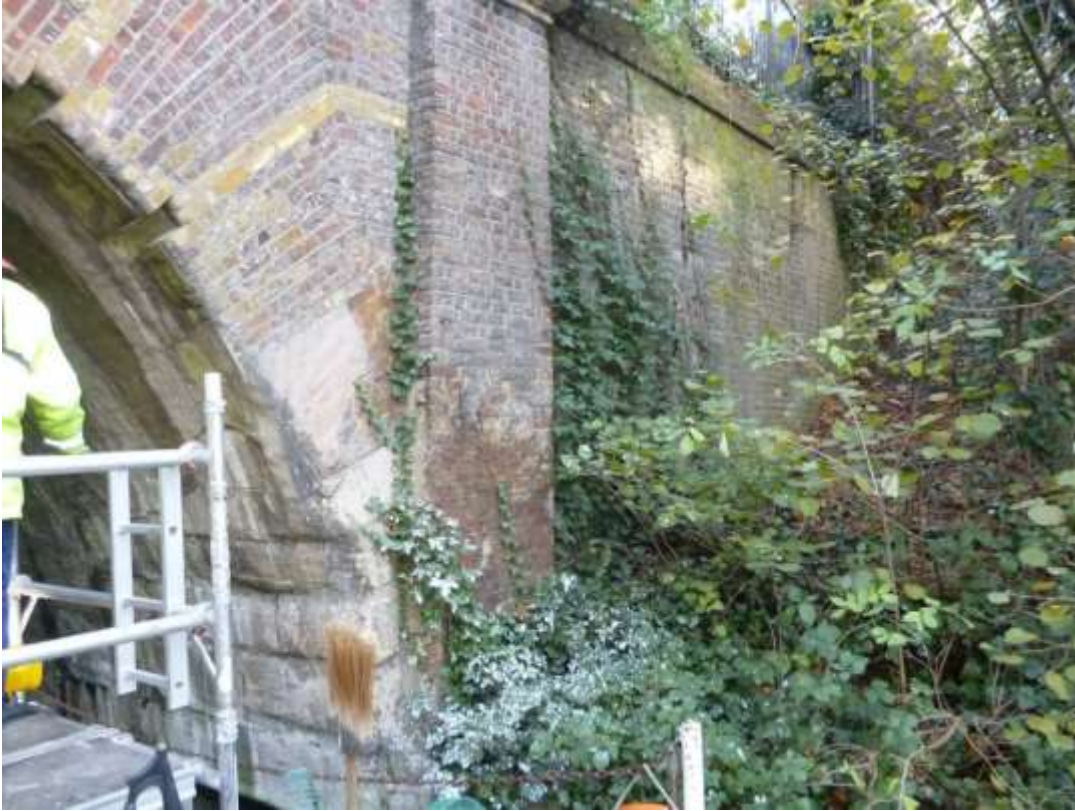
West Portal	Brick infill repairs to the recessed channels, brick patch repairs and re-pointing.	Repairs dating from 1981
West Portal – South wingwall	Two significant but old, displaced, vertical movement cracks (North and South cracks). Some ivy growth on the front face.	Cracks are displaced but appear to be similar to the last PI.
West Portal – North wingwall	Two significant but old, displaced, vertical movement cracks (North and South cracks including broken tell-tails). Heavy graffiti on the wall.	Cracks are displaced but appear to be similar to the last PI. Graffiti has increased.
West Portal – North wingwall	Old, vertical movement to north section of wingwall with ivy growth and sapling growth on the front face.	Open mortar joints but condition appears to be similar to the last PI

The west portal is also considered to be in poor condition due to the old vertical movement cracks.

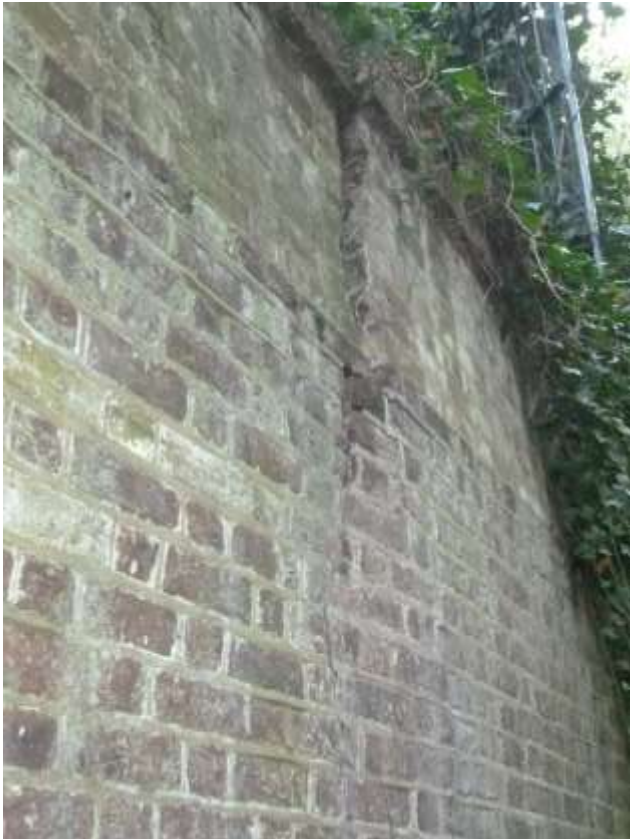
West Portal – South wingwall – South crack is displaced at the top

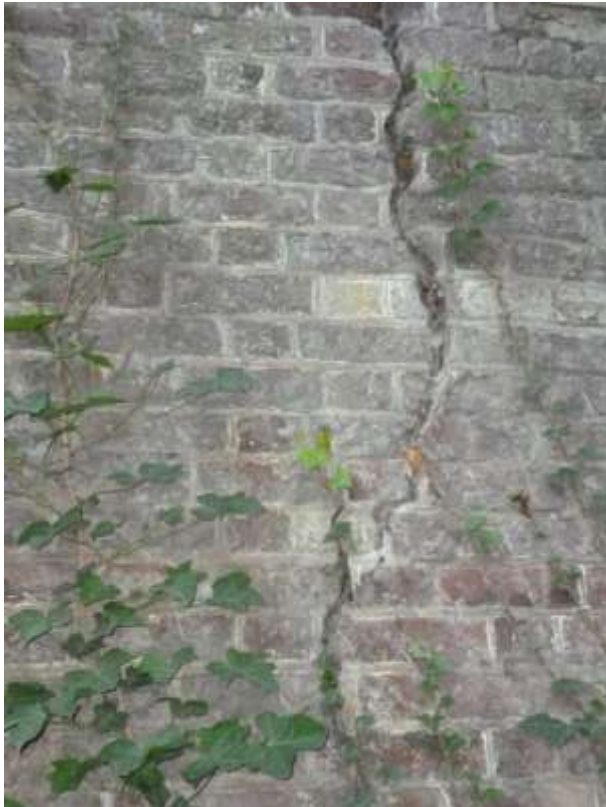
West Portal – South wingwall – Base of an old, vertical movement crack (North crack extending up to the top of the wall)

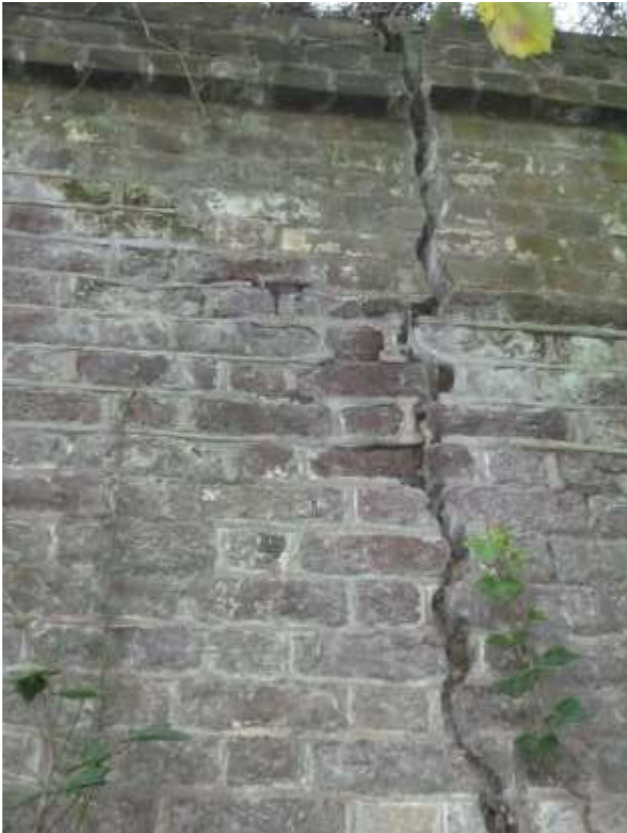
West Portal – South wingwall – North crack displaced near the top of the wall.

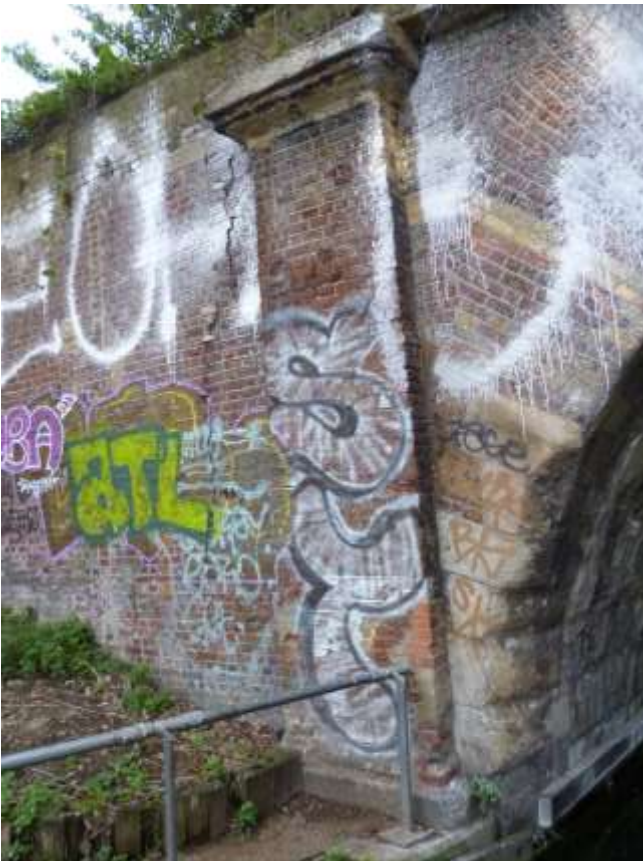
West Portal – North wingwall – Old, vertical movement crack (South crack extending up to the top of the wall with old tell-tails present)

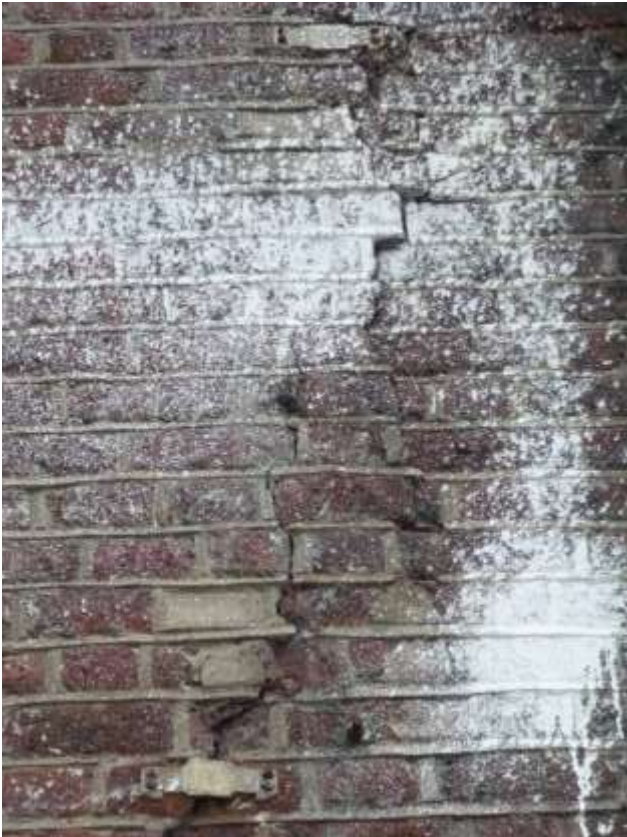
West Portal – North wingwall – South crack – Tell-tails are broken

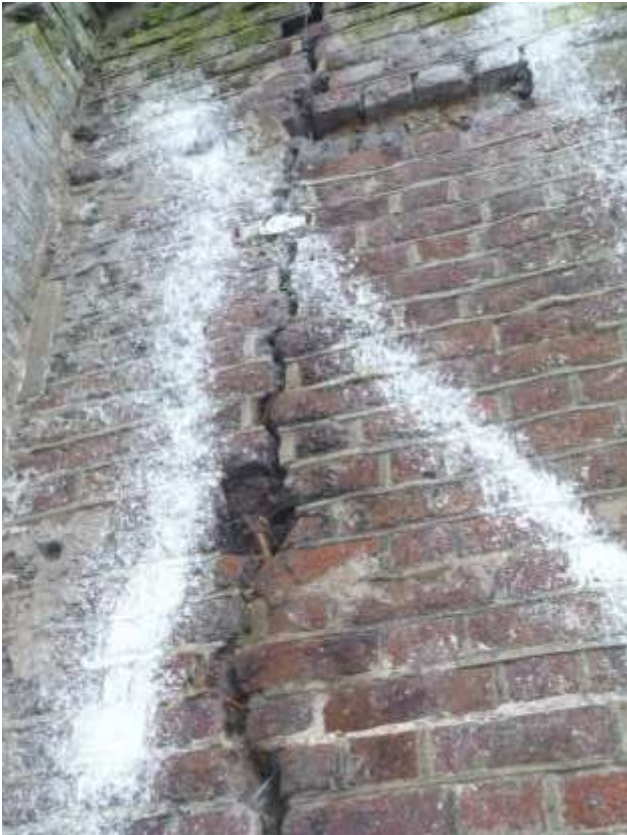
West Portal – North wingwall – North crack – Wall is displaced near the top

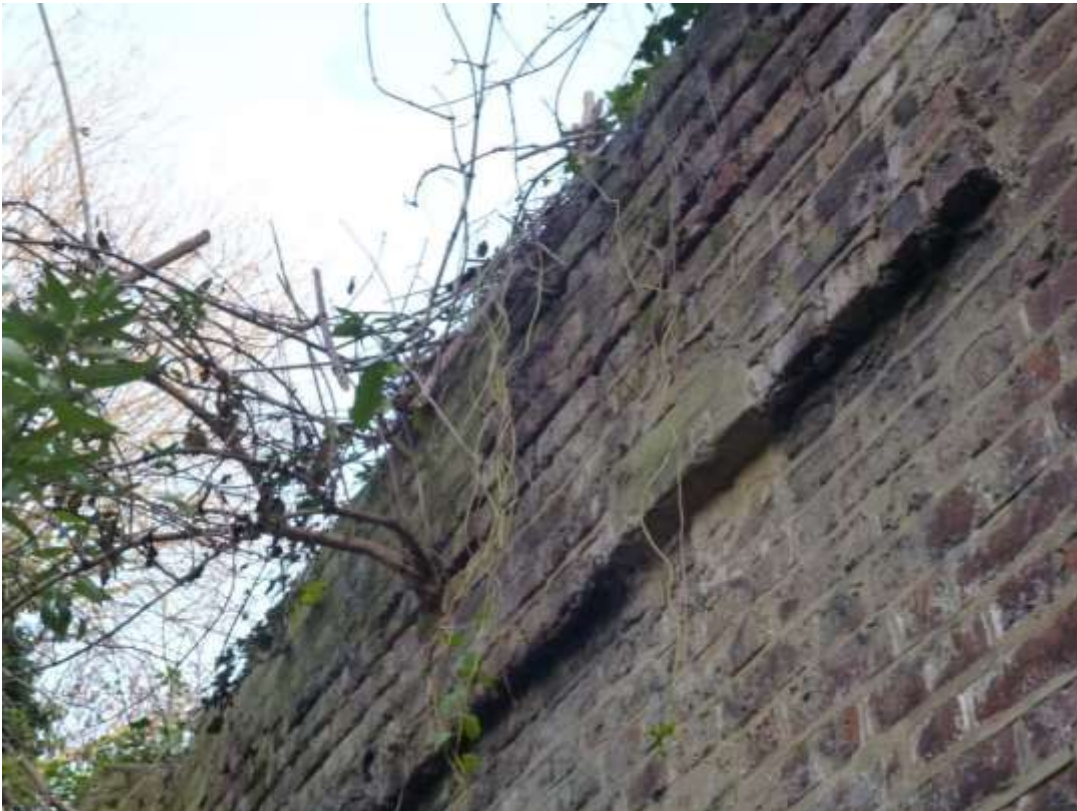
West Portal – Crack through north end of the north wing wall with vegetation growing on the wall.

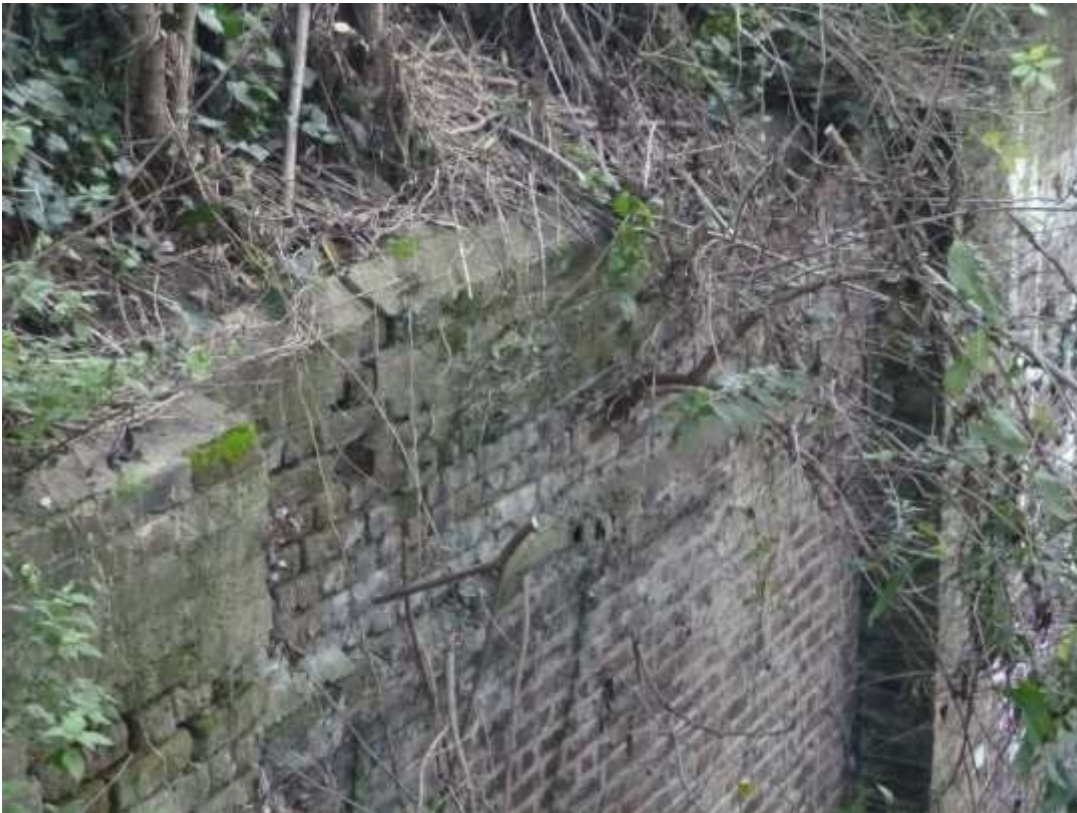
West Portal – Vegetation growth
