## Field Biologist Site Inspection for Family Mart

FamilyMart Mayang Mall / 21 Jul 2025

Document No.	000148
Audit Title	Post-Opening Site Inspection
Site Name	FamilyMart Mayang Mall
Location	Lower Ground Mayang Mall, 20000 Kuala Terengganu, Terengganu, Malaysia (5.3370937, 103.14438159999999)
Contractor Present	Yes
Name	Adam IDZire
Project PIC Present	Yes
Name	Sim Hant Shen
Inspected by	Naim Yusuf
Inspection Date	21.07.2025
Prepared by	Naim Yusuf

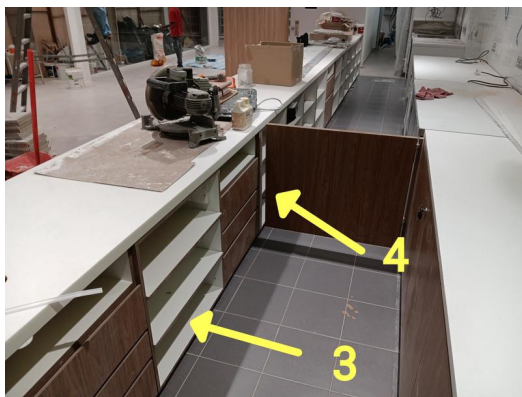
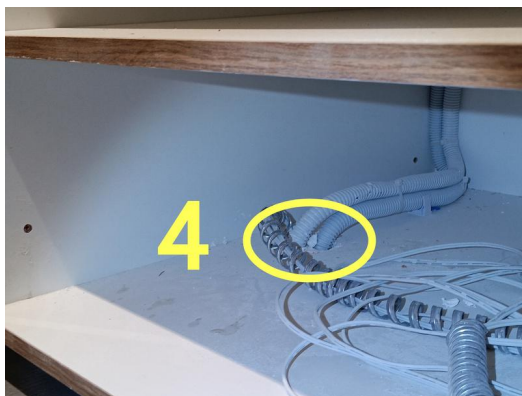
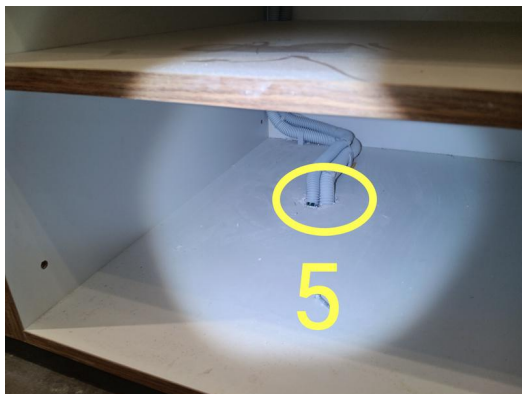
Some gaps found around the conduit. Existing proofing need to be improved.

Fix the proofings and seal the gaps completely.

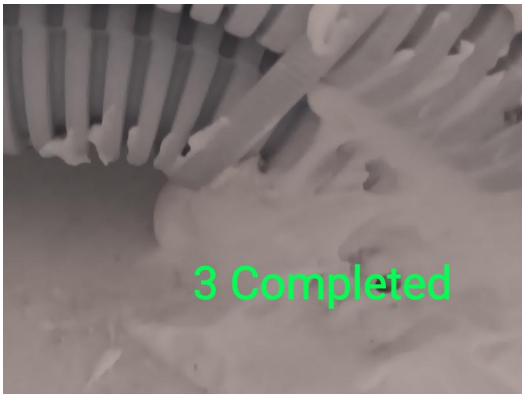
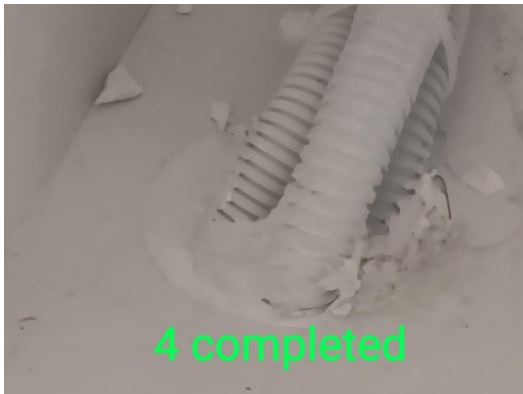
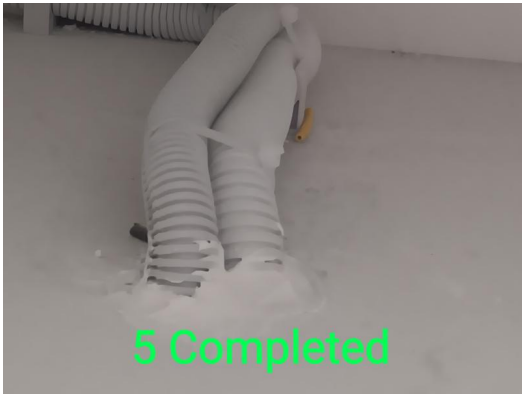
- 3. Completed ☒
- 4. Completed ☒
- 5. Completed ☒

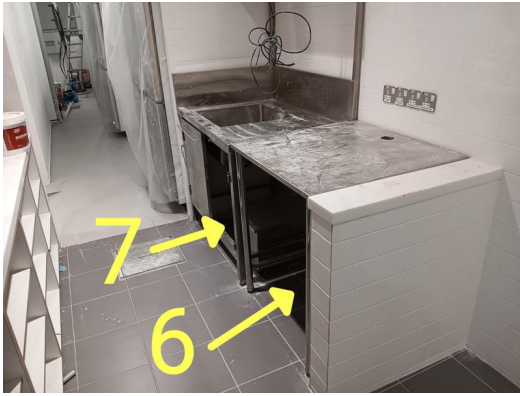
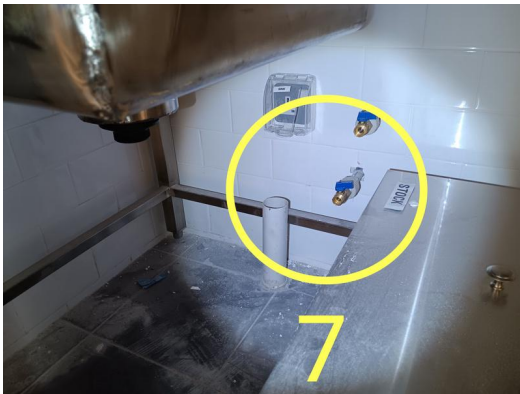
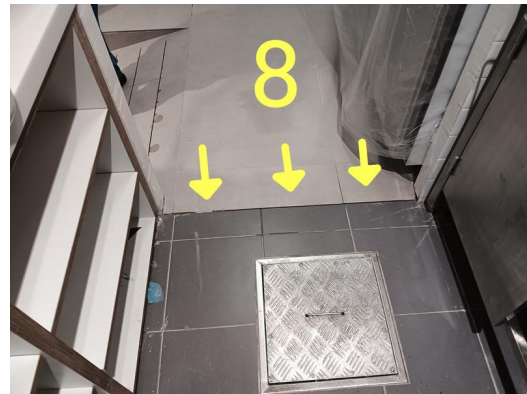
Pipe installation works not done yet and leaving exposed openings at the pipes.

Crevices observed on the floor tiles.

Please do not left any gap after pipe installation done.

Please seal the crevices.

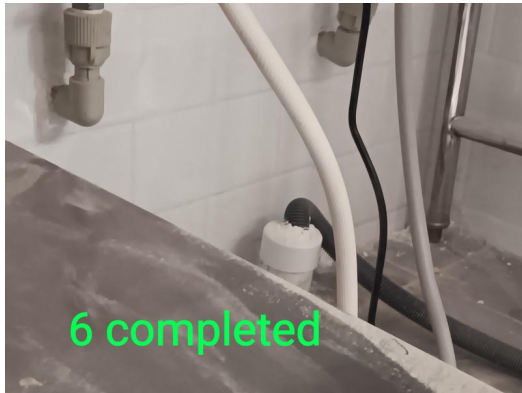
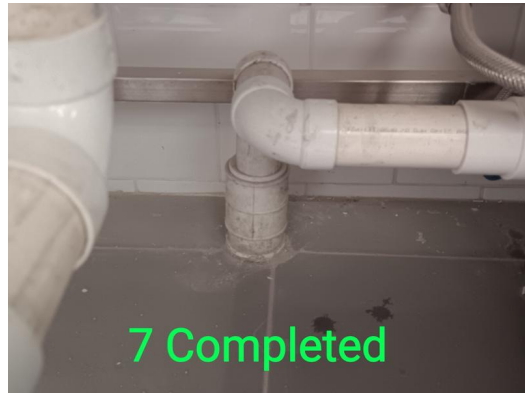
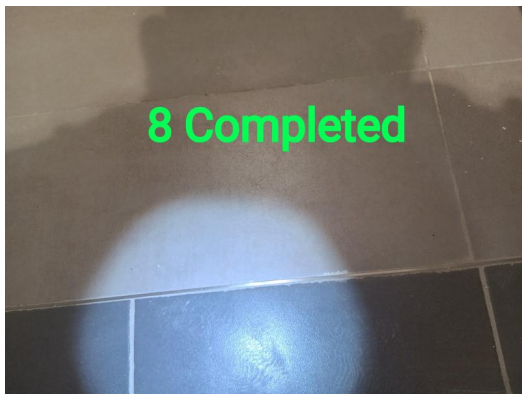
6. Completed ☒

7. Completed ☒

8. Completed ☒

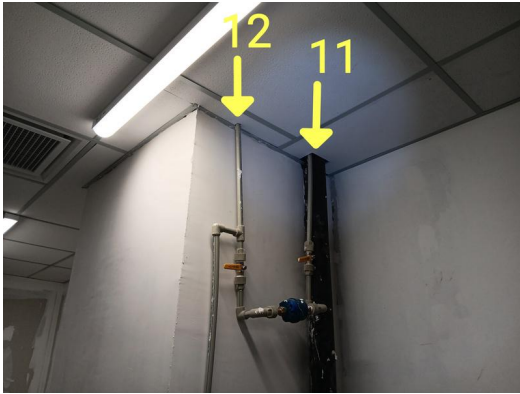
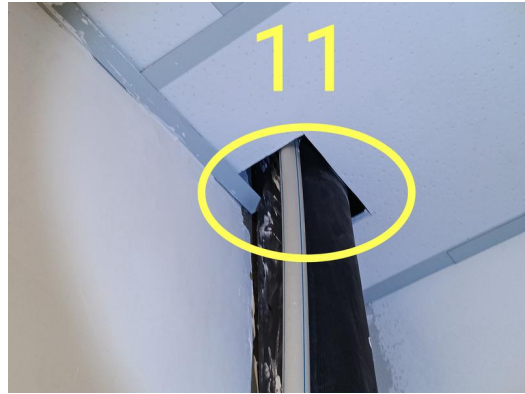
Gaps observed around the ceiling pipes.

Unused pipe with opening found on the floor.

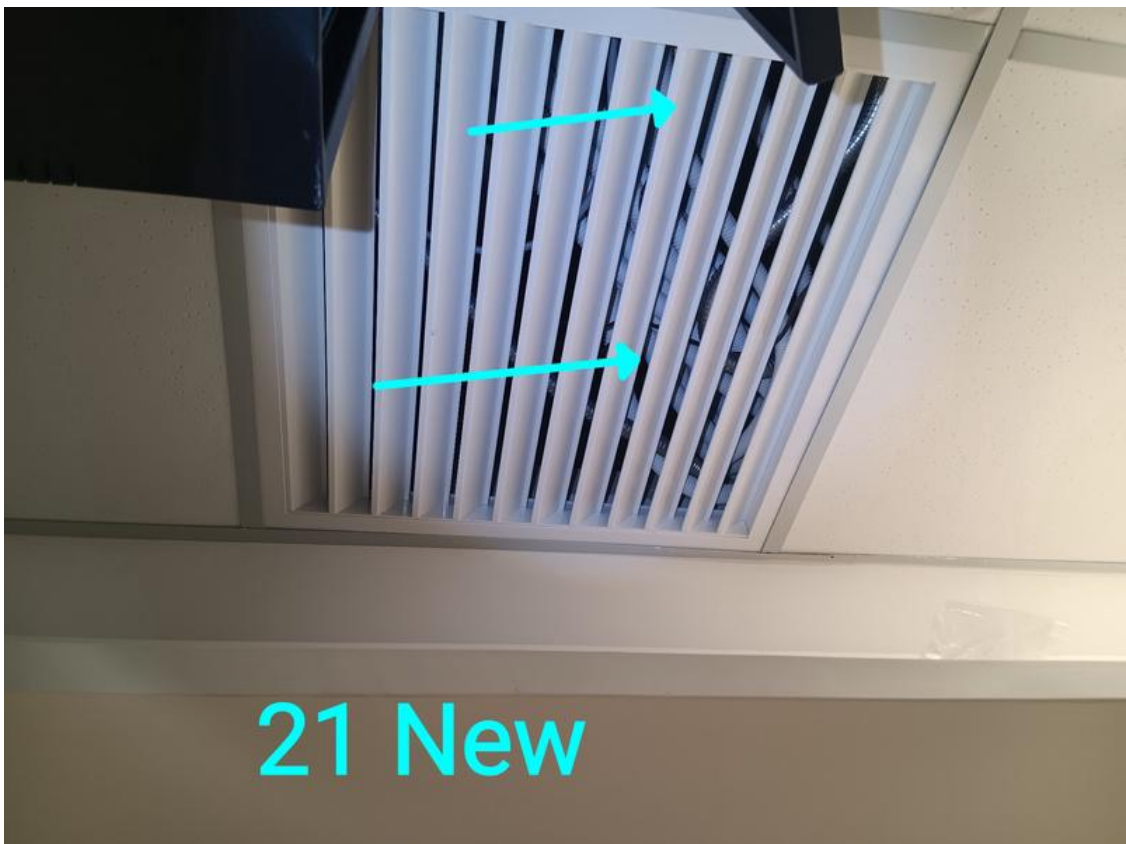
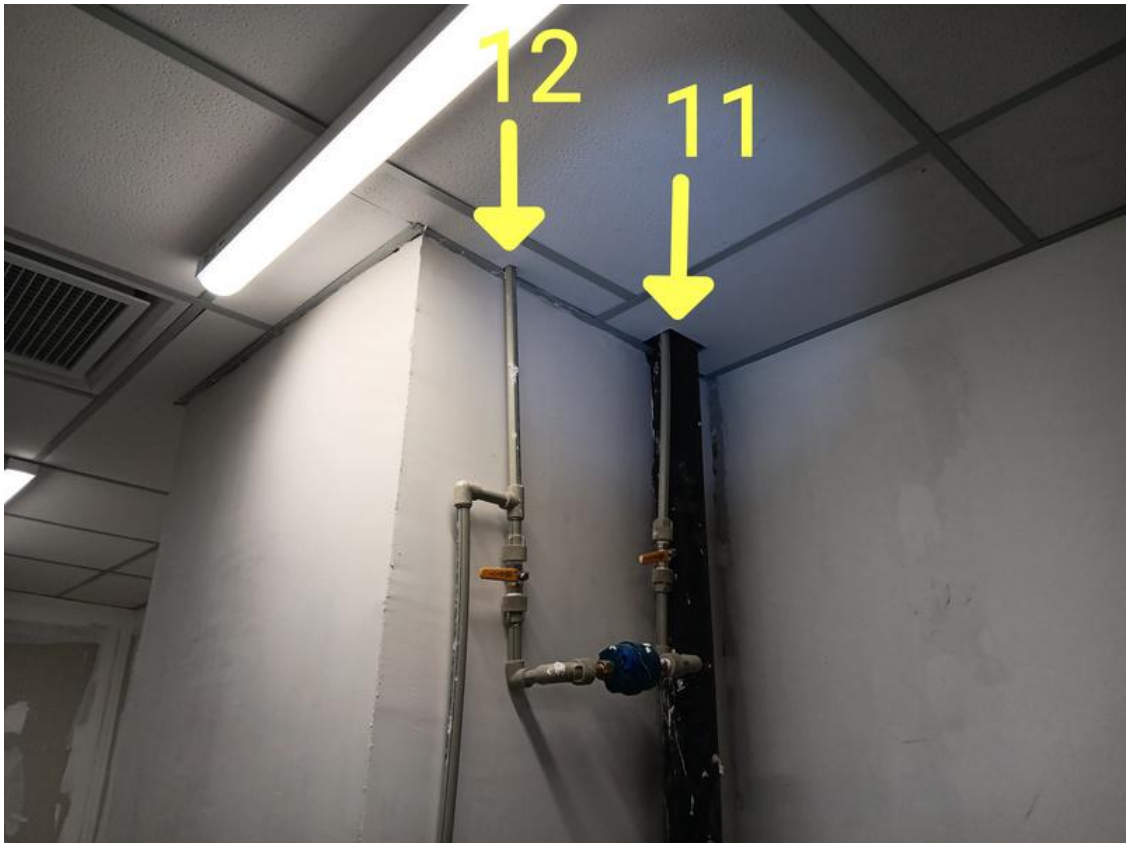
Ventilation grill at the ceiling was observed without net screening, allowing easy pest entry into the floor area.
