Pest Inspection Report

Post-Inspection Report / MFM0131 Porto Historia / 18 Jul 2025

Inspection	Post-Inspection Report
Store ID and Name	MFM0131 Porto Historia
Tracker	Other pest
Inspector	Irshad
Project Team PIC	Faiz
Project Team Present	Yes
Contractor Present	No
Inspection Date	18.07.2025
Report Date	18.07.2025
Handover Date	18.07.2025

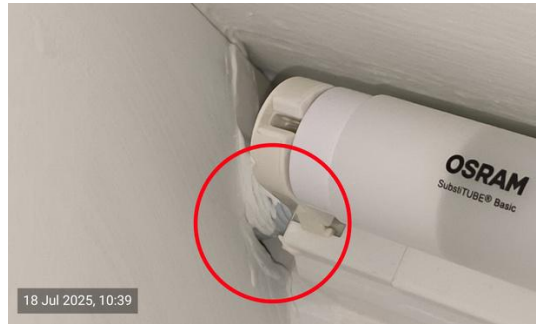
Photo 21

Findings	Noted with cracks and a gap.
Recommendation	Kindly assist to seal.
Status	New Findings
Findings #9

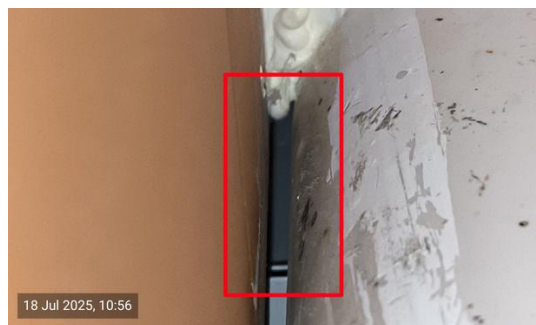
Photo 27

Findings	There is no metal wire mesh net installed.
Recommendation	Kindly assist to install the metal net.
Status	New Findings
Findings #10

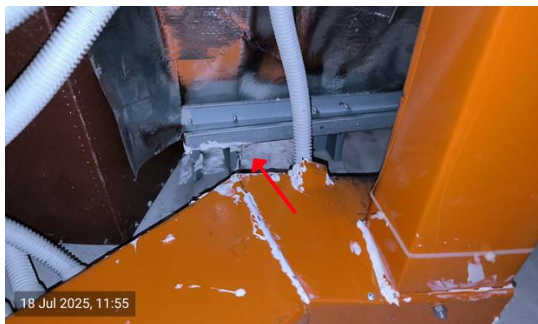
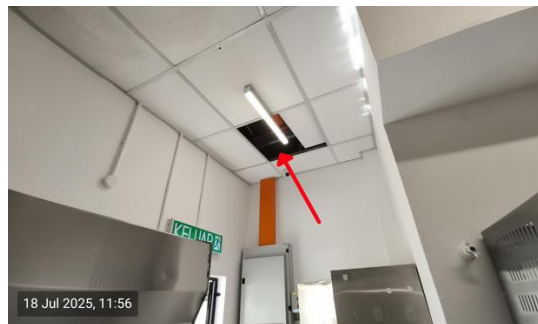
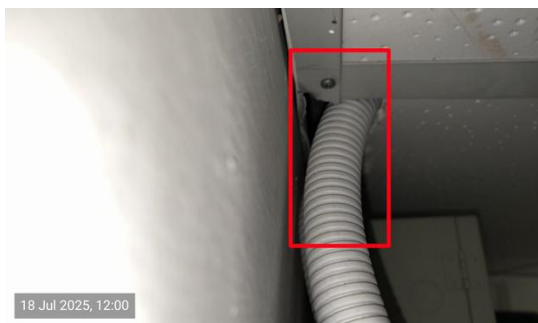
Findings Noted with gaps.

Recommendation Kindly assist to seal.

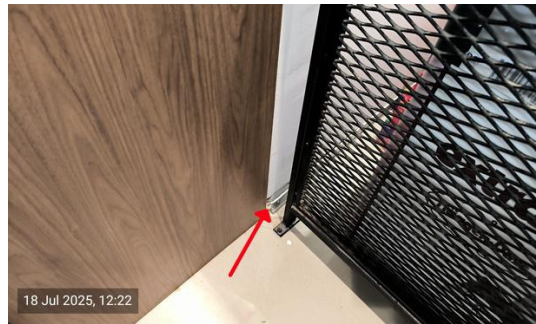
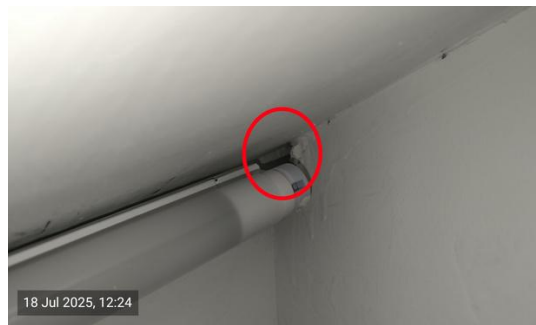
Findings Noted detached.

Recommendation Kindly assist to rectify.

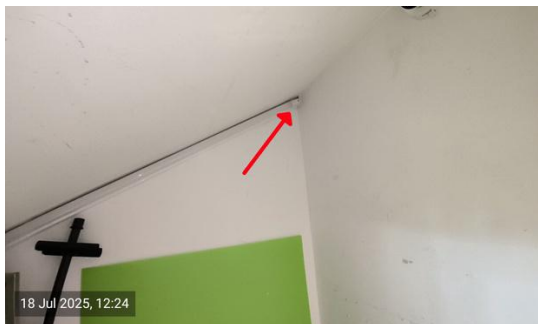
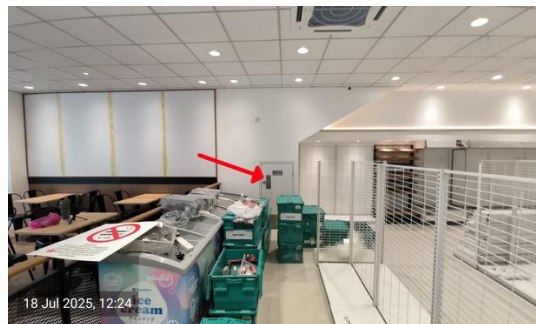
Findings Noted with a gap.

Recommendation Kindly assist to seal.

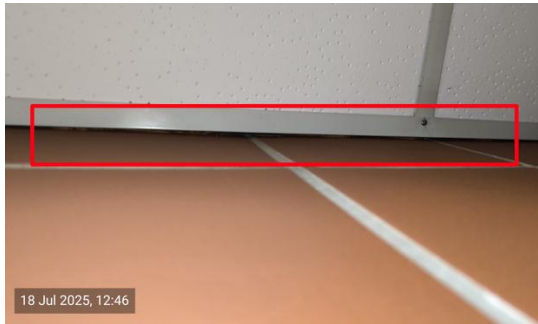
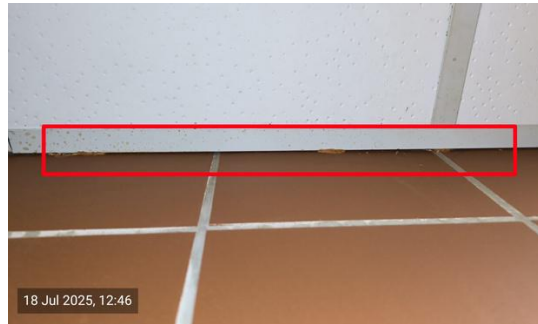
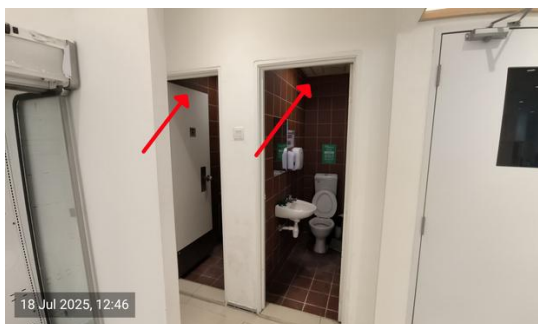
Findings	Ceiling skirting with gaps.
Recommendation	Kindly assist to seal.
Status	New Findings
Findings #24	
Location	Backroom - Backdoor
