PHYSICAL NEEDS ASSESSMENT

PHYSICAL NEEDS ASSESSMENT of EAST STROUDSBURG READINESS CENTER 42B30 271 Washington Street East Stroudsburg, Pennsylvania 18301-2839

EMG Project #: 88798.09R-009.017
Date of Report: June 30, 2009
On site Date: May 26, 2009

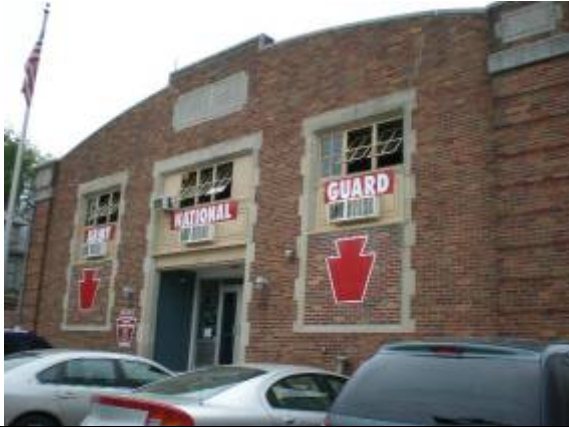
Photo #1: Front (west) elevation of the Readiness Center Building along Washington Street

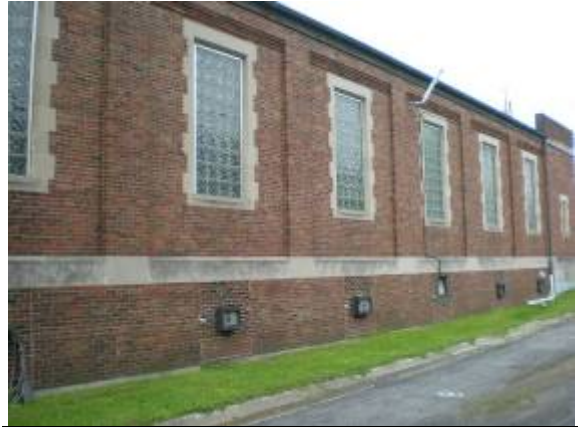
Photo #2: Left (north) elevation of the Readiness Center Building

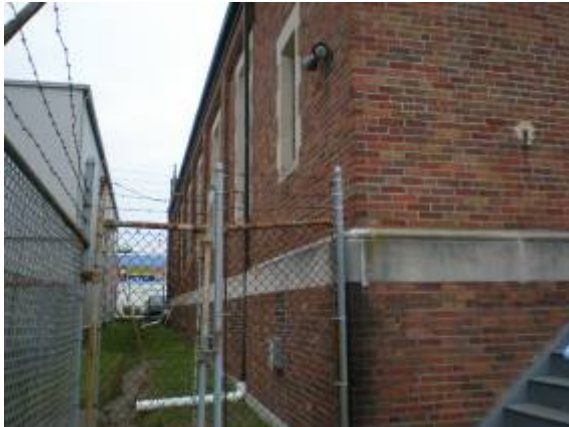
Photo #3: Right (south) elevation of the Readiness Center Building

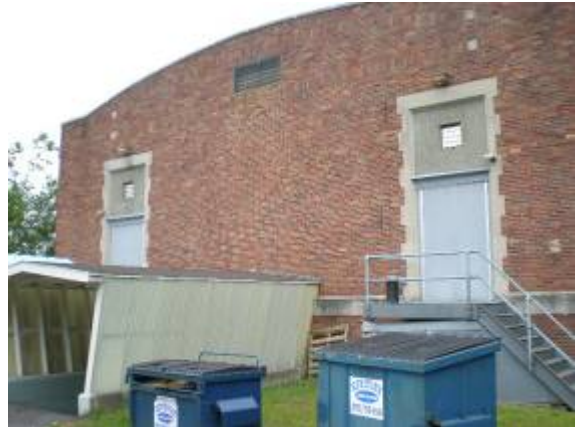
Photo #4: Rear (north) elevation of the Readiness Center Building

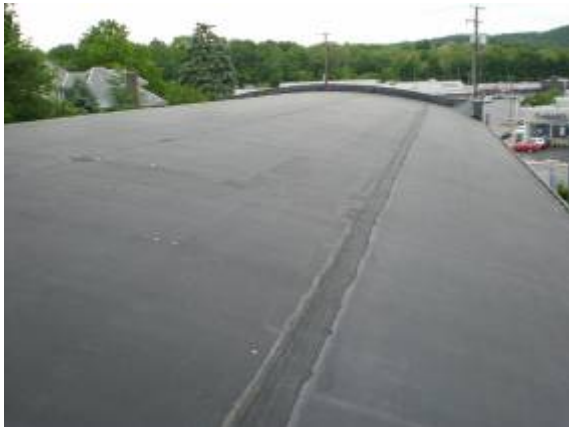
Photo #5: Overview of roof of the Readiness Center building

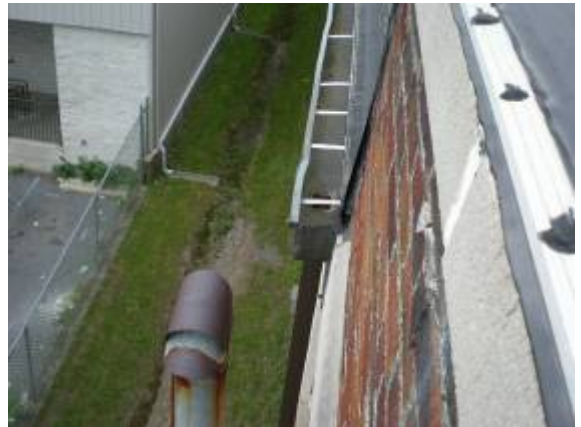
Photo #6: Gutter

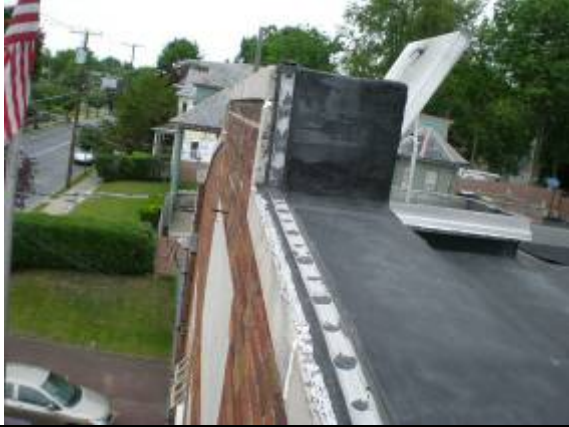
Photo #7: Copping and roof termination bar

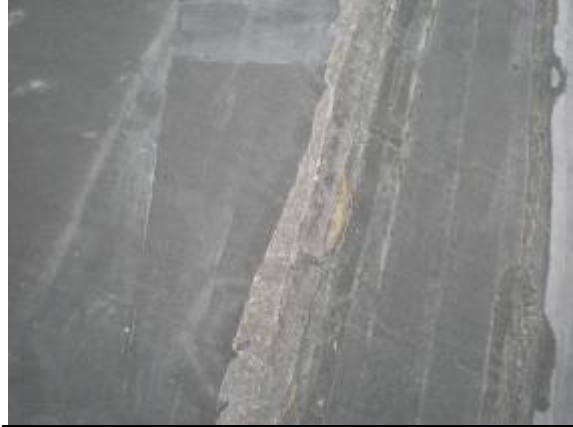
Photo #8: Seam separation in roofing membrane

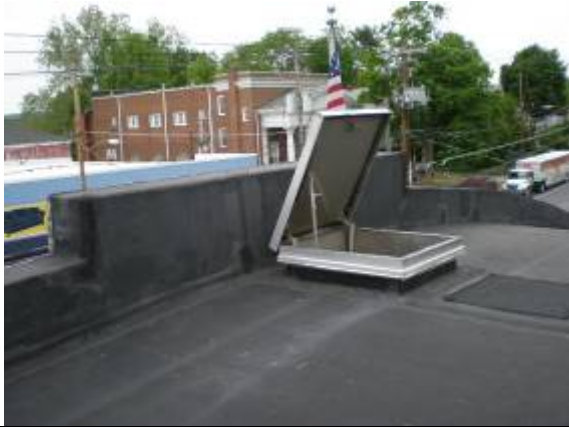
Photo #9: Roof access hatch

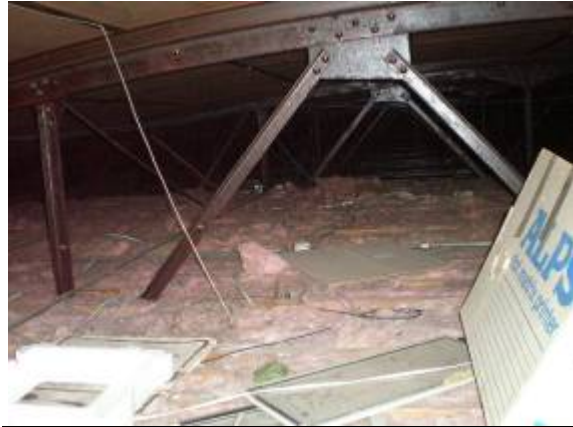
Photo #10: Attic space with bow truss & insulation

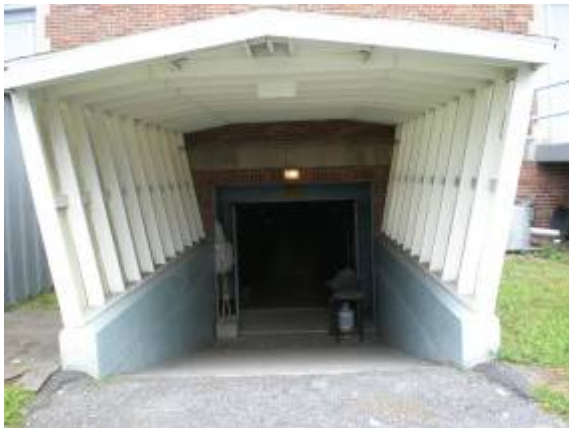
Photo #11: Wood framed canopy at Basement entry

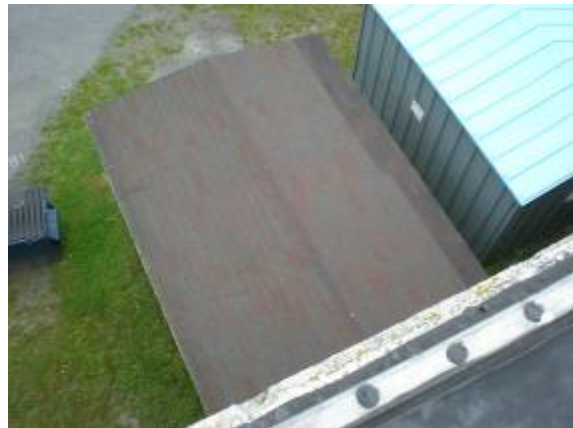
Photo #12: Shingle roofing at Basement canopy

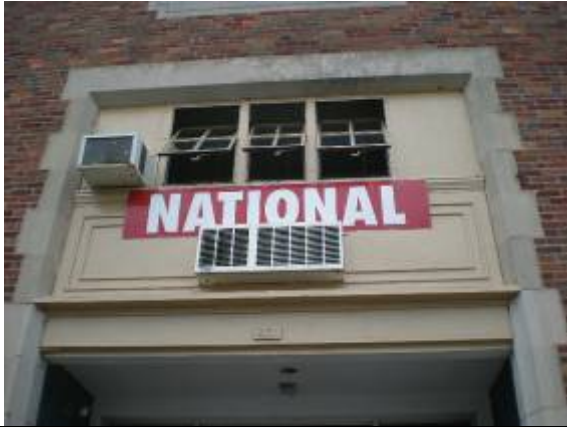
Photo #13: Main entrance finishes

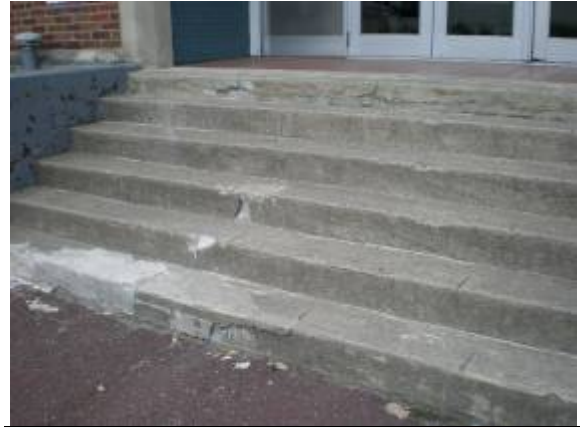
Photo #14: Main entrance staircase. Note: spalling of concrete.

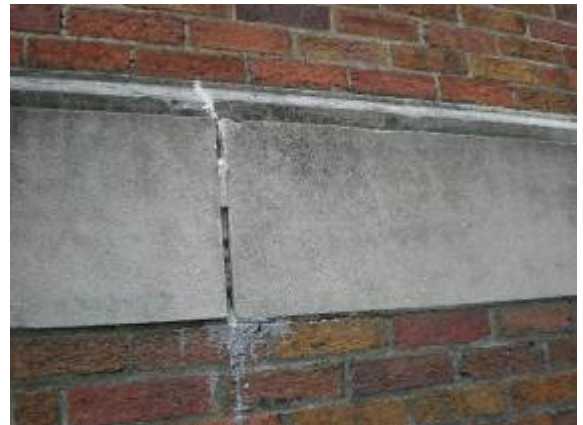
Photo #16: Stone trim. Note: Pointing deterioration

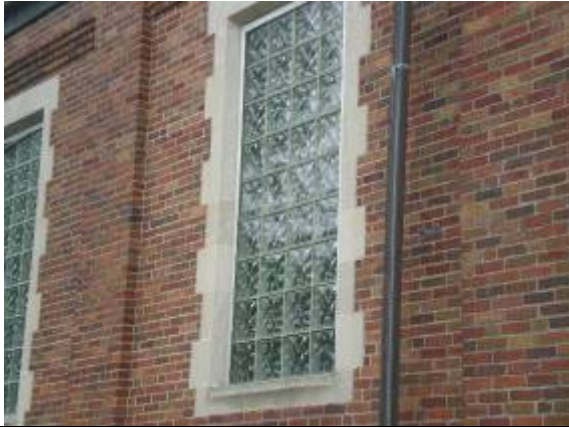
Photo #19: Typical Drill Hall window

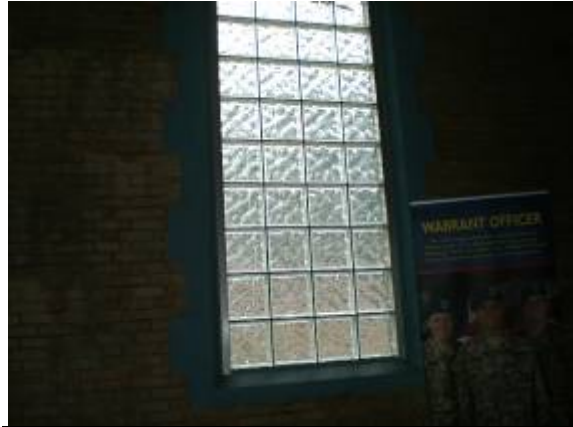
Photo #20: Interior of Drill Hall window

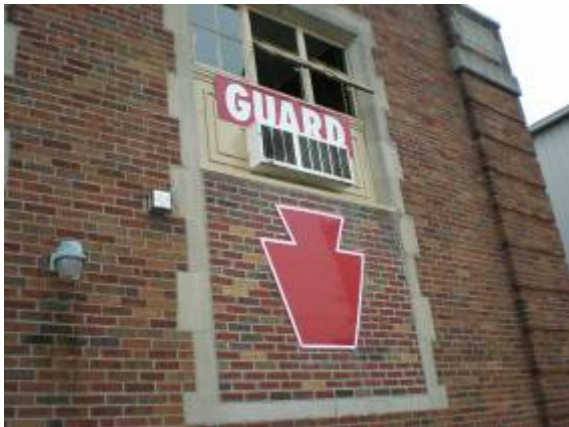
Photo #21: Administration window

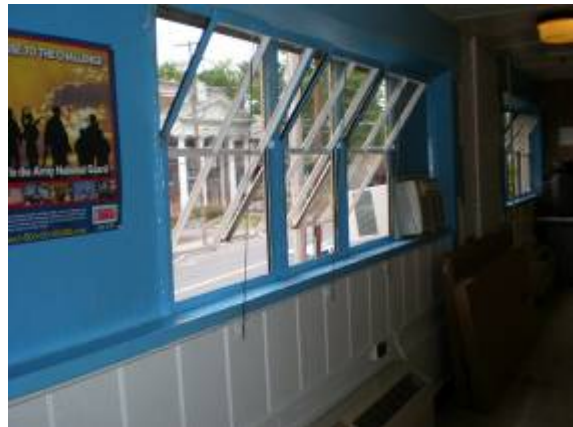
Photo #22: Interior of Administration window

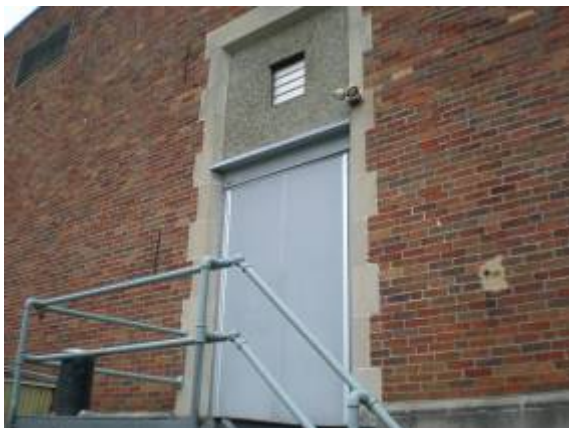
Photo #23: Exit door

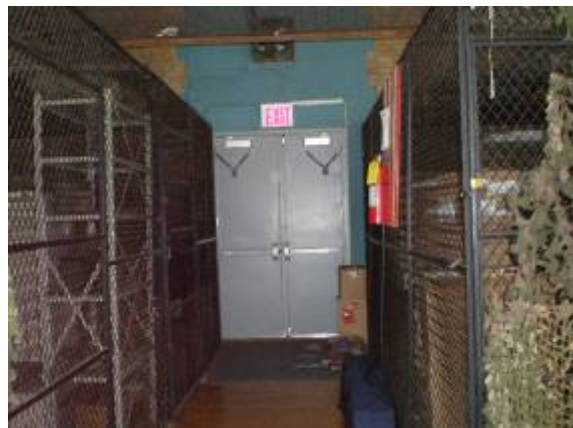
Photo #24: Interior of Drill Hall exit doors

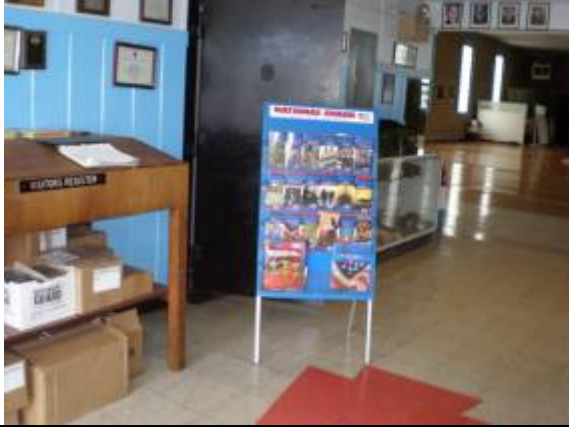
Photo #25: Lobby

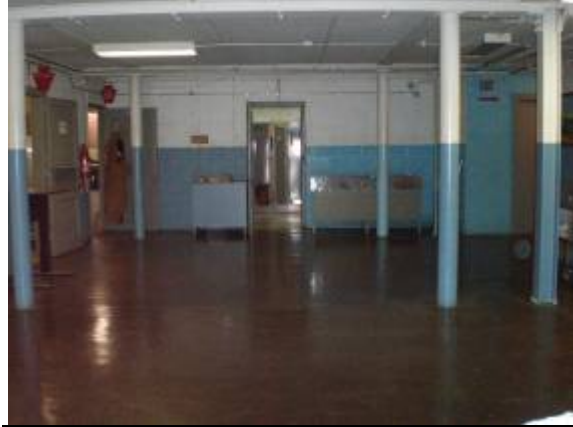
Photo #26: Basement Corridor

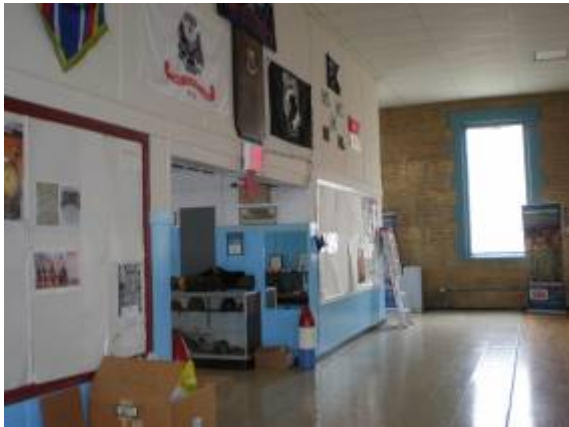
Photo #27: Drill Hall

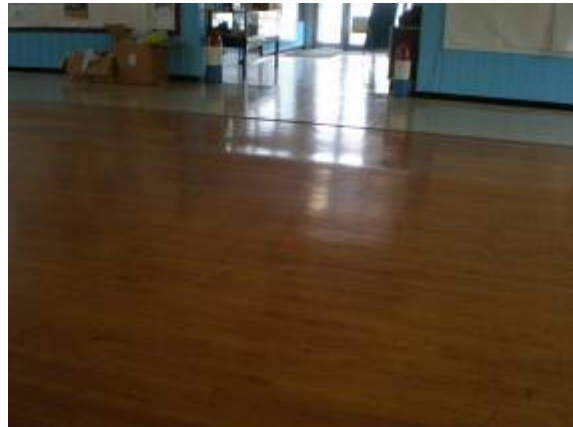
Photo #28: Drill Hall hardwood flooring

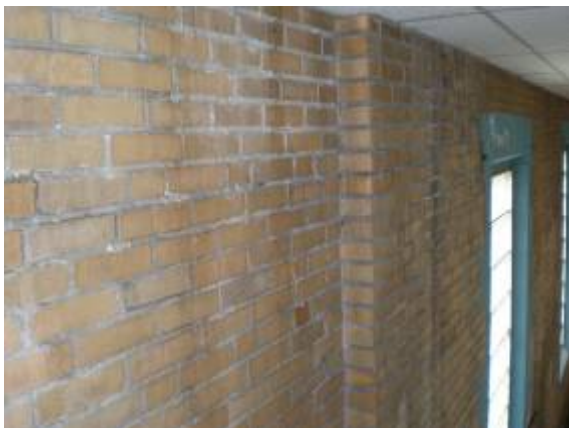
Photo #29: Drill Hall walls. Note: staining

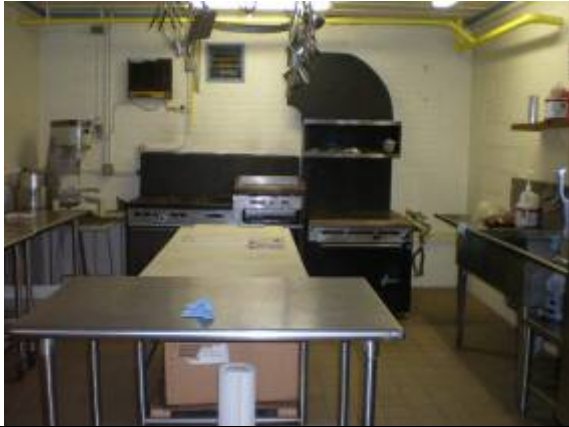
Photo #31: Kitchen

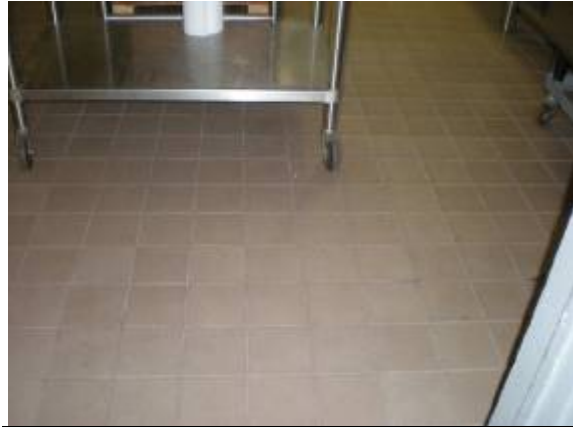
Photo #32: Kitchen floor tile

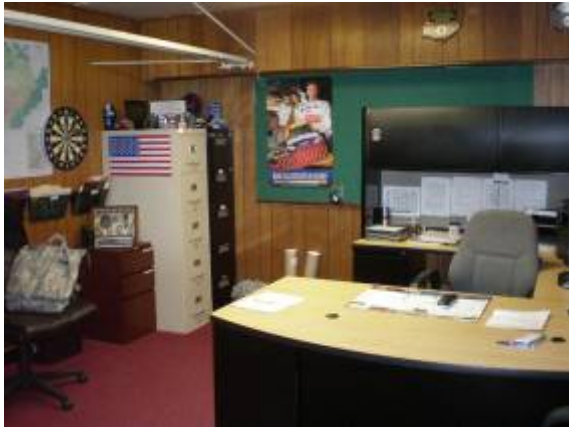
Photo #33: Office and FF&E

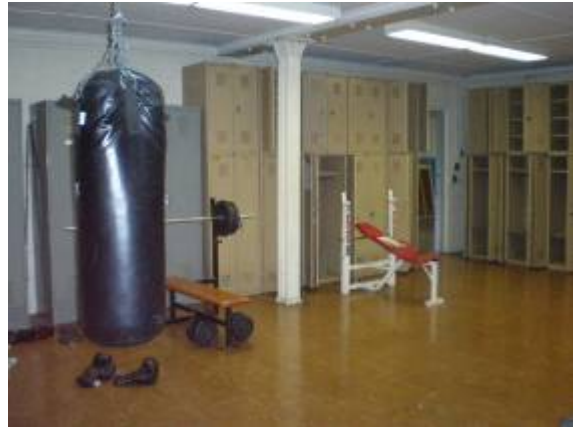
Photo #34: Physical training room. Note: suspect asbestos flooring tile

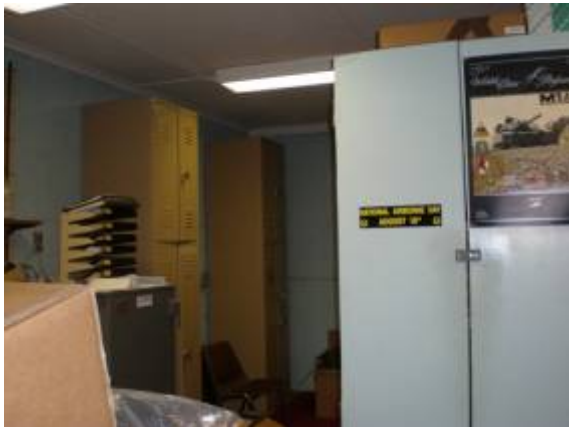
Photo #35: Basement storage

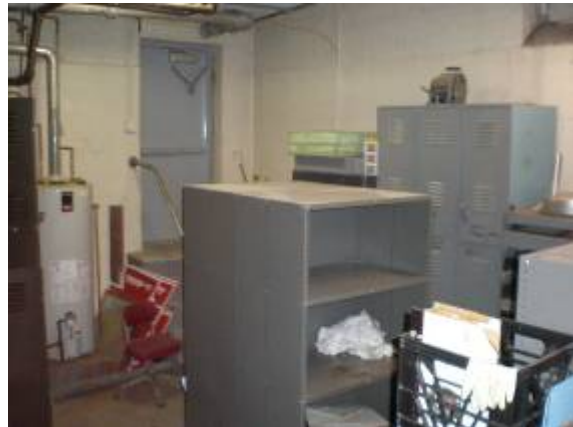
Photo #36: Mechanical Room

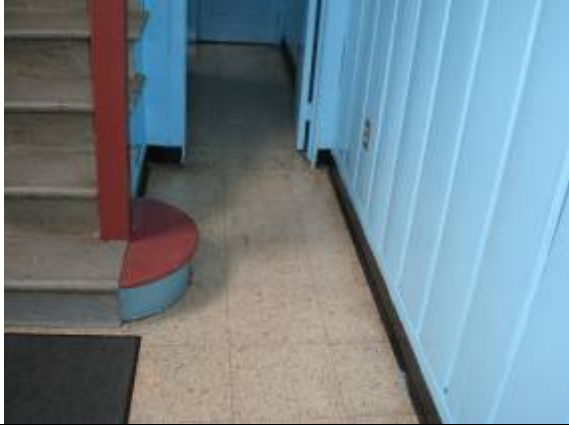
Photo #37: Entry to restroom. Note: stairway intrusion into narrow entry

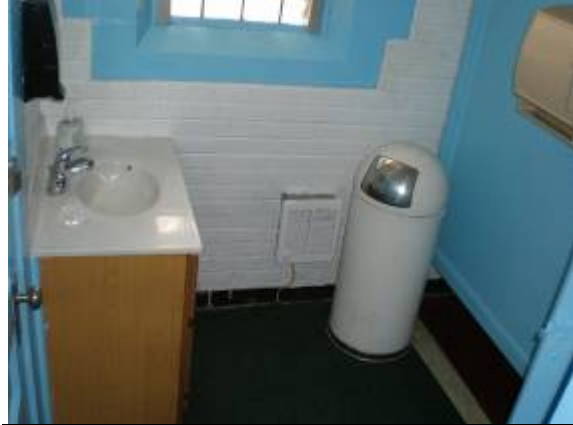
Photo #38: Drill Hall Restroom finishes

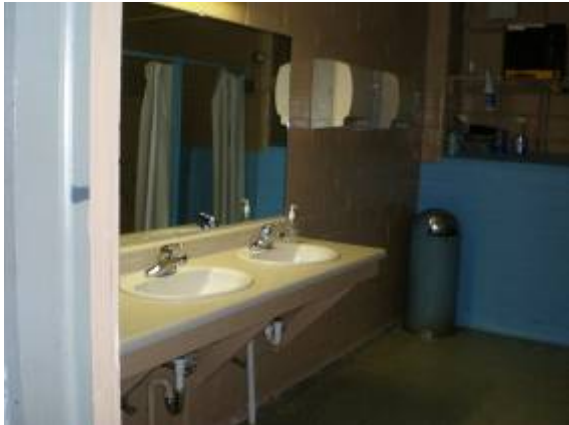
Photo #39: Basement restroom

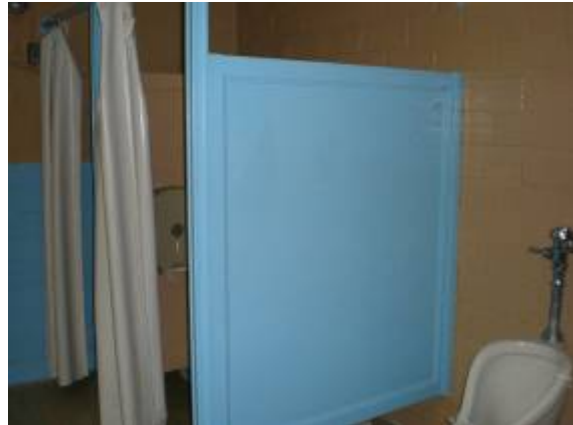
Photo #40: Basement restroom stalls

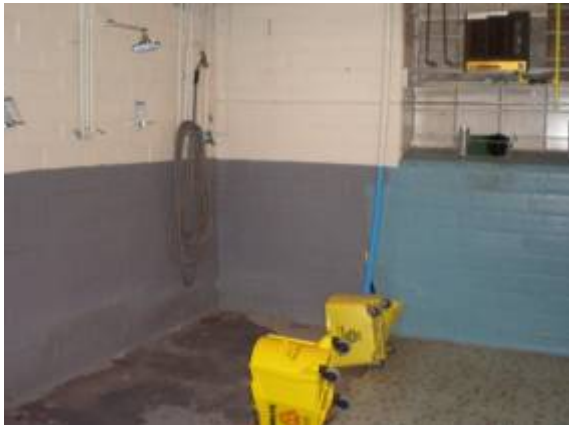
Photo #41: Basement shower

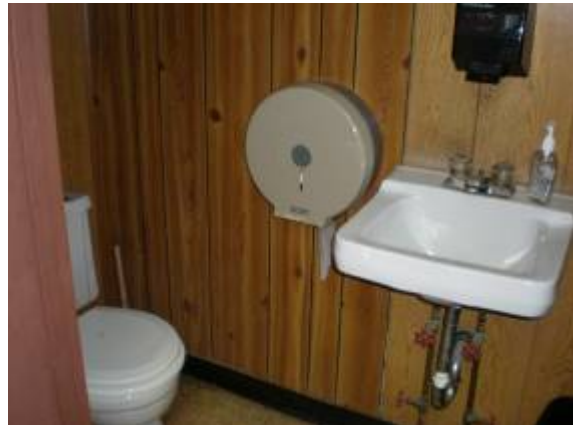
Photo #42: Administration restroom

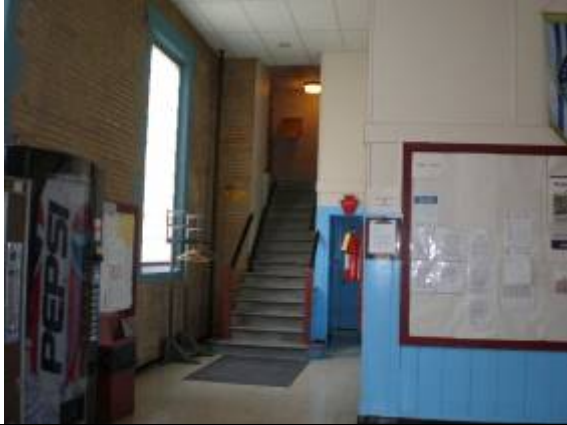
Photo #43: Stairwell lobby

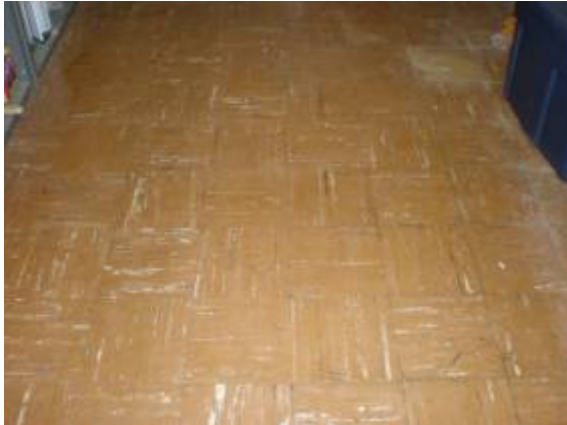
Photo #49: Vinyl tile. Note: Suspect asbestos

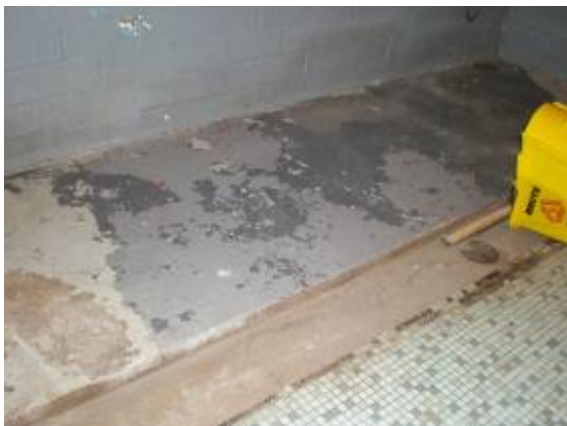
Photo #53: Deterioration of waterproofing at shower floor and chipped tiles

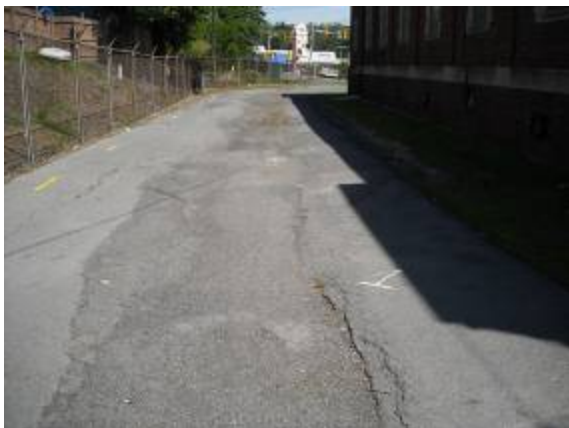
Photo #71: Drive aisle to rear of property along north side of building; note condition

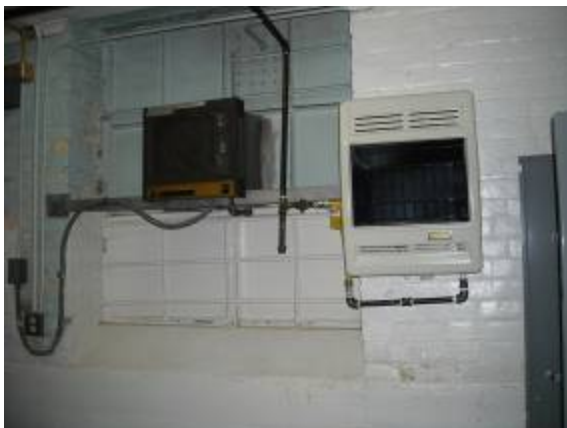
Photo #83: Ventless gas-fired wall heater (right) and disconnected wall heater (left)

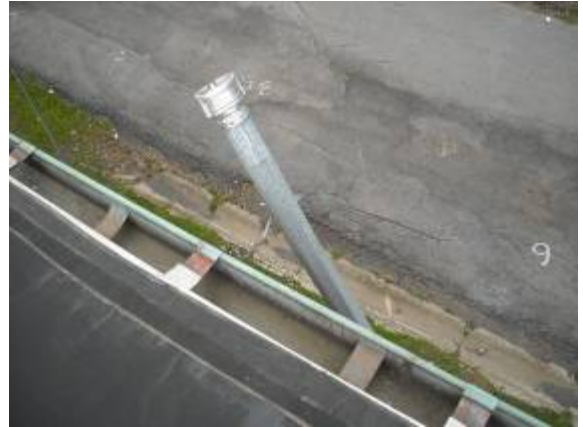
Photo #86: Drill floor unit heater flue torn loose during recent storm

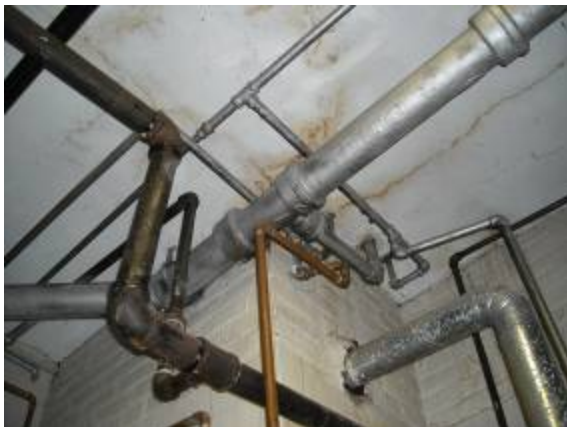
Photo #89: Cast iron and galvanized soil piping; note black iron gas piping

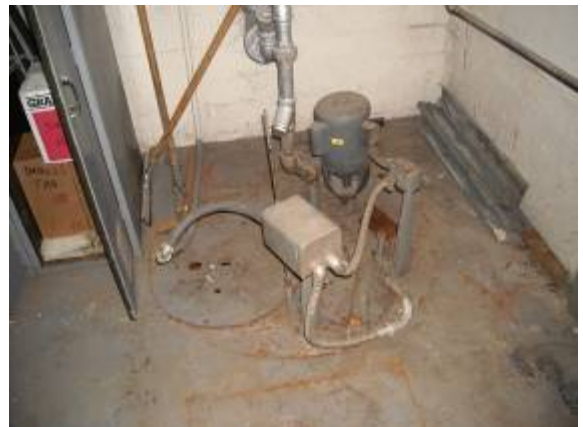
Photo #90: Mechanical room sump pump; note removed pump and loose wiring

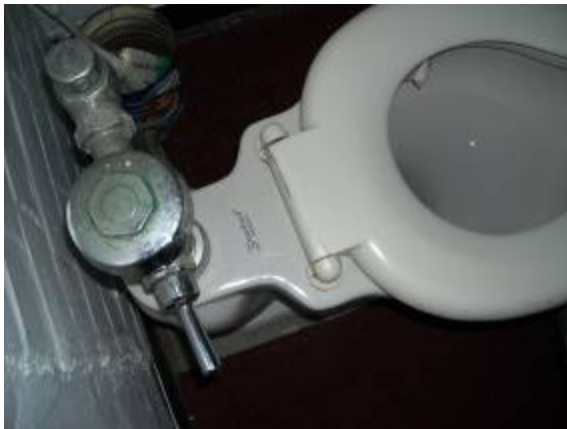
Photo #93: Cracked seat on ladies restroom water closet

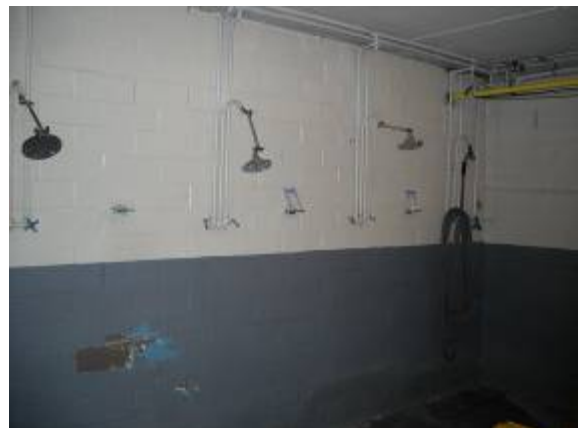
Photo #96: Basement shower room

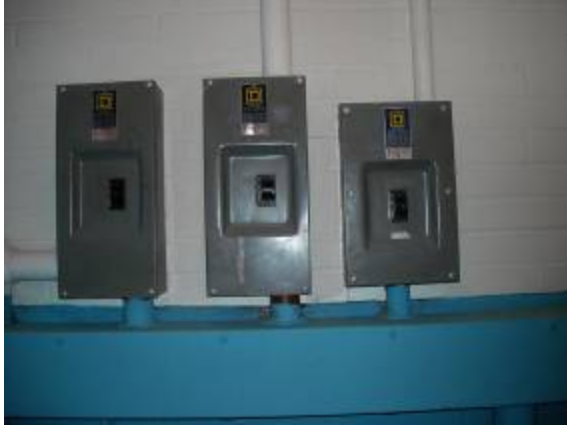
Photo #97: Main electrical disconnects

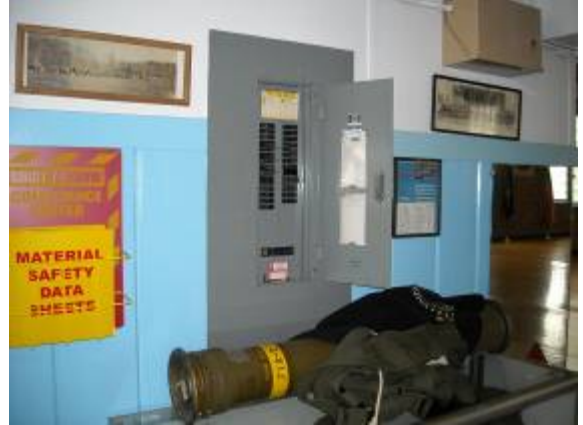
Photo #98: Load center at main lobby area

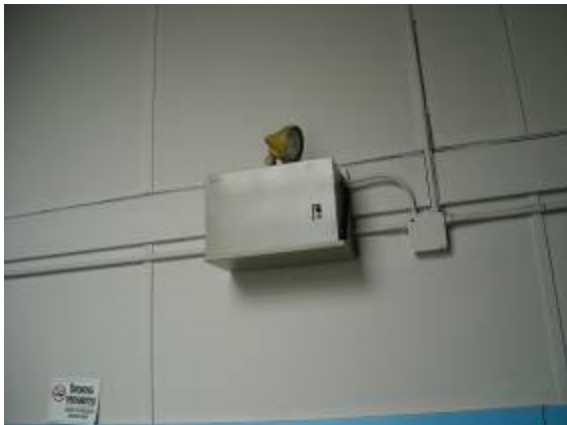
Photo #99: Interior battery backup emergency light (inoperative)

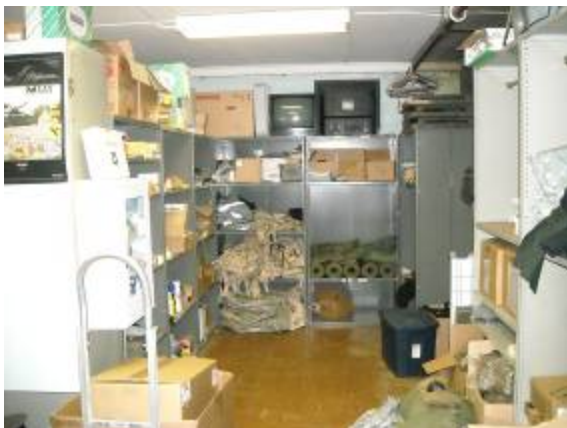
Photo #101: Typical surface mounted light fixture

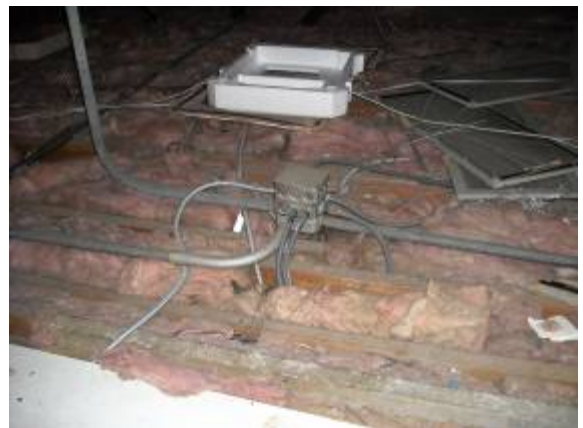
Photo #102: Electrical wiring above second floor office ceiling

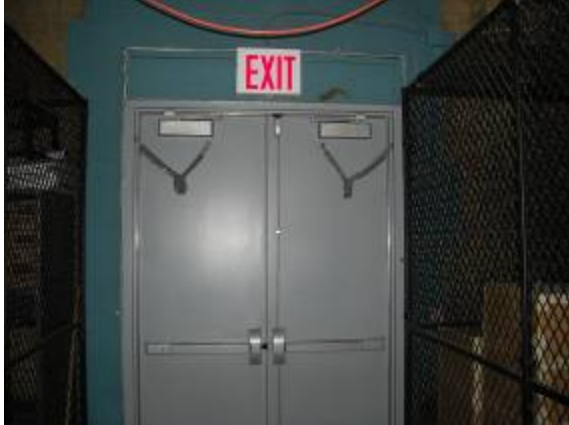
Photo #103: Illuminated exit sign at east door from drill floor

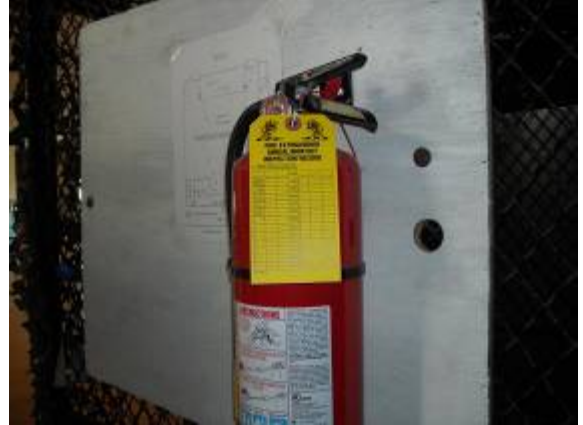
Photo #104: Portable fire extinguisher (typical)

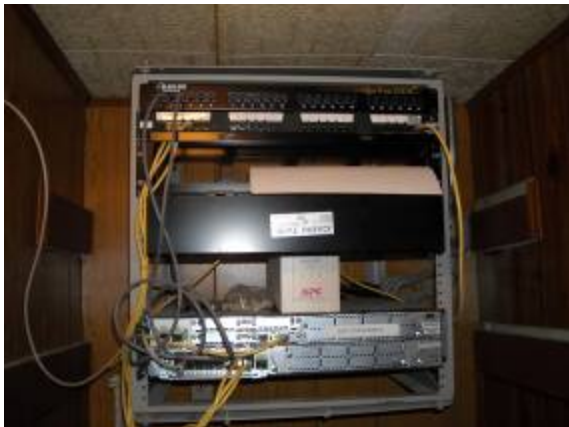
Photo #105: RCAS networking equipment at second floor restroom

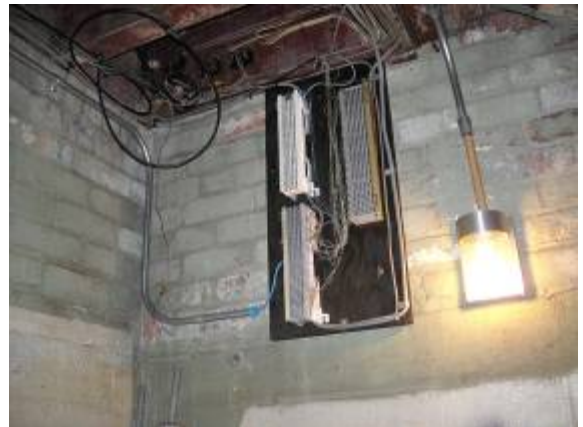
Photo #106: Telephone service blocks in basement closet under stairs

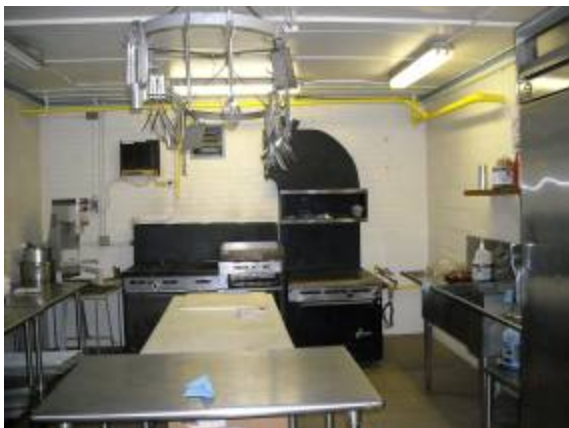
Photo #107: Basement kitchen; note absence of hood equipped with fire suppression system

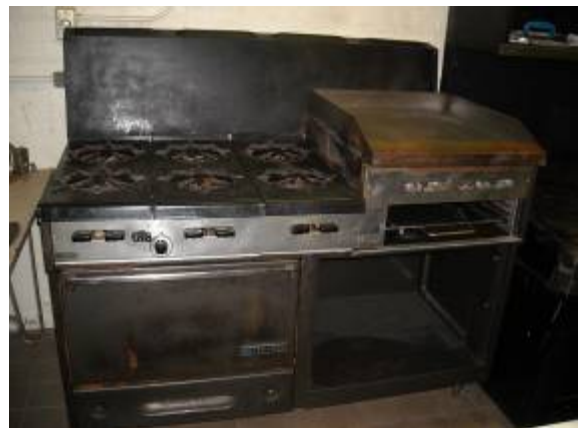
Photo #108: Range

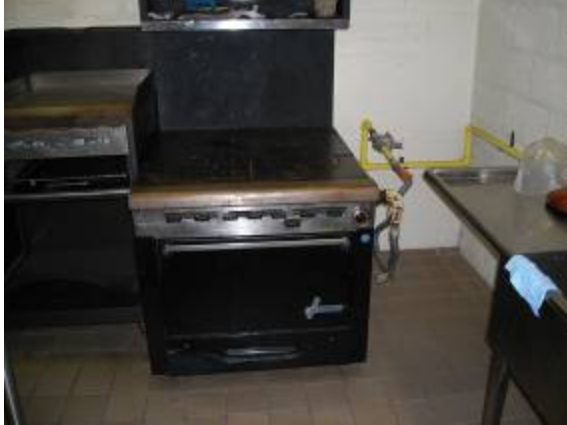
Photo #109: Griddle

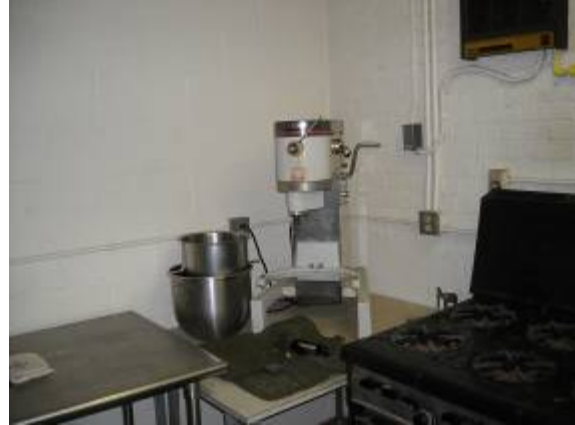
Photo #110: Mixer on table

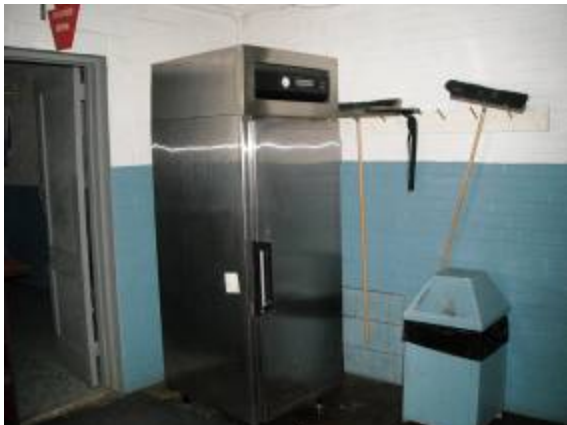
Photo #111: Reach-in refrigerator

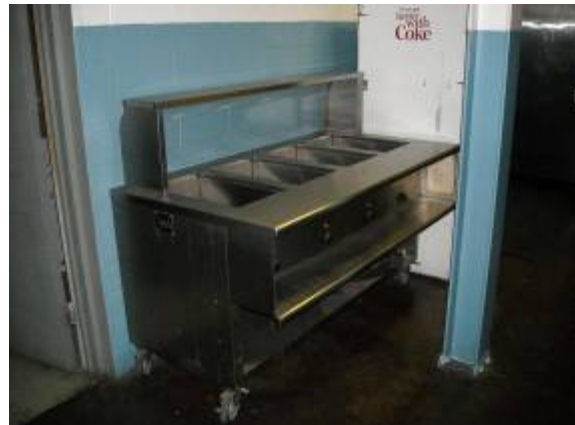
Photo #112: Hot food table

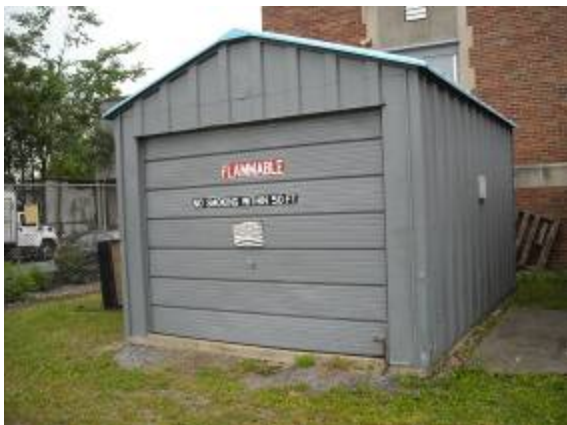
Photo #113: Flammables storage building, east of RC in MVSC

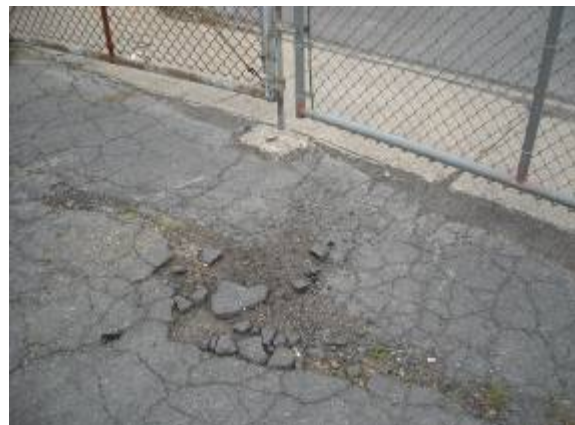
Photo #114: Cracked pavement at entrance gate from Brown Street

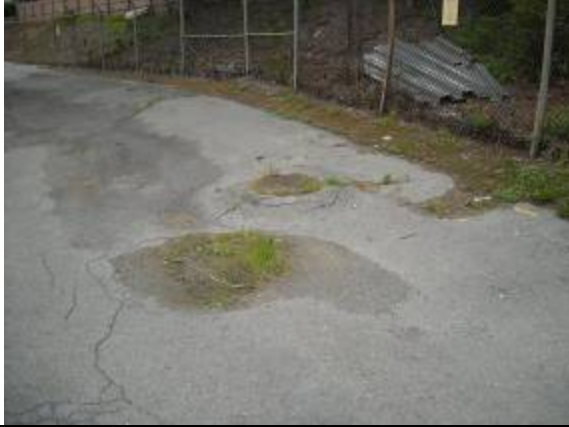
Photo #115: Manhole raised up several inches above surrounding paving

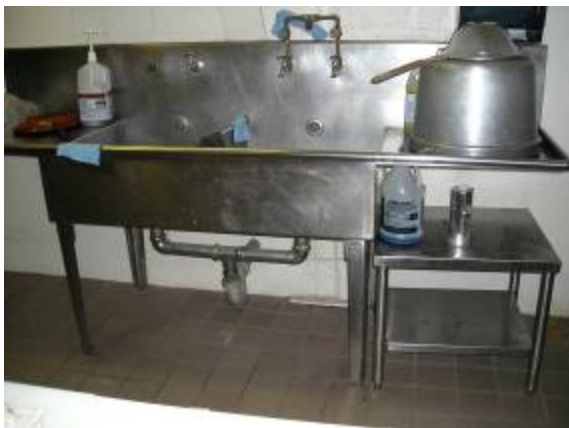
Photo #119: Kitchen sink without grease interceptor
