PRE-PURCHASE BUILDING REPORT

Property Address	123 Hillview Road, Alexandra, Otago 9391		
Client	Paul O'Connell		
Date of Inspection	23rd August 2022	Time	12:00 pm
Inspector	Mike Waymouth National Certificate in Carpentry		
LBP Number	257024		
Inspection Type	Pre-Purchase Report		
People Present	Owner, Inspector		
House Occupied	Yes

CERTIFICATE OF INSPECTION IN ACCORDANCE WITH NZS 4306:2005

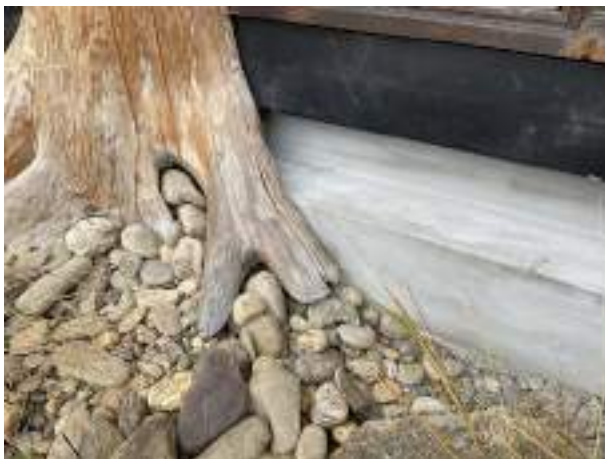
Photo 2

Concrete Strip foundation wall
beneath living room windows.

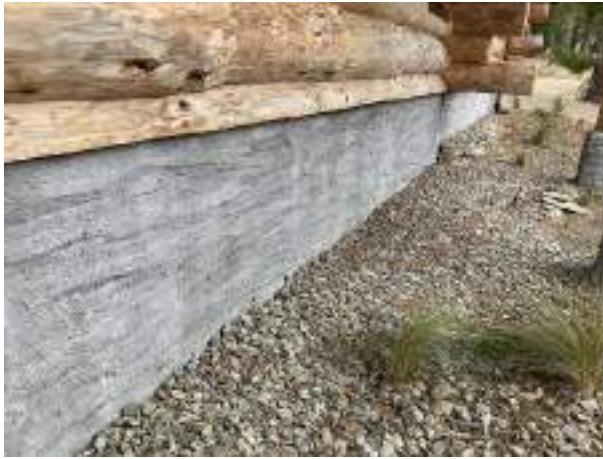
Photo 3

Foundation wall on western side of house.

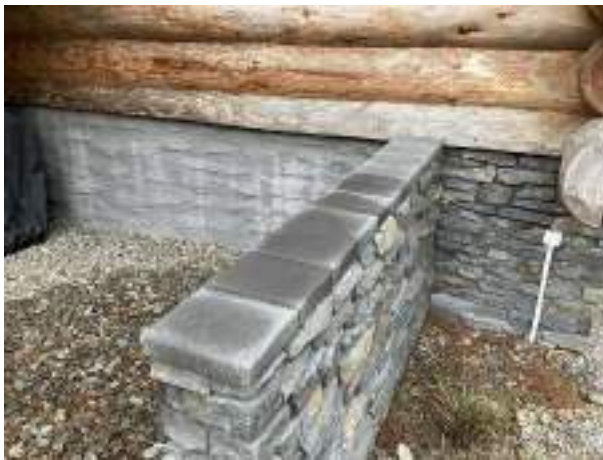
Photo 4

Garage schist veneered masonry foundation wall.

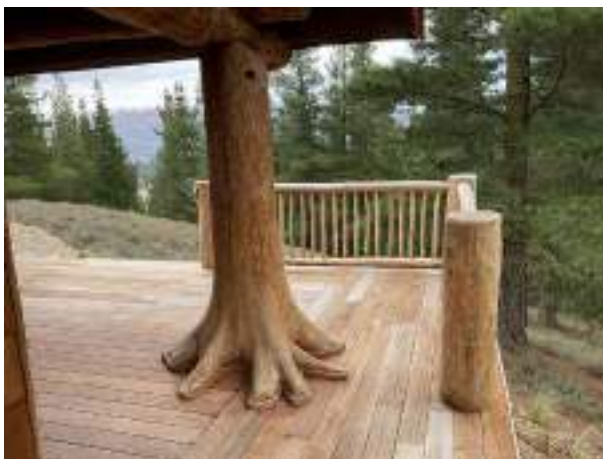
Photo 5

Structural pole foundation.

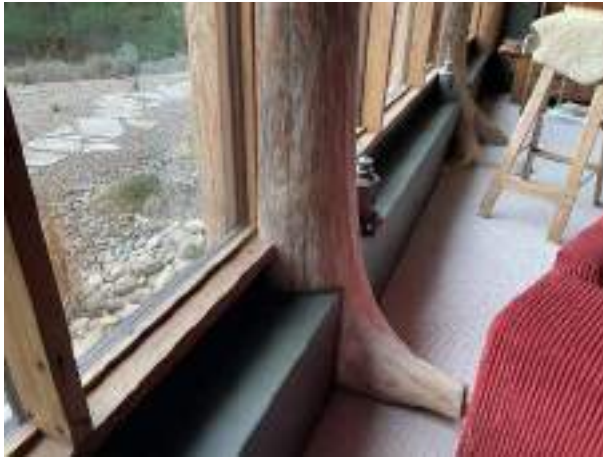
Photo 6

Foundation wall in the lounge.

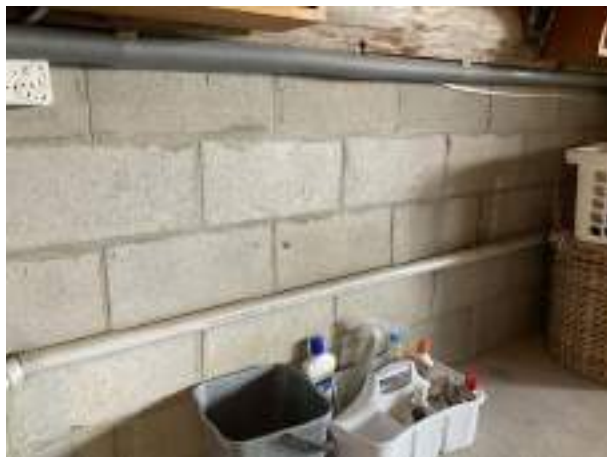
Photo 7

Structural masonry wall in garage supporting timber poles.

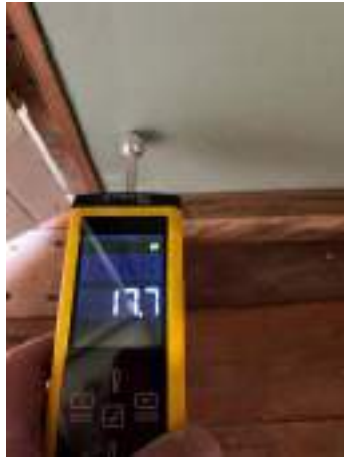
Photo 9

Example of moisture test done in cabin using a Trotec T660 moisture tester.

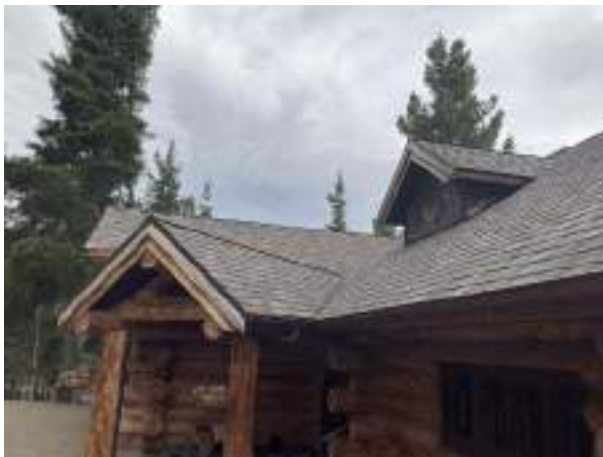
Photo 40

Asphaltic tiles to entrance of house.

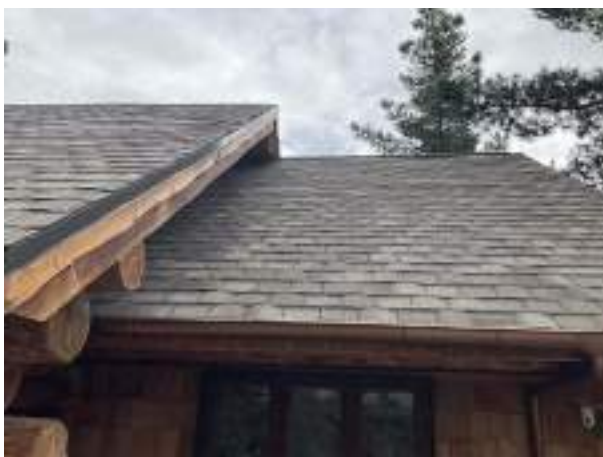
Photo 41

Roofing above kitchen.

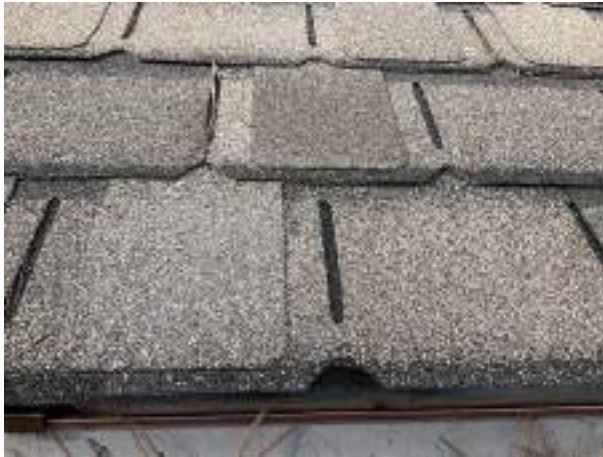
Photo 42

Asphaltic tile.

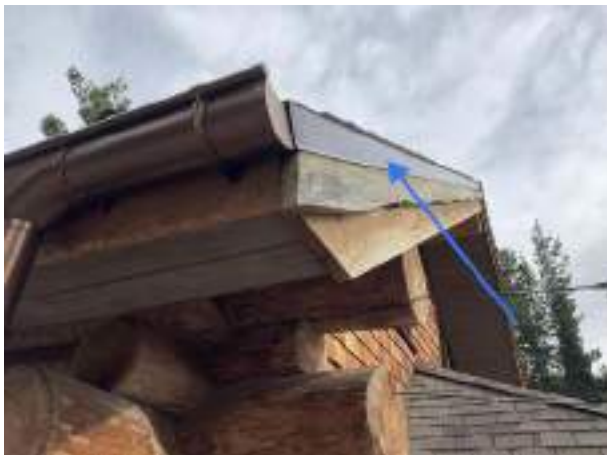
Photo 43

Barge flashing.

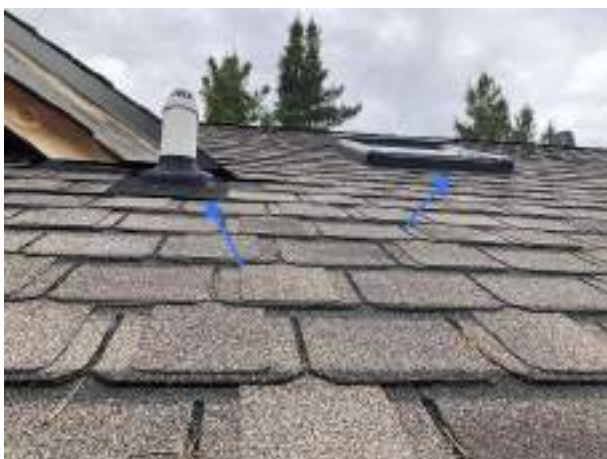
Photo 44

Roof penetrations above apartment.

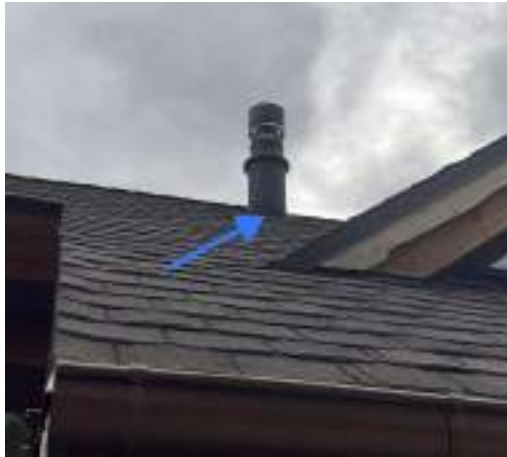
Photo 45

Gas fire flue penetration above apartment.

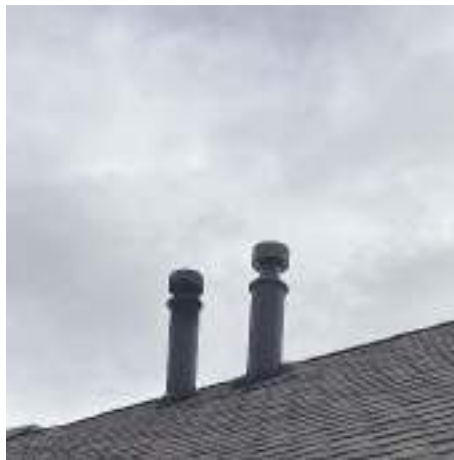
Photo 46

Roof penetrations on main house.

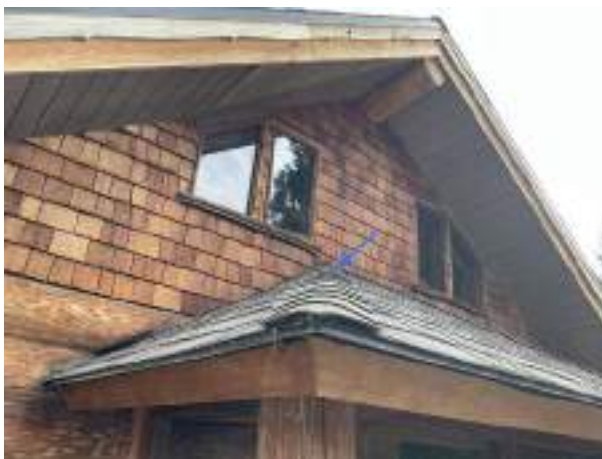
Photo 47

Example of the ridge flashings.

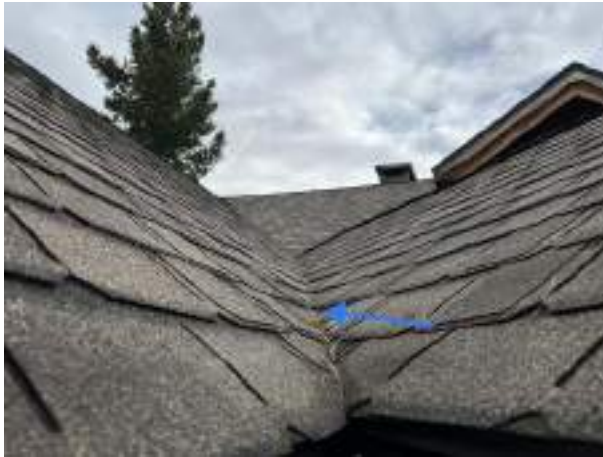
Photo 48

Asphaltic tiles forming the valley.

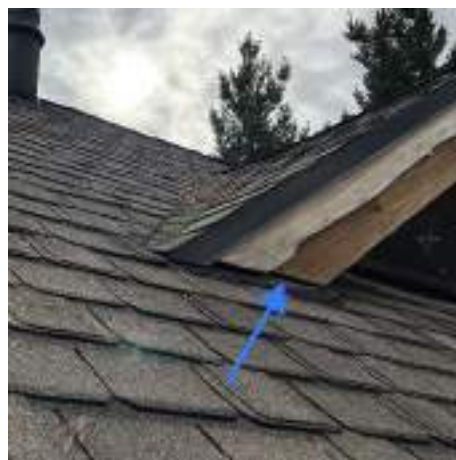
Photo 49

Example of apron flashing.

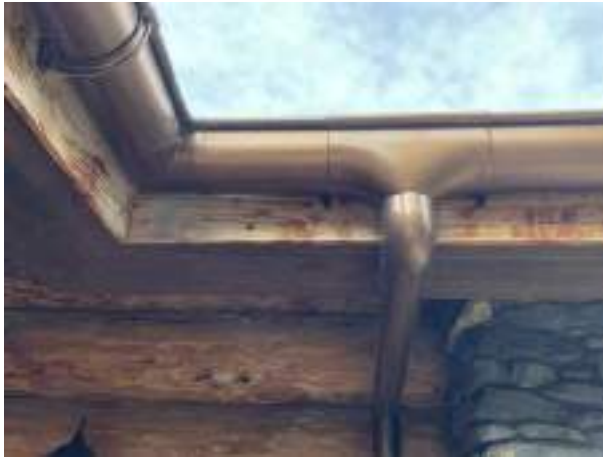
Photo 51

PVC guttering and downpipe system.

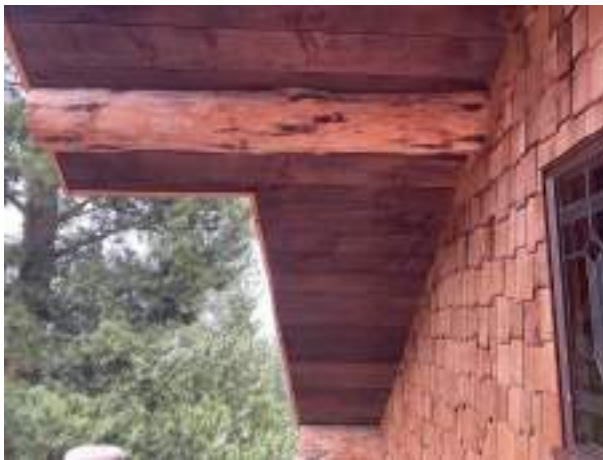
Photo 52

Timber soffits.

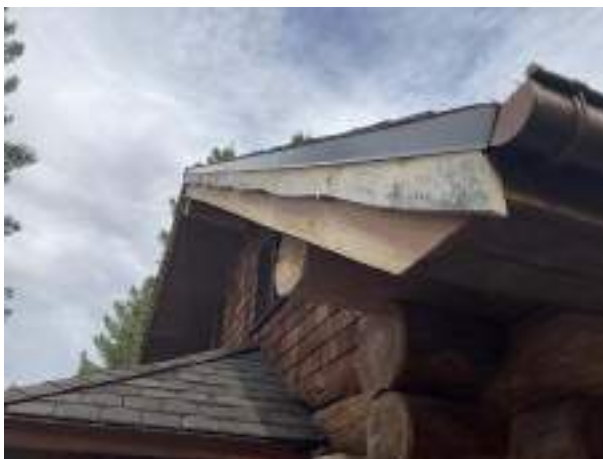
Photo 53

Timber fascia on apartment.

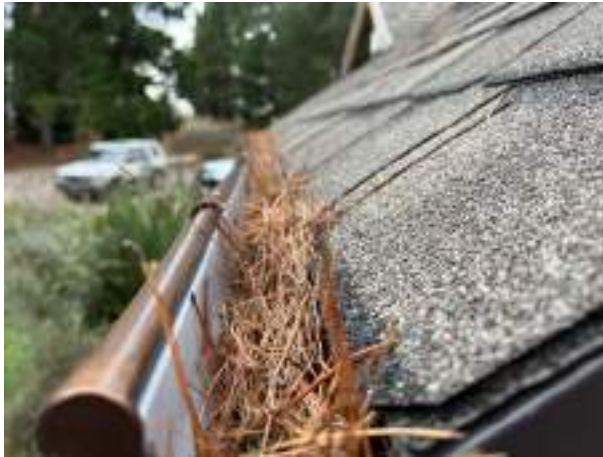
Photo 54

Example of debris in guttering that requires removal.

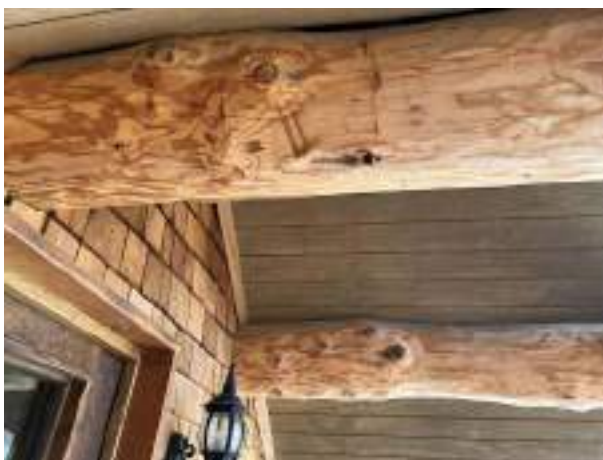
Photo 55

Plywood soffits on apartment above garage.

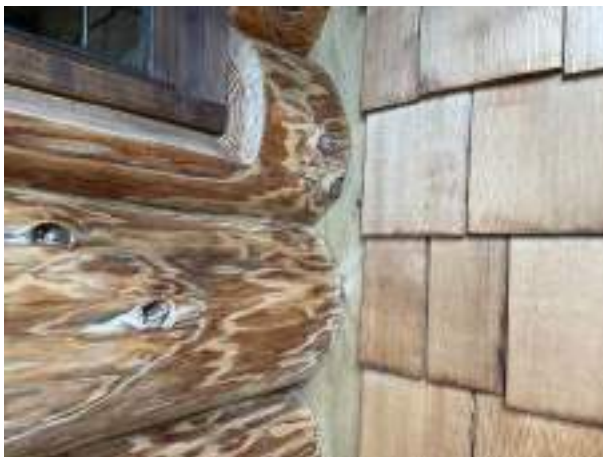
Photo 56

Shingle and pole junction detail.

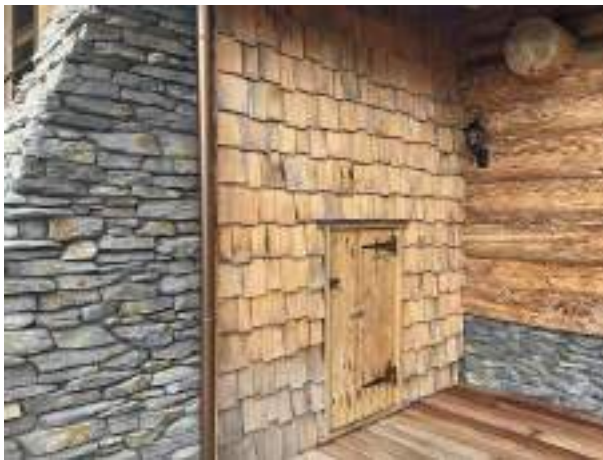
Photo 58

Mixed use of cladding materials outside lounge.

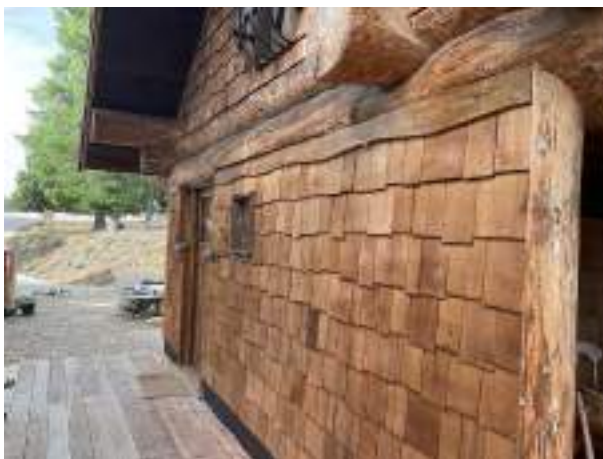
Photo 59

Shingle cladding outside laundry.

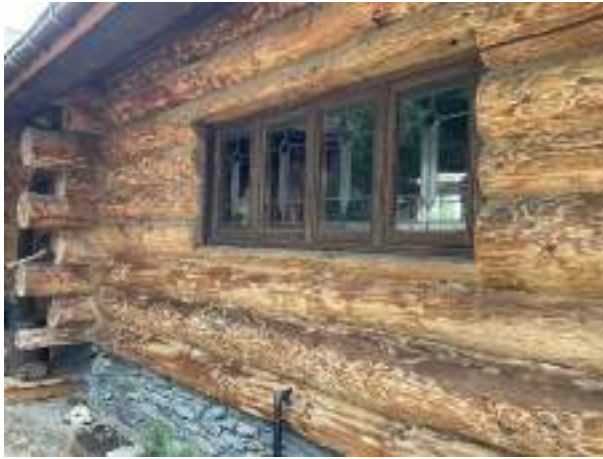
Photo 60

Douglas Fir timber pole cladding and timber exterior cladding.

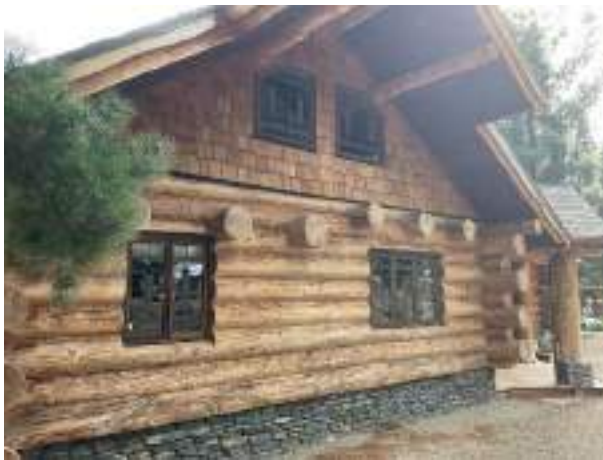
Photo 61

Shingle gable end cladding outside downstairs bedrooms.

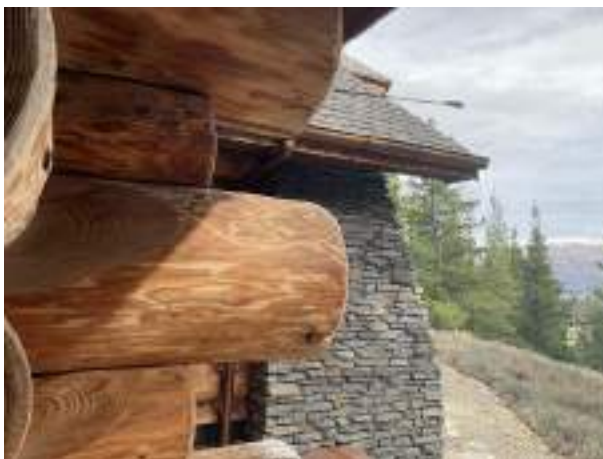
Photo 62

Schist cladding outside lounge.

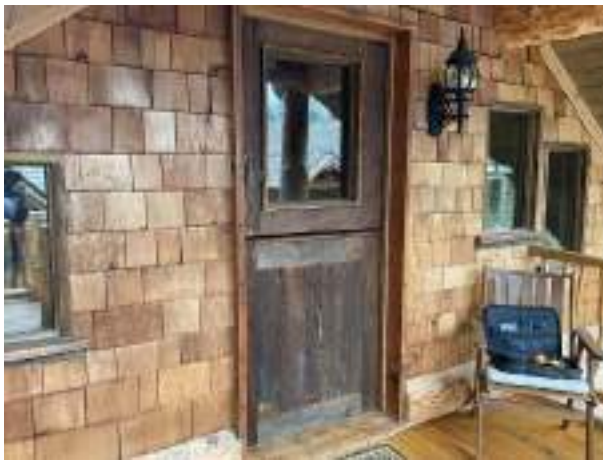
Photo 65

Apartment entry door.

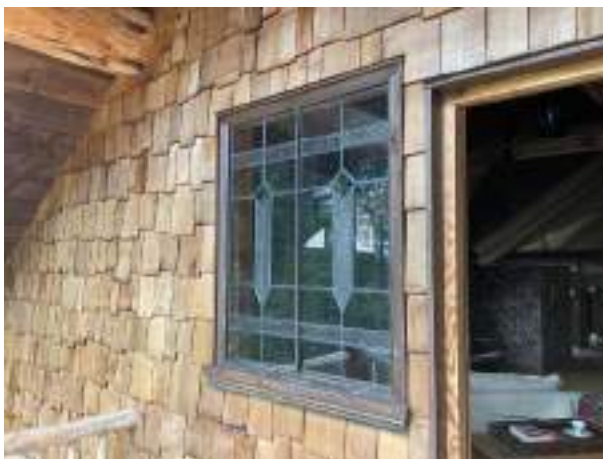
Photo 66

Single glazed lead light lounge window.

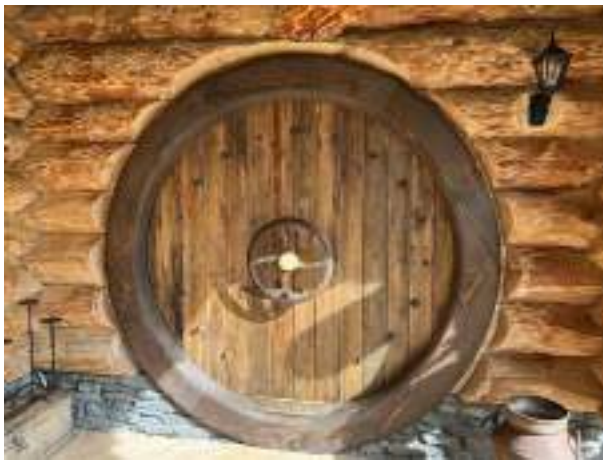
Photo 68

Bespoke timber and steel front entry door.

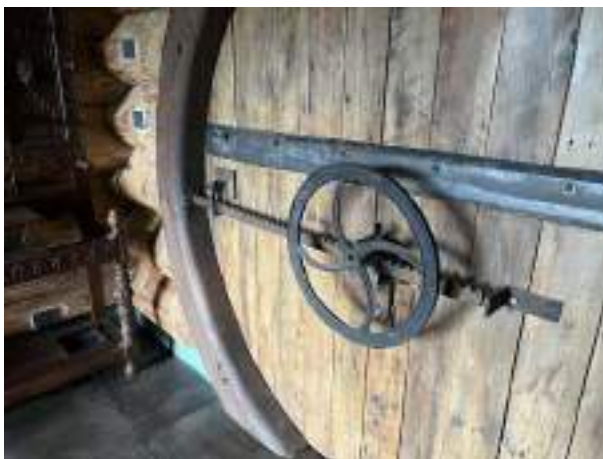
Photo 69

Unique steel door hardware.

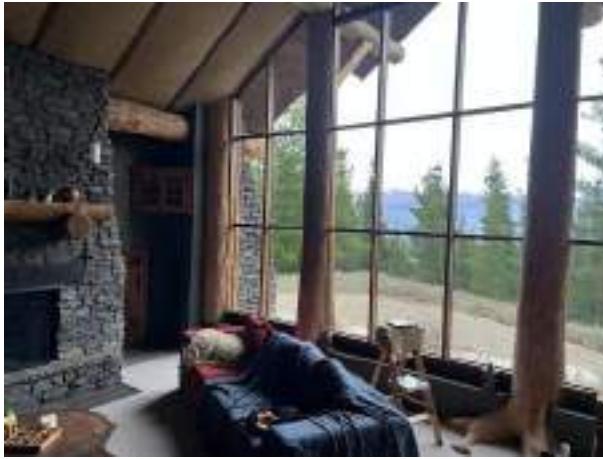
Photo 70

Large double glazed window in the lounge.

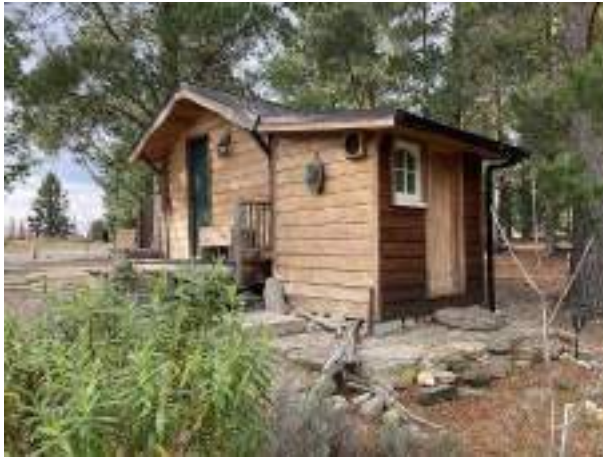
Photo 71

Cottage

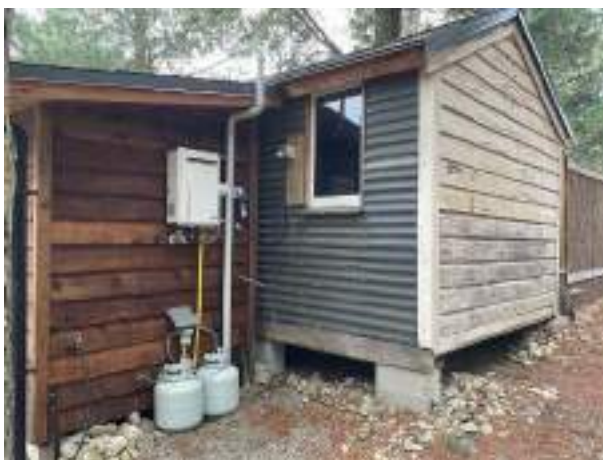
Photo 72

Cottage and detached bathroom with califont hot water.

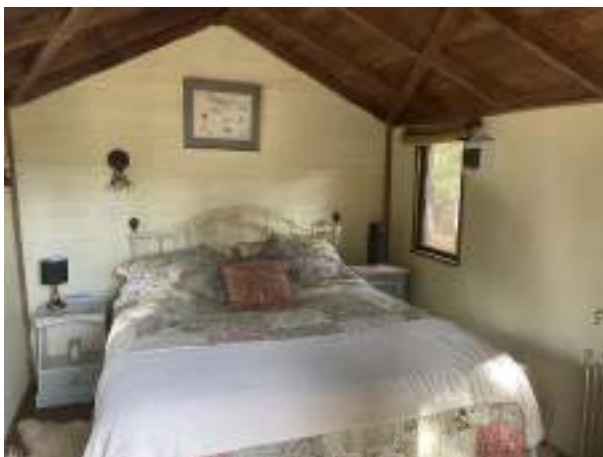
Photo 73

Cottage bedroom.

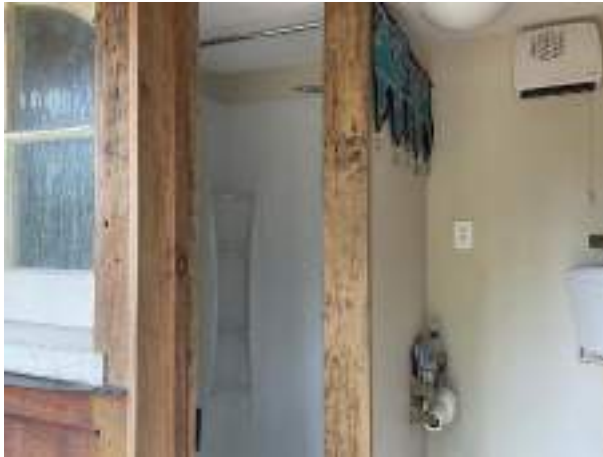
Photo 74

Cottage bathroom.

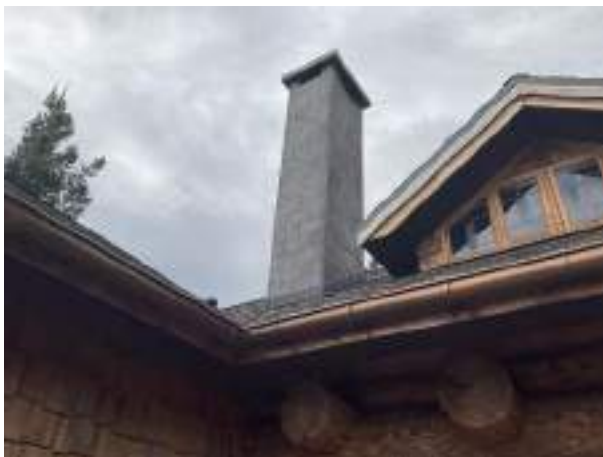
Photo 75

Structural masonry plastered internally flued chimney.

It is recommended to have the flue cleaned and checked annually.

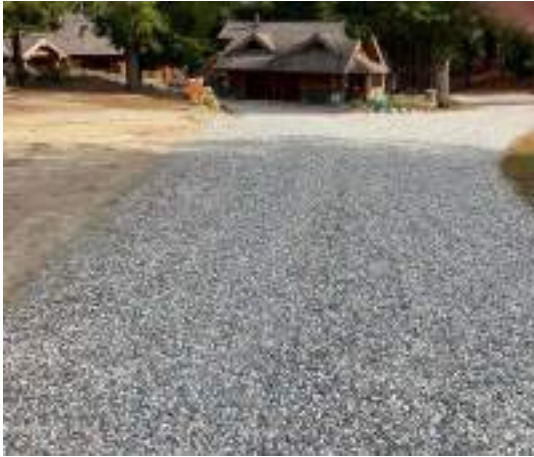
Photo 76

Shingle driveway.

Add more shingle as required.

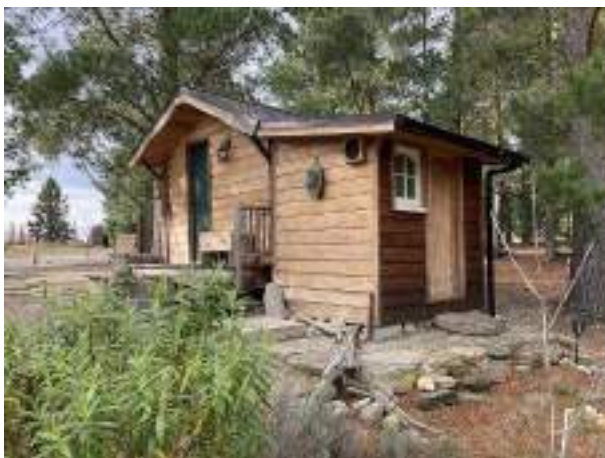
Photo 77

Example of stone path outside cabin.

General upkeep and maintenance.

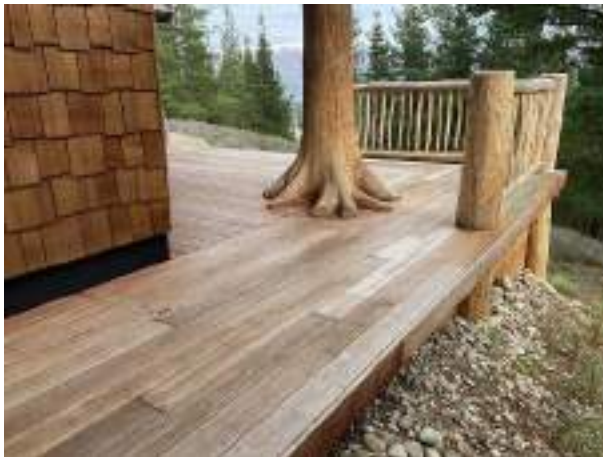
Photo 79

North facing hardwood deck
and balustrade.

General upkeep and maintenance.

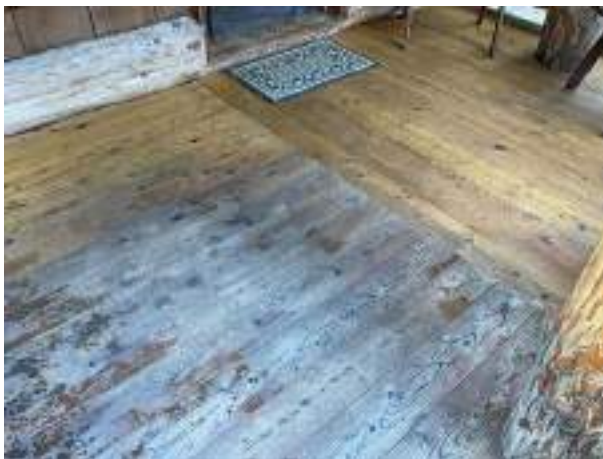
Photo 80

Screw fixed decking at entrance
to apartment.

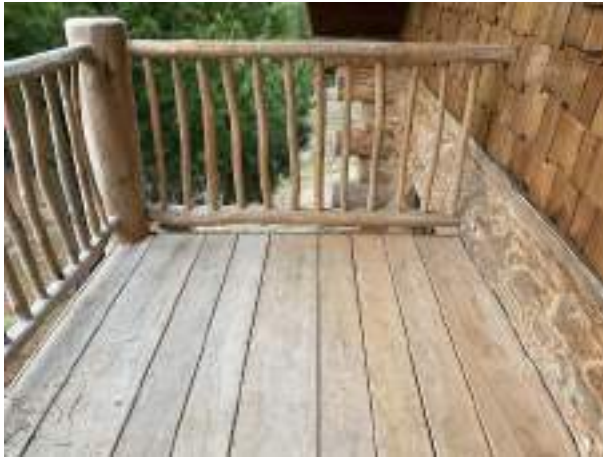
Photo 81

Mezzanine lounge balcony deck.

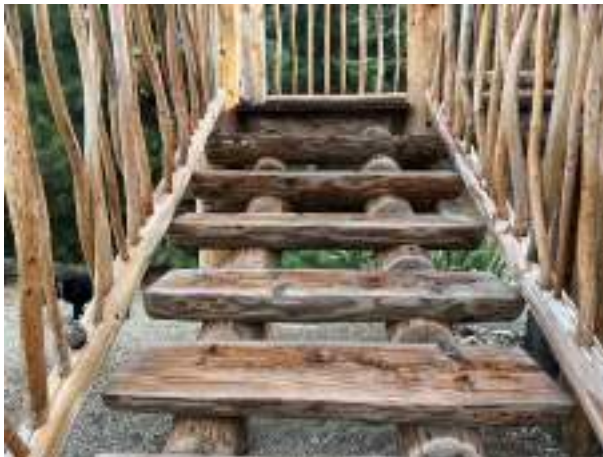
Photo 82

Timber framed apartment stairs handrail secure.

General upkeep and maintenance of external stairs by cleaning and keeping free of debris.

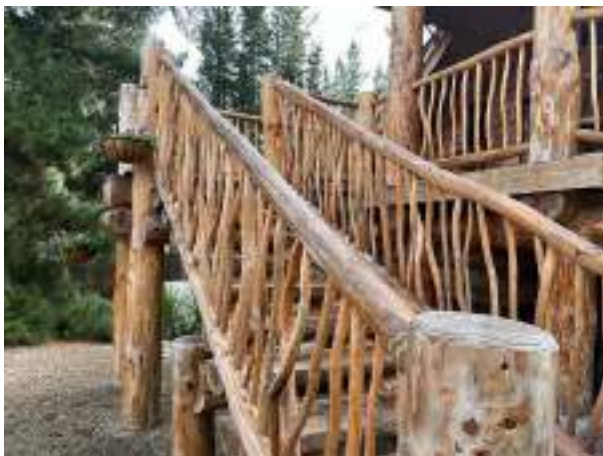
Photo 83

External timber stairs to apartment.

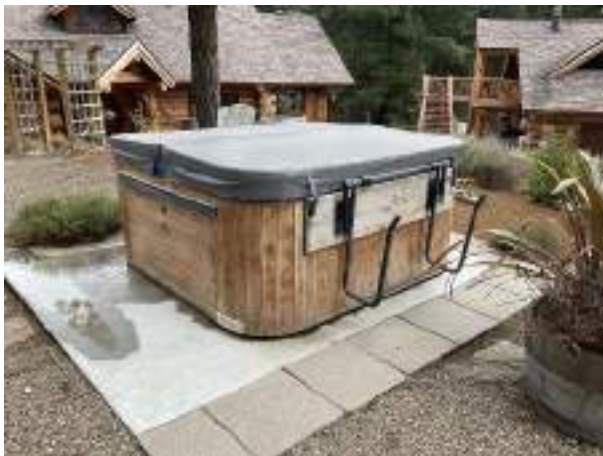
Photo 84

Spa pool.

A safety cover must have signage indicating its child safety features, and must be able to:

- restrict entry of children under five years of age when closed
- withstand a foreseeable load
- be readily returned to the closed position.

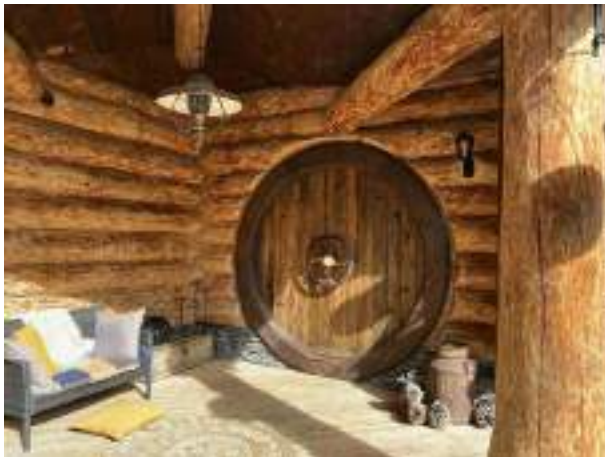
Photo 85

Entry front porch.

General upkeep and maintenance.

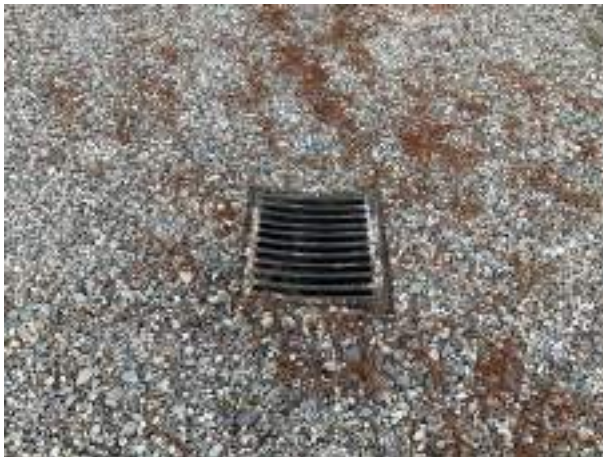
Photo 86

Driveway grated drain.

Keep vegetation and soils clear of drainage.

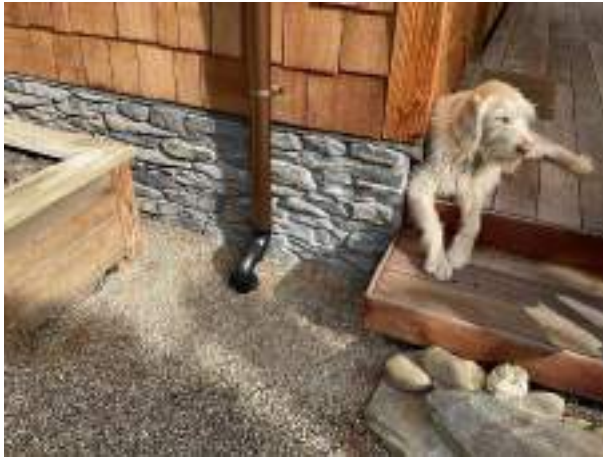
Photo 88

Stormwater riser outside laundry.

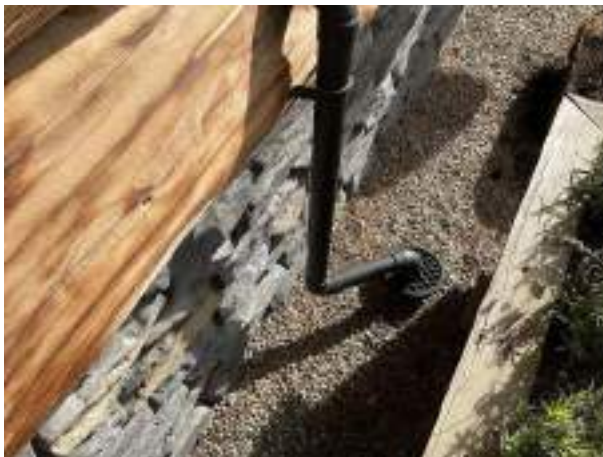
Photo 89

Kitchen gully trap.

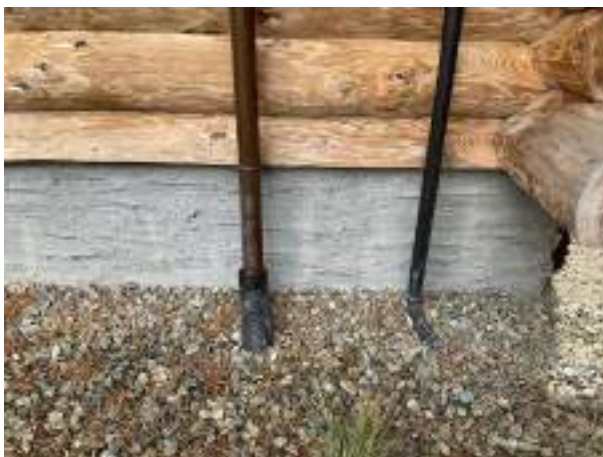
Photo 90

Stormwater riser western side of main building.

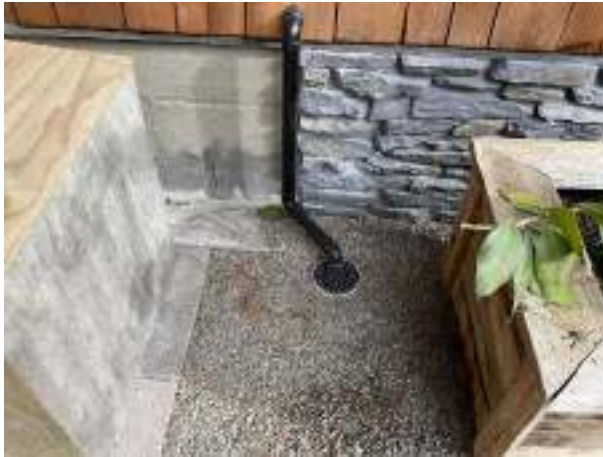
Photo 91

Laundry gully trap

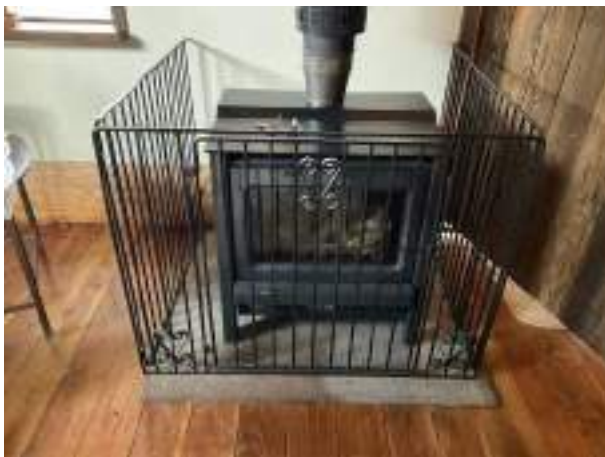
Photo 92

Gas fire in apartment living room.

Service as per manufacturer's recommendations.

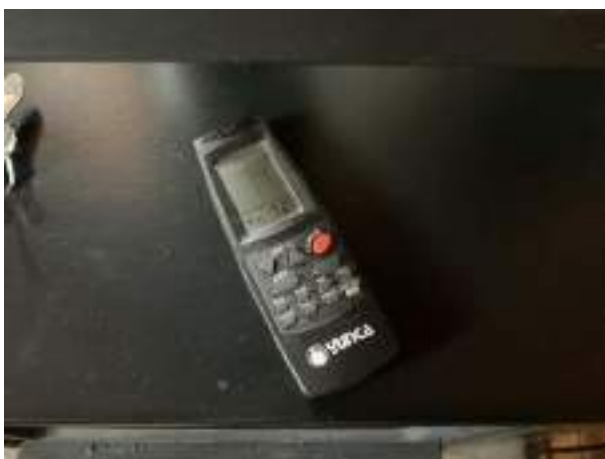
Photo 93

Gas fire control.

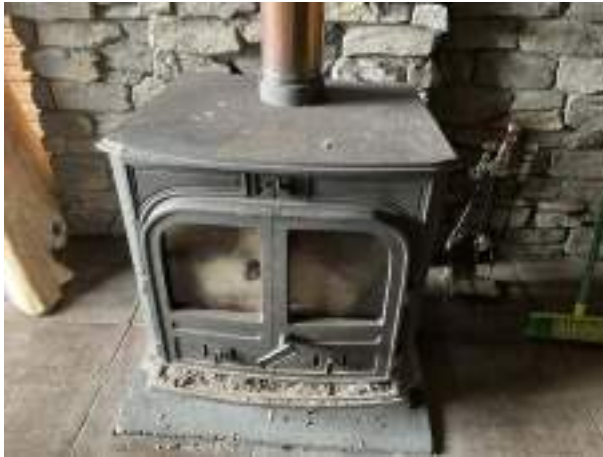
Photo 94

Wood fire with water jacket in entrance - heating for radiators in bedrooms and under floor heating under steel tiles seen in this photo.

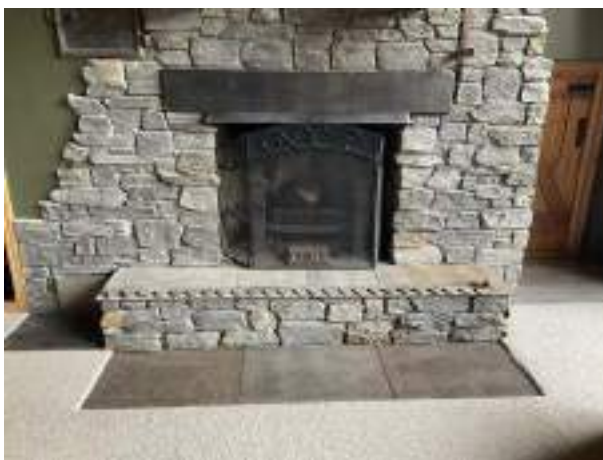
Photo 95

Open fire in the lounge

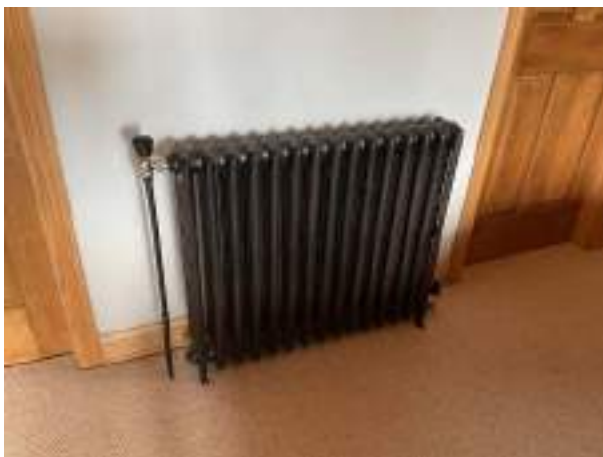
Photo 96

Radiator in bedroom 1

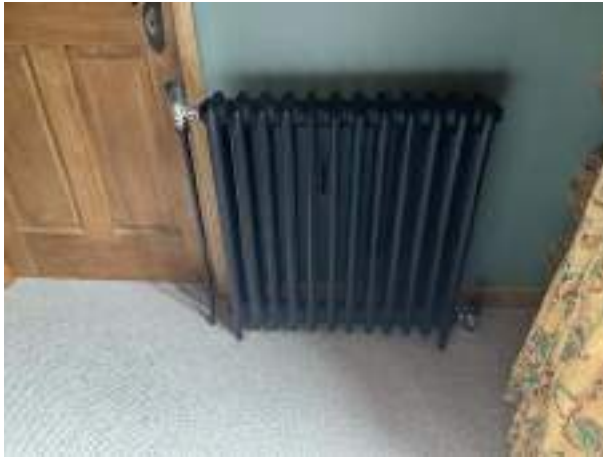
Photo 97

Radiator in bedroom 2

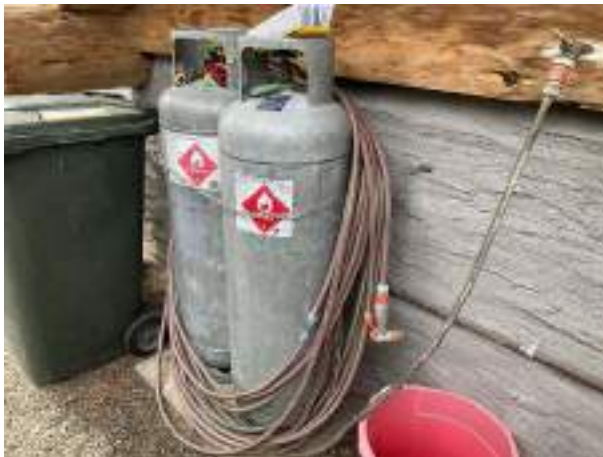
Photo 99

Gas storage at the rear of garage.

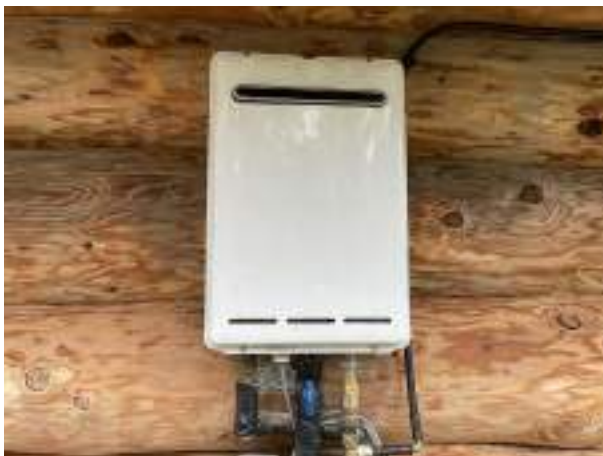
Photo 100

Gas califont water heating for apartment.

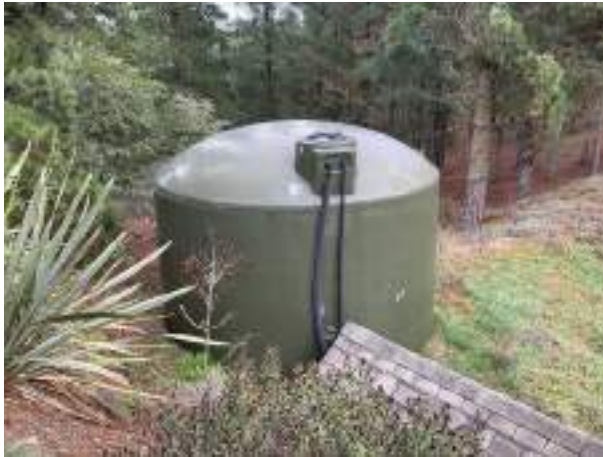
Photo 101

Water storage.

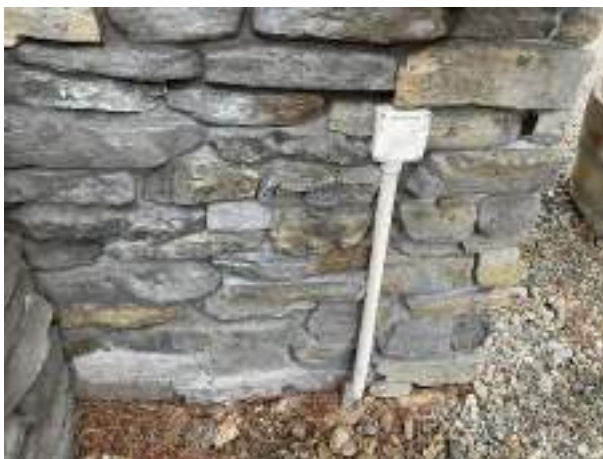
Photo 103

Telecommunications outside front of garage.

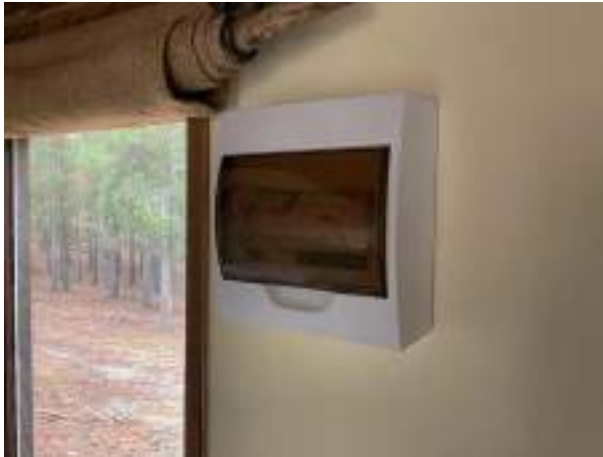
Photo 104

Cottage sub-main.

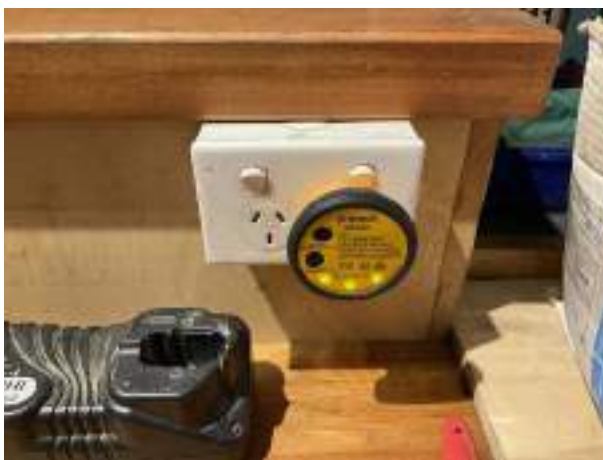
Photo 105

Example of Powerpoint testing in garage.

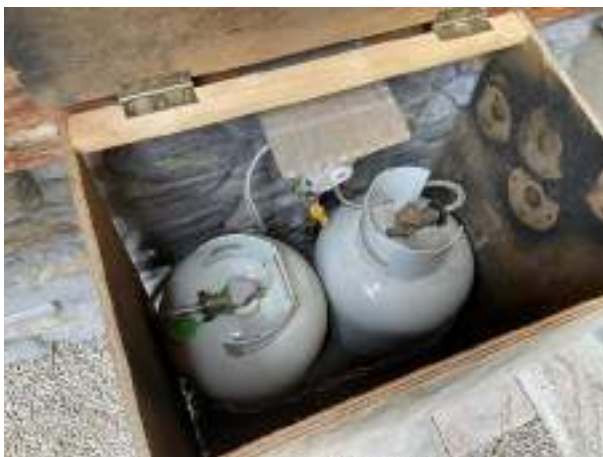
Photo 106

Gas bottle storage main dwelling.

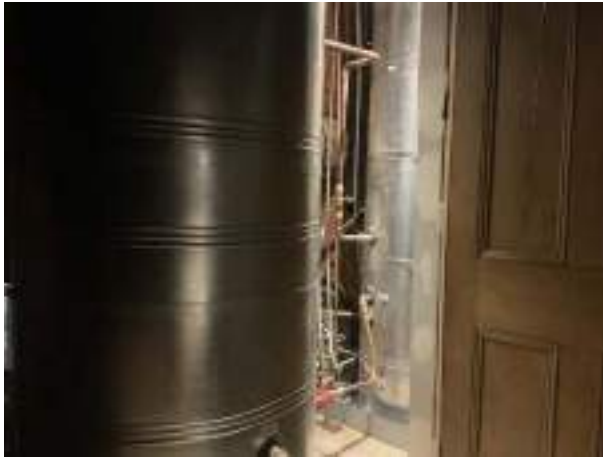
Photo 107

Hot 300L and 625L water cylinders on mezzanine floor.

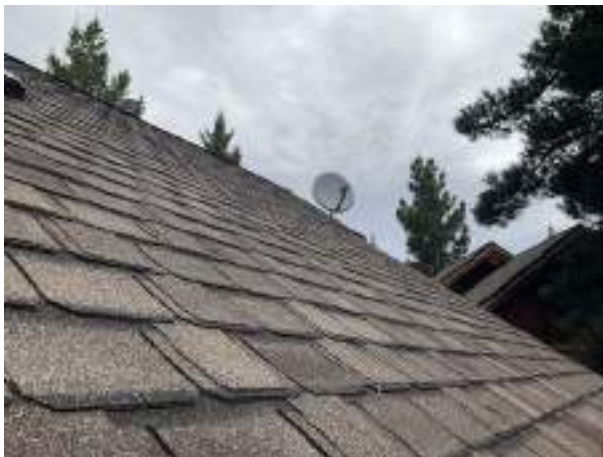
Photo 108

Satellite dish above apartment.

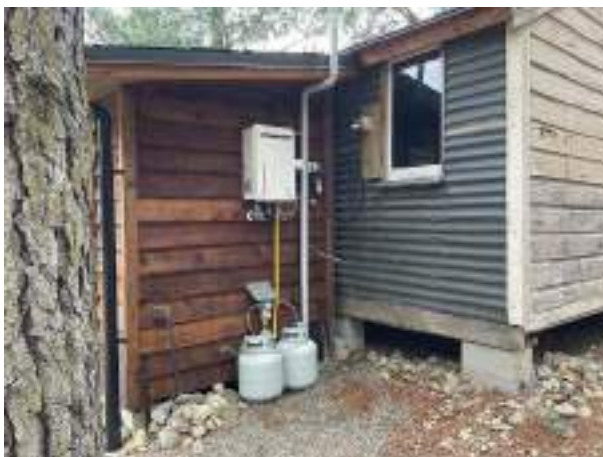
Photo 109

Gas califont outside cottage.

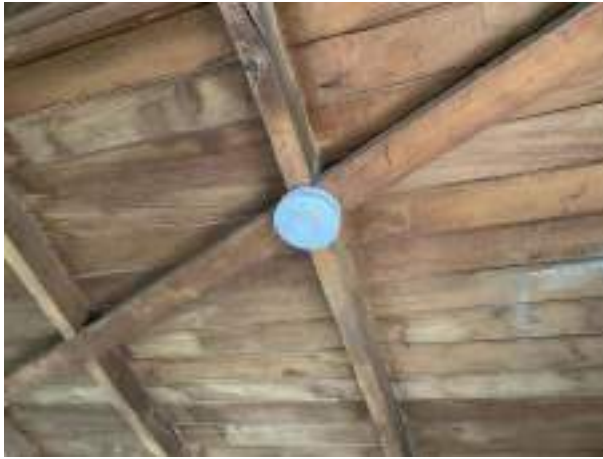
Photo 110

Smoke alarm in cottage.

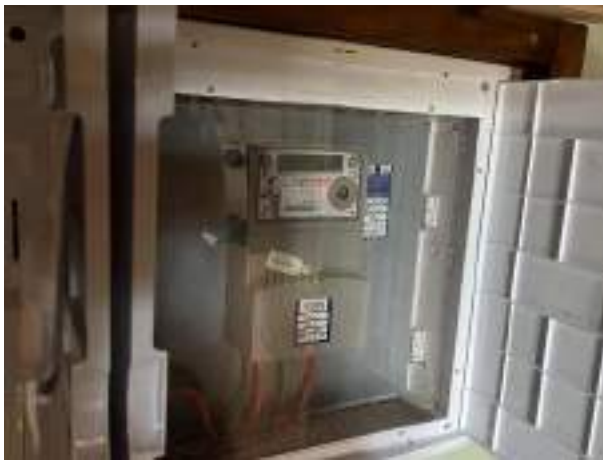
Photo 111

Meter board inside entrance.

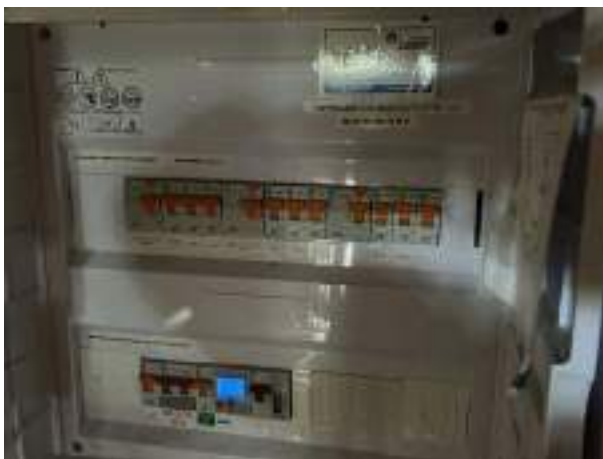
Photo 112

Distribution board inside entrance.
