PRE-PURCHASE BUILDING REPORT

Property Address	65 The Masthead Whitby Porirua 5024		
Client	The Law Family Trust		
Date of Inspection	24th August 2022	Time	12:00 pm
Inspector	Trevor Garrett MSc, Licensed Building Practitioner, Advanced Trade Certificate Carpentry, National Diploma Construction Management. Member of NZIOB.		
LBP Number	131790		
Inspection Type	Pre-Purchase Report		
People Present	Owner		
House Occupied	Yes

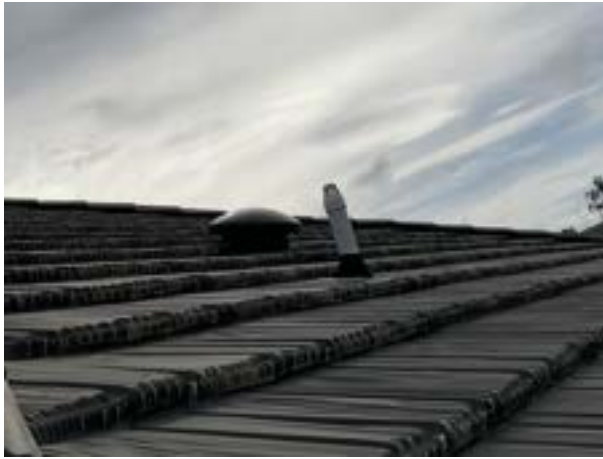
Photo 7

East side roof penetrations, no visible issues.

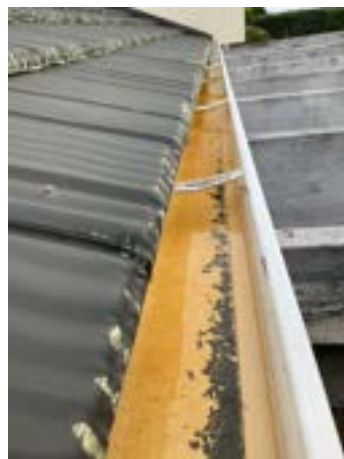
Photo 9

Northeast gutter is holding water.

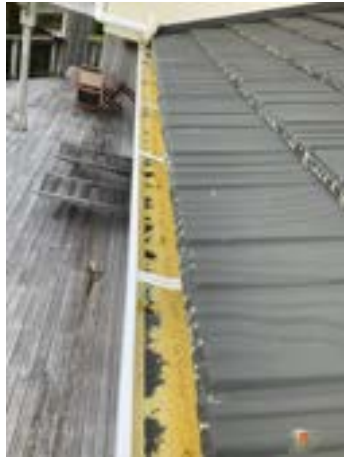
Photo 10

Northwest gutter is holding water.

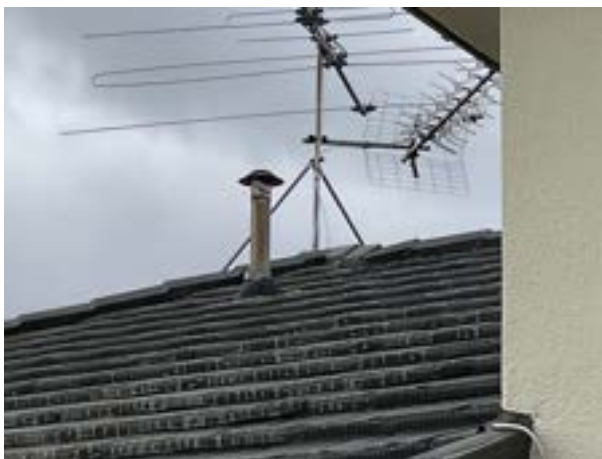
Photo 12

West side roof penetration, no visible issues.

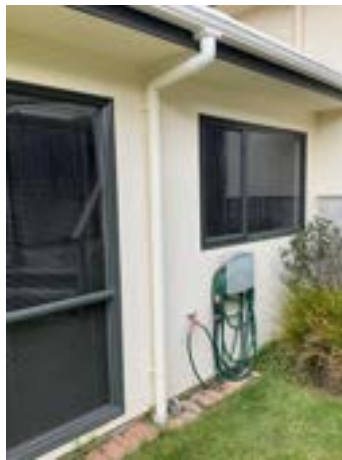
Photo 14

West downpipe, no visible issues.

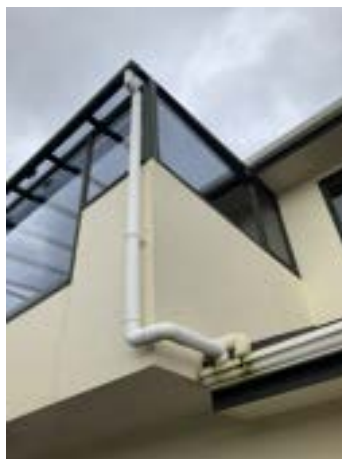
Photo 15

North side conservatory downpipe discharges into lower roof gutter.

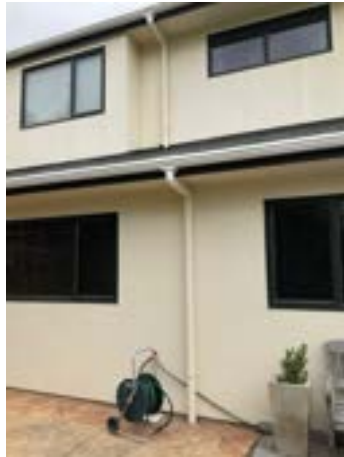
Photo 16

East side upper downpipe discharges onto lower roof.

We recommend the installation of a spreader to the downpipes discharging onto the lower roof.

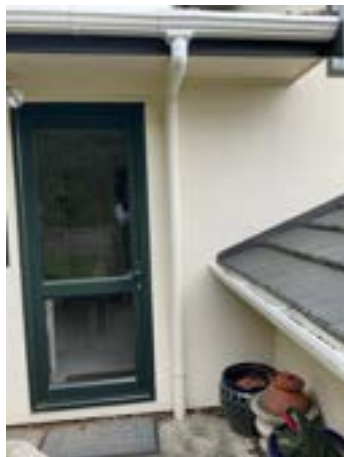
Photo 17

East downpipe, no visible issues.

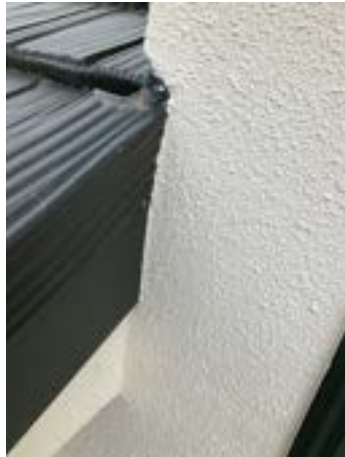
Photo 18

East side roof wall connection.

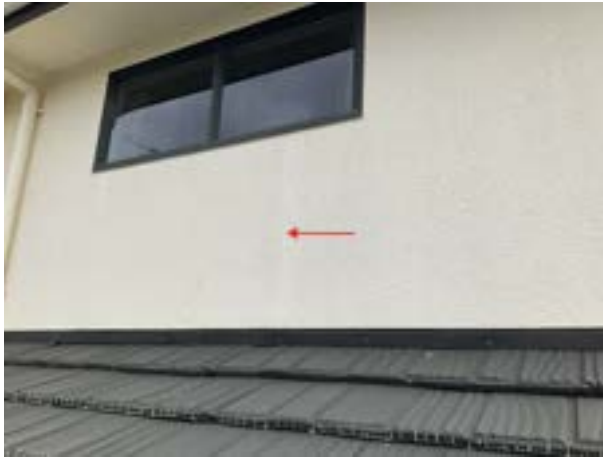
Photo 21

East side vertical joint.

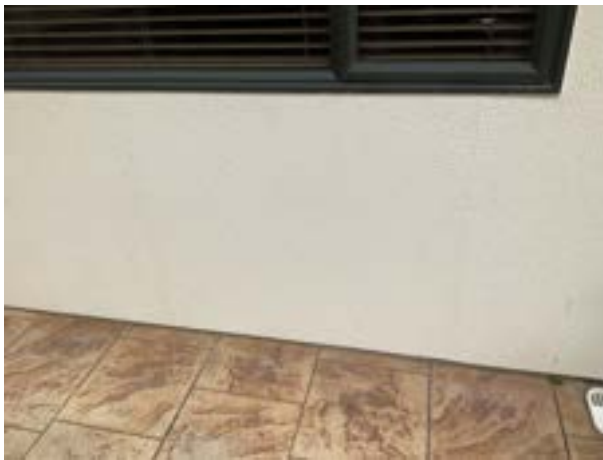
Photo 22

East side visible vertical joints.

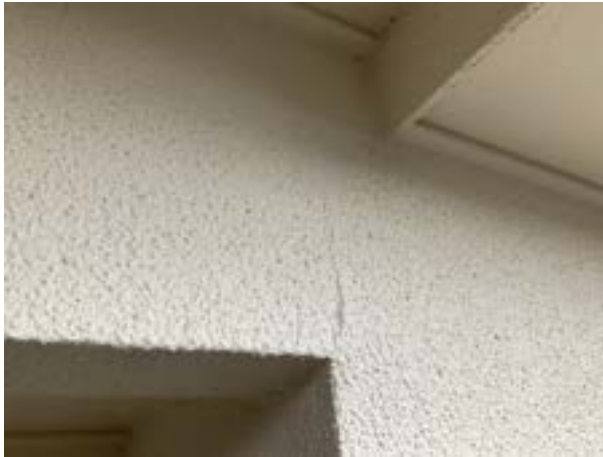
Photo 24

North side visible sheet joint.

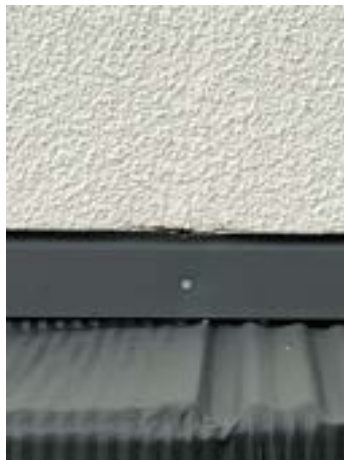
Photo 34

Close up of west side sheet delamination.

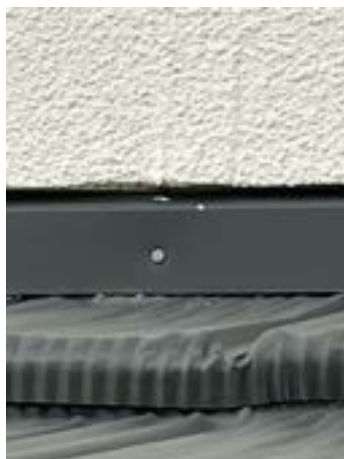
Photo 35

Close up of sheet joint delamination.

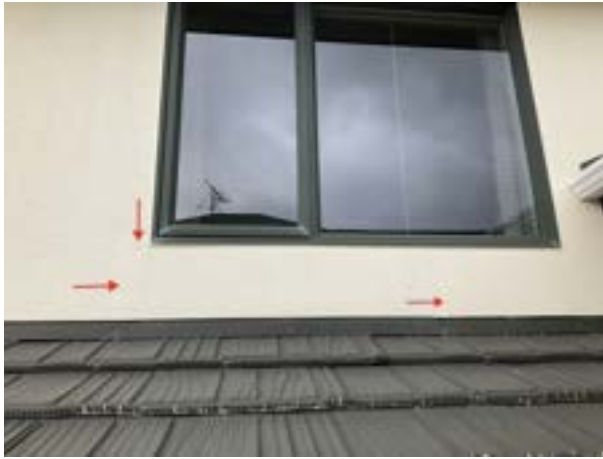
Photo 36

West side visible sheet joints.

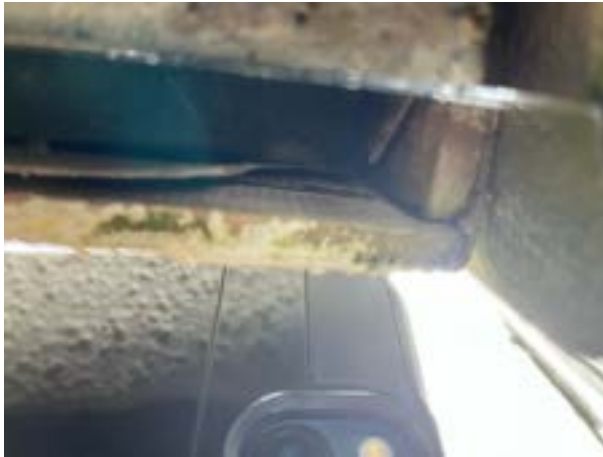
Photo 39

West side external corner, looking up from the bottom of the sheet. No visible corner flashing.

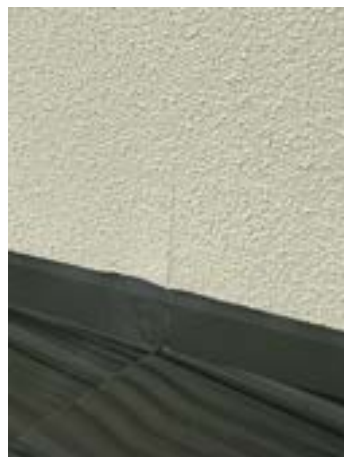
Photo 41

West face of conservatory has a visible sheet joint.

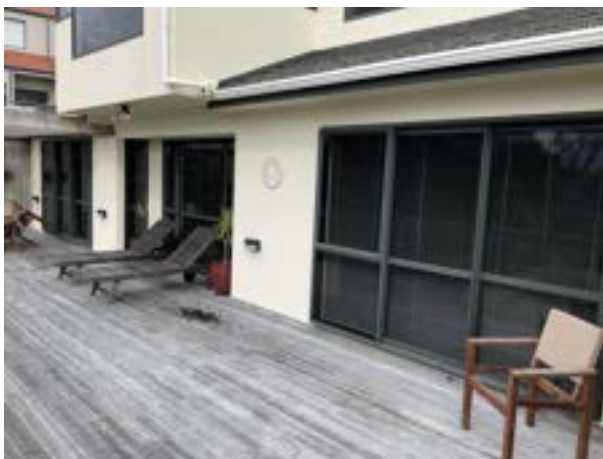
Photo 42

North side, all windows are single glazed.

Single glazed joinery needs to have any condensation/moisture addressed daily. To prevent the condensation from forming, the installation of a positive airflow ventilation system such as an HRV, DVS, I-Vent or similar should be considered. These greatly reduce any moisture in the home.

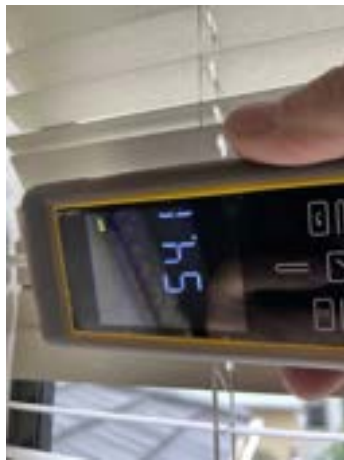
Photo 46

Window reveals measurements have indications of normal moisture readings.

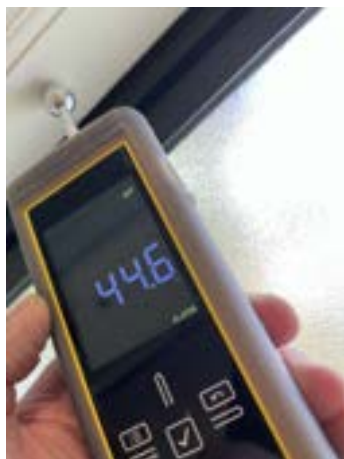
Photo 47

Window reveals measurements have indications of normal moisture readings.

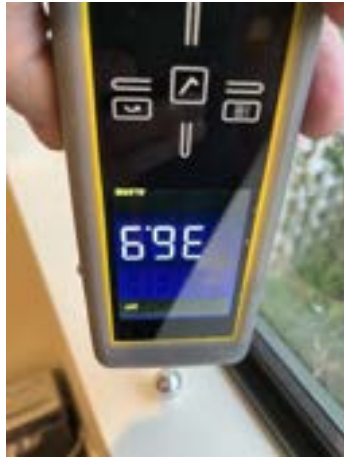
Photo 48

Window reveals measurements have indications of normal moisture readings.

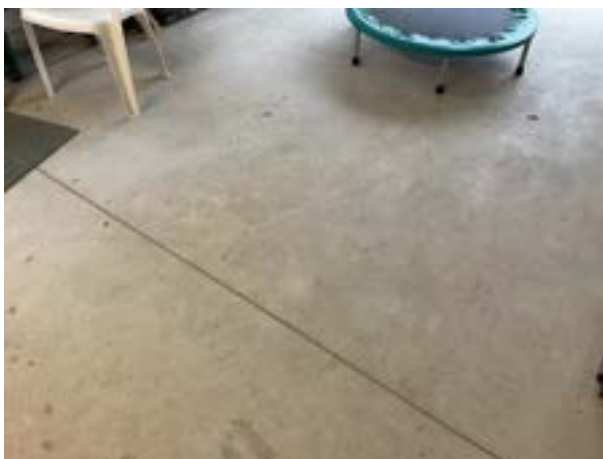
Photo 49

Garage slab, no visible issues.

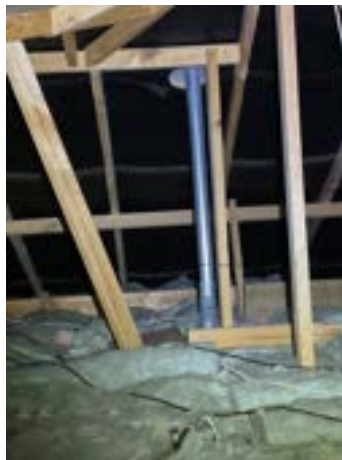
Photo 51

Hot water cylinder flue, no visible issues.

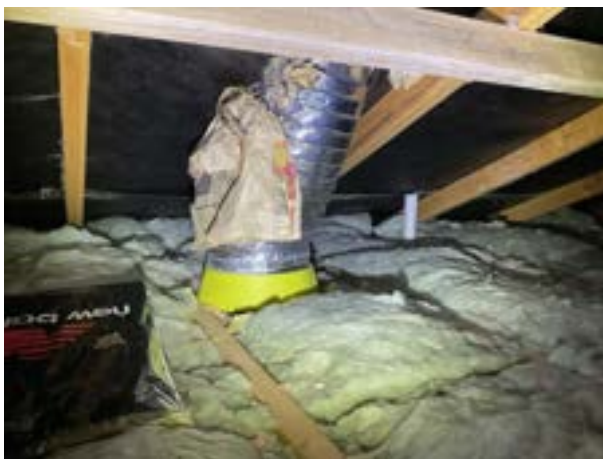
Photo 52

Ensuite extract ducting. Unclear the purpose of the newspaper.

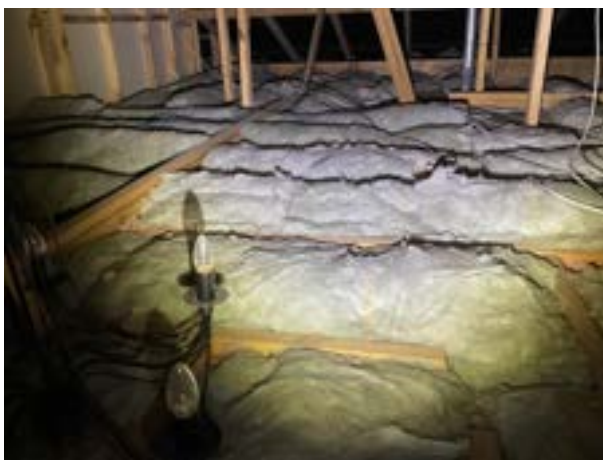
Photo 54

Insulation has good coverage.

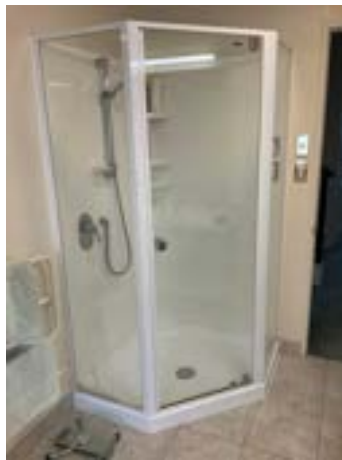
Photo 67

Shower.

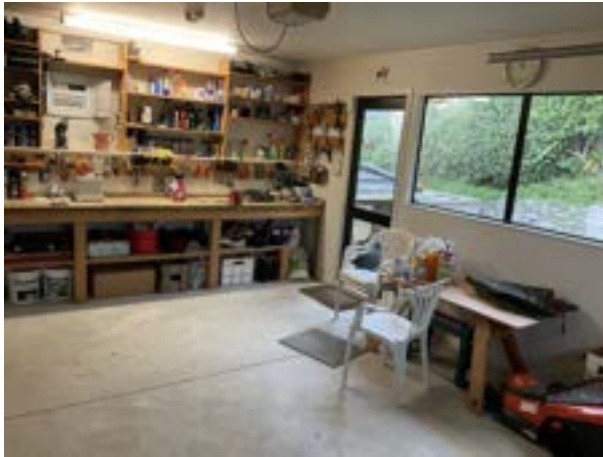
Photo 68

Garage 1.

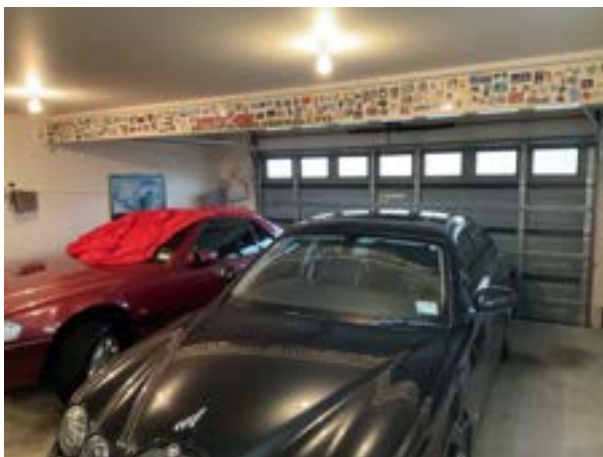
Photo 69

Garage 2.

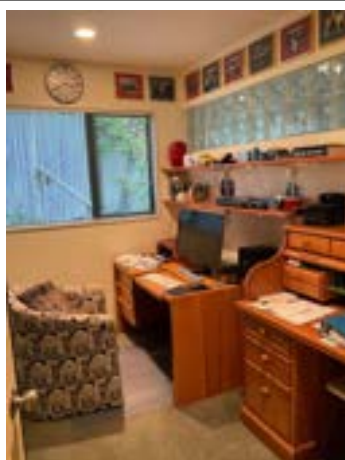
Photo 70

Study.

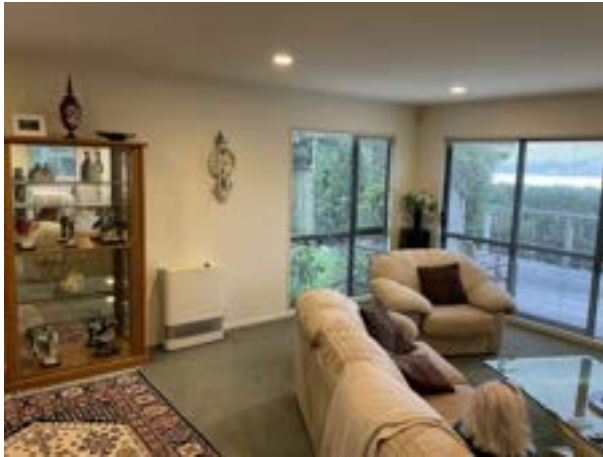
Photo 71

Living room.

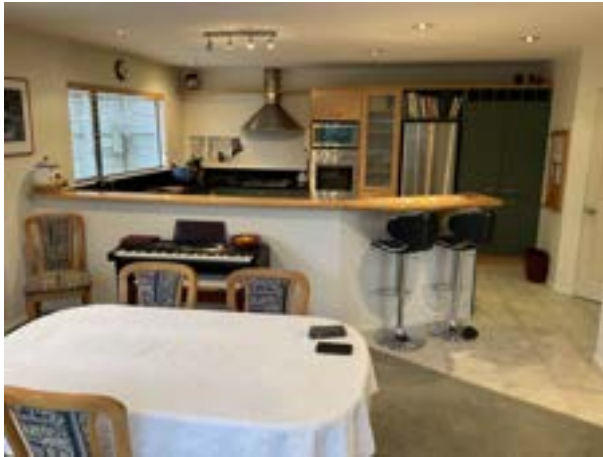
Photo 72

Kitchen.

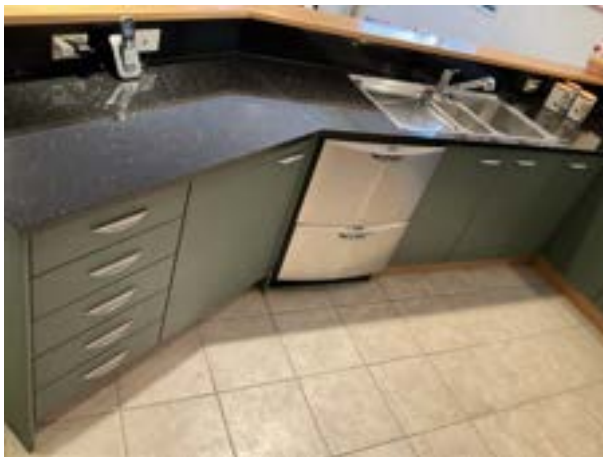
Photo 73

Kitchen.

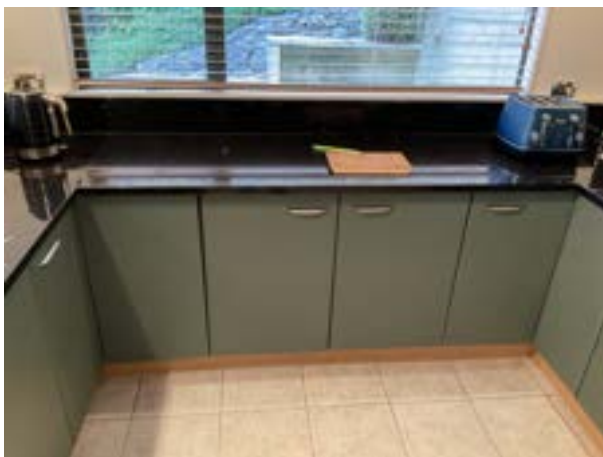
Photo 74

Kitchen.

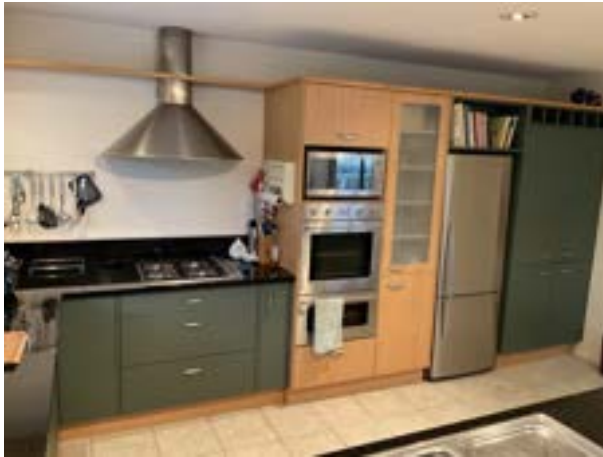
Photo 75

Kitchen.

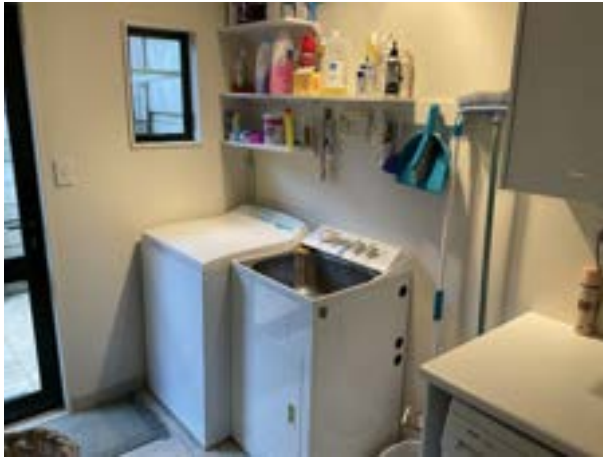
Photo 76

Laundry.

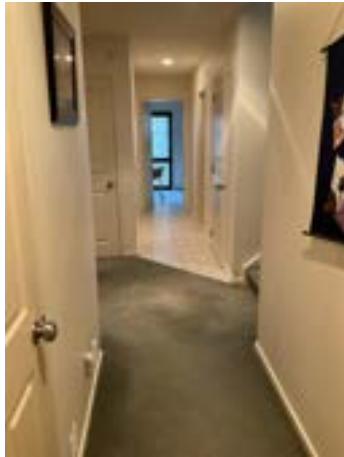
Photo 79

Hallway.

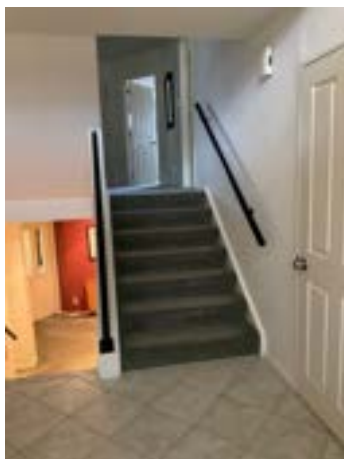
Photo 81

Stair handrail is secure.

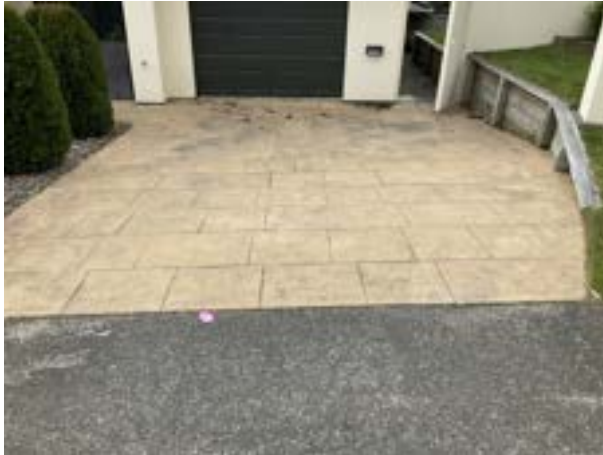
Photo 82

Driveway, functional.

General upkeep and maintenance of driveway by cleaning and keeping free of debris.

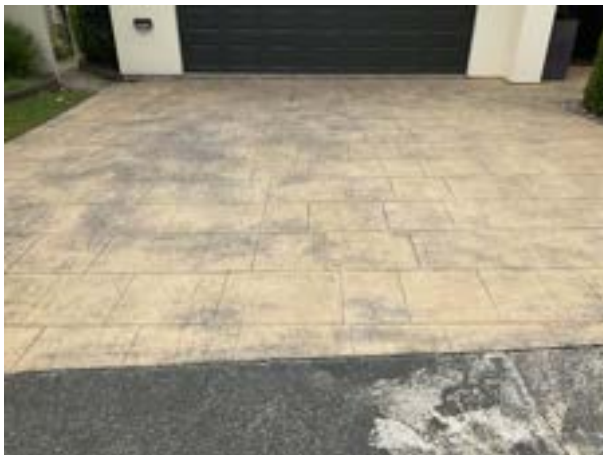
Photo 83

Driveway has some cracking no issue.

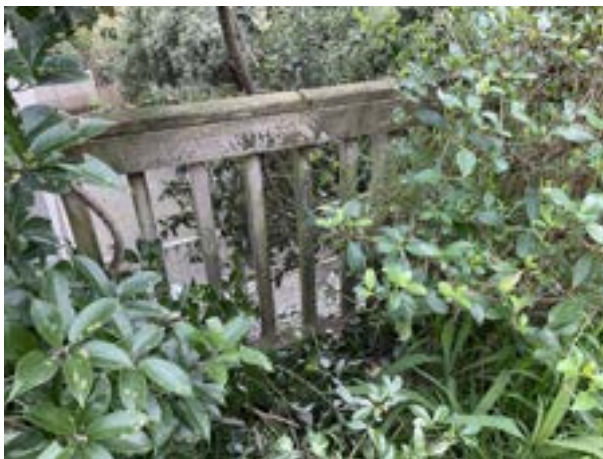
Photo 85

North side, functional.

General upkeep and maintenance, keep vegetation and soils clear of timbers as these timbers are only exterior treated and will rot if vegetation or soils are up against them.

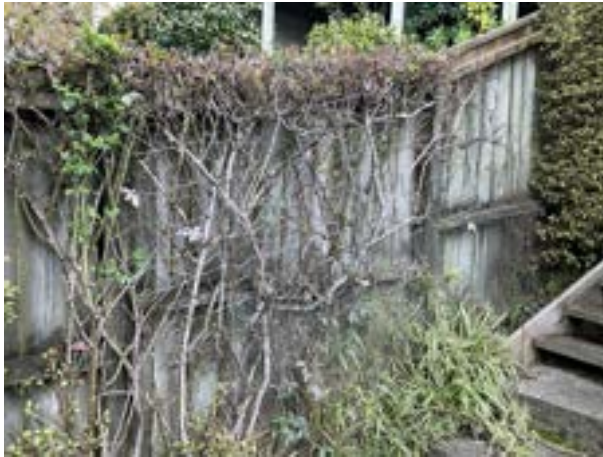
Photo 86

East side mostly covered in vegetation, functional.

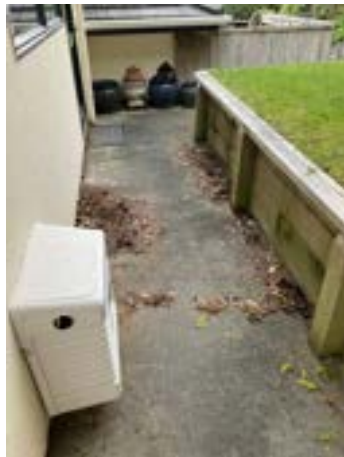
Photo 88

East side, functional.

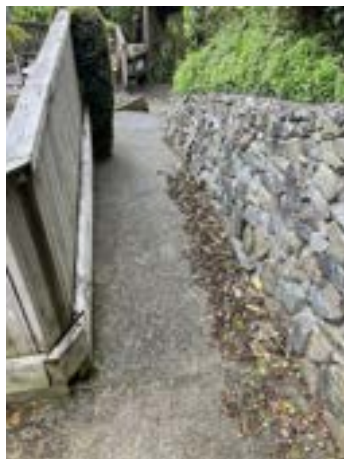
Photo 89

East side, functional.

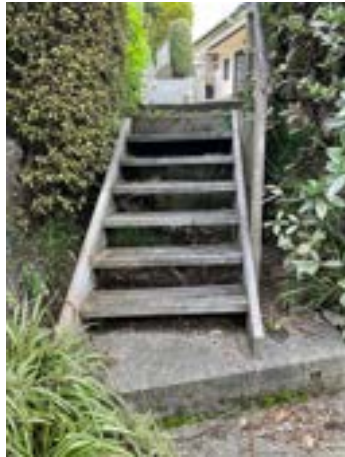
Photo 90

East side handrail is not secure.

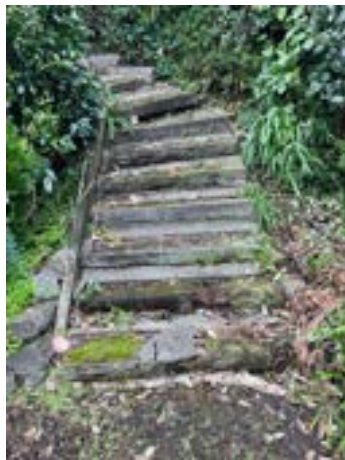
Photo 91

West side steps formed by sleepers. A number of the sleepers are rotten.

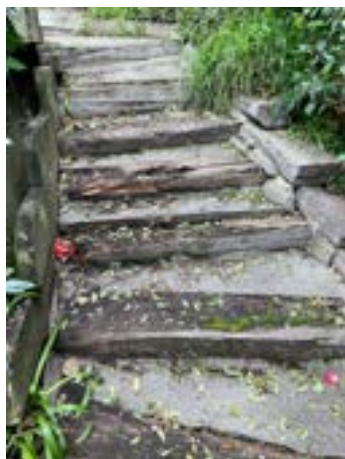
Photo 92

West side steps formed by sleepers. A number of the sleepers are rotten.

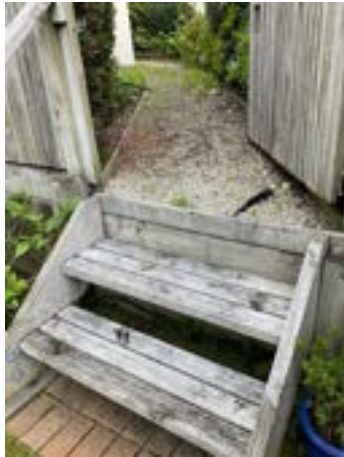
Photo 93

West side, wooden steps and shingle path, functional.

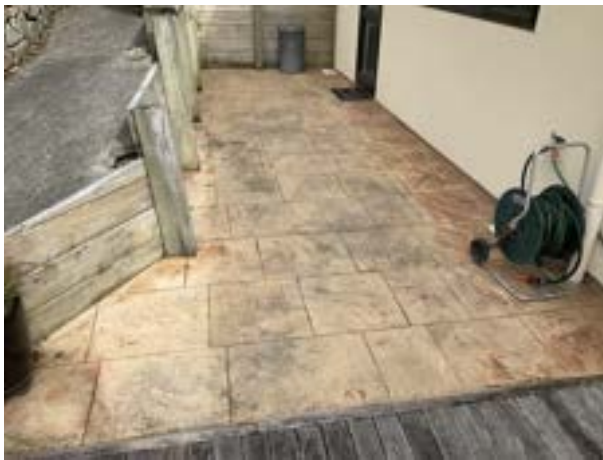
Photo 94

East side, functional.

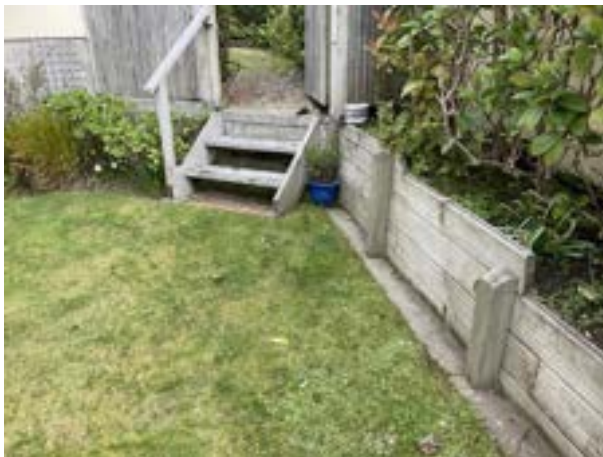
Photo 95

West side is 700mm high.

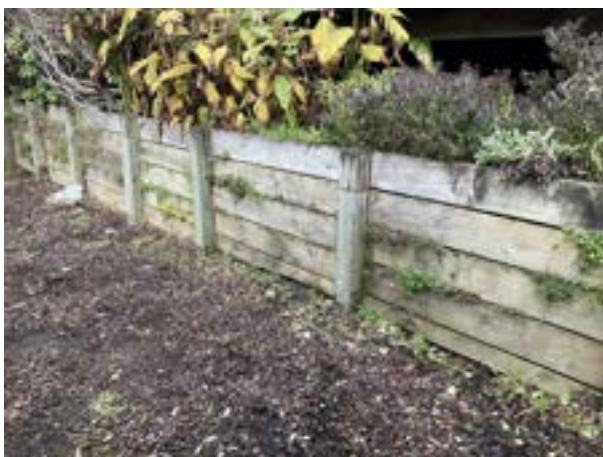
Photo 96

North side is 1m high.

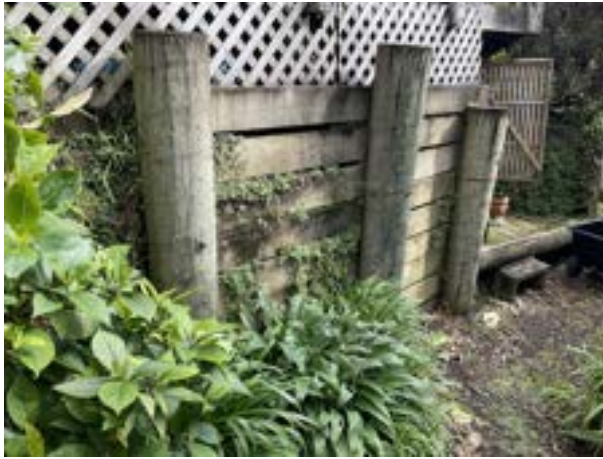
Photo 97

Northeast is slightly rotated and is 1.6m high.

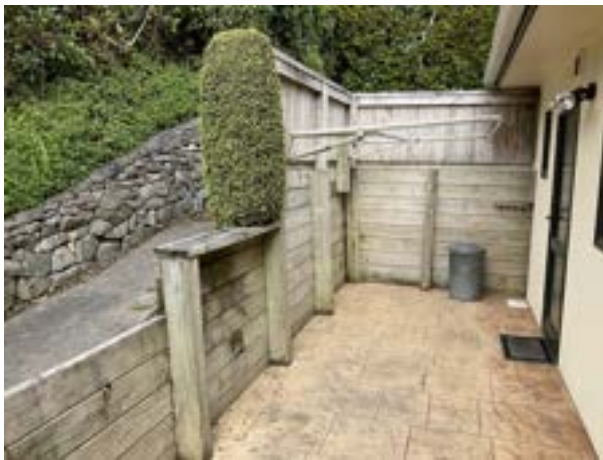
Photo 98

East side is 1.5m high.

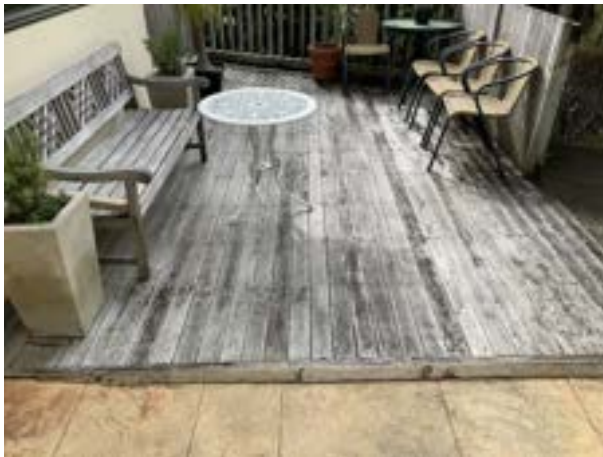
Photo 99

Northeast, functional.

General upkeep and maintenance. Punch nails that are protruding above the decking as required.

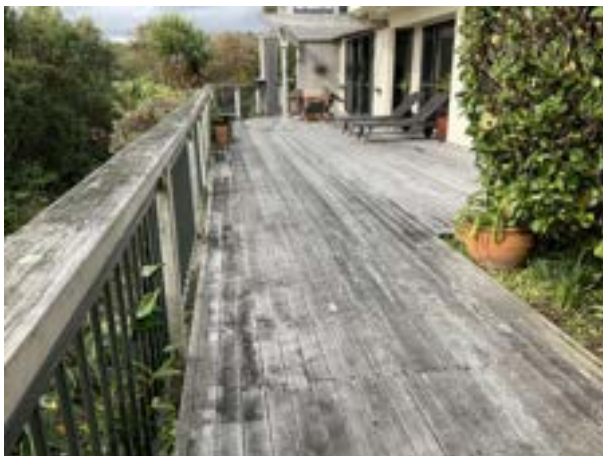
Photo 100

North side handrail is secure, functional.

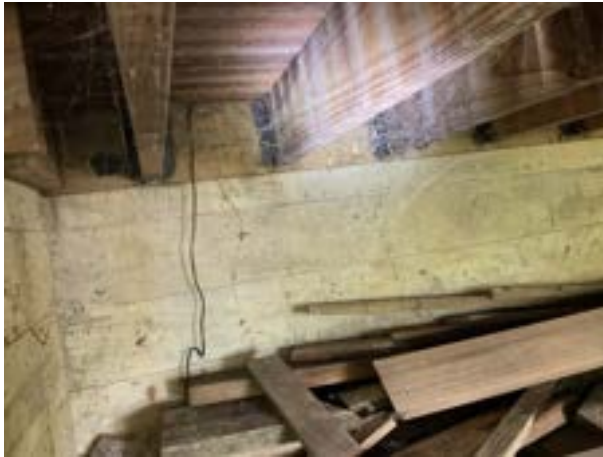
Photo 101

Subfloor area, no visible issues.

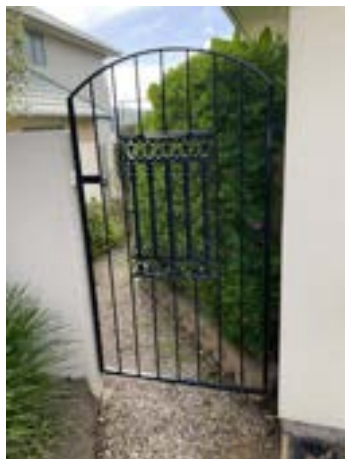
Photo 103

Southwest is functional.

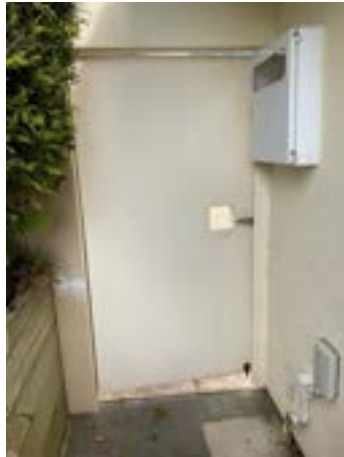
Photo 104

Southeast is functional.

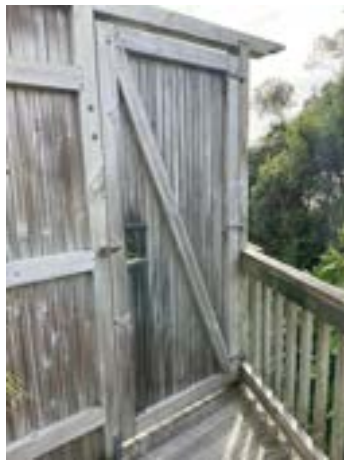
Photo 105

North side, functional.

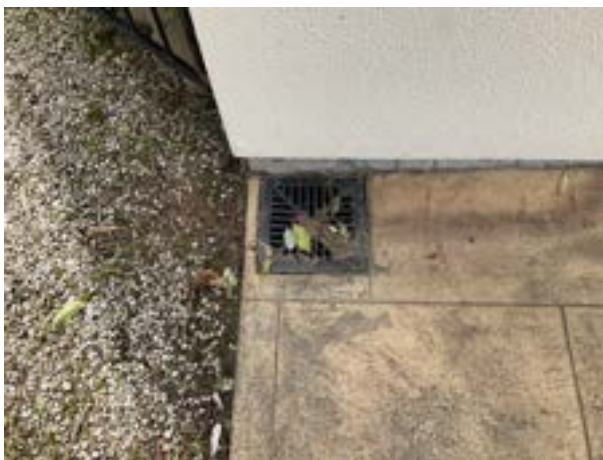
Photo 106

Southwest sump.

Keep vegetation and soils clear of drainage. Surface water needs to be prevented from flowing into a trap by ensuring that the rim of the gully dish is at least: 25 mm higher than a paved surface and/or 100 mm higher than an unpaved surface.

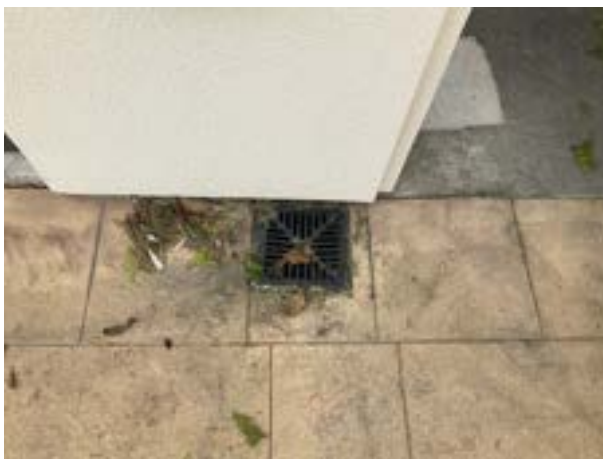
Photo 107

Southeast sump.

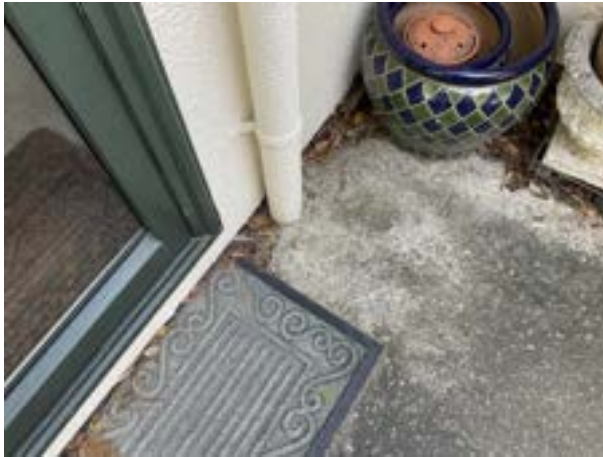
Photo 108

East side downpipe connection is not visible.

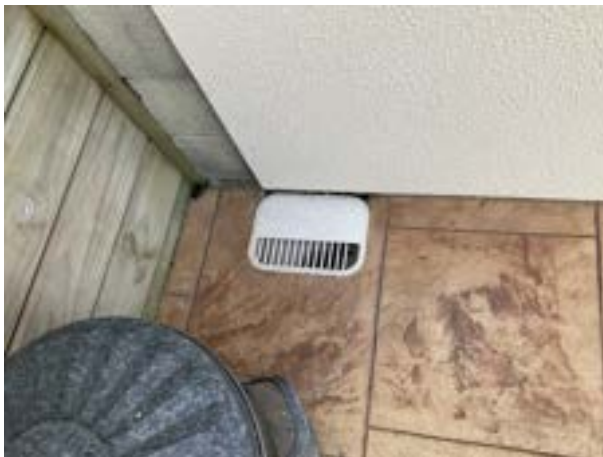
Photo 109

Southeast side gully trap is flush with the ground. the surrounding pavement slopes to gully.

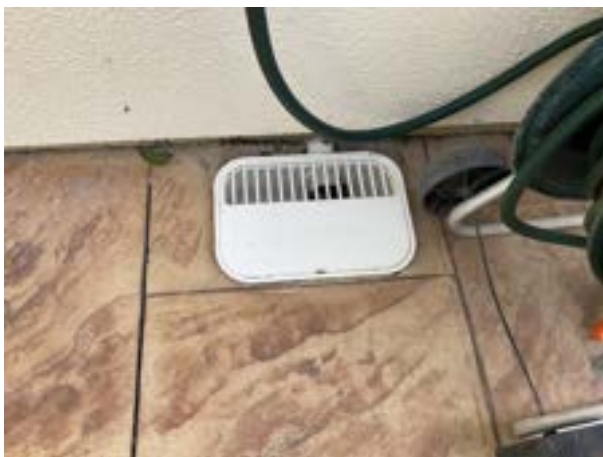
Photo 110

East side gully trap.

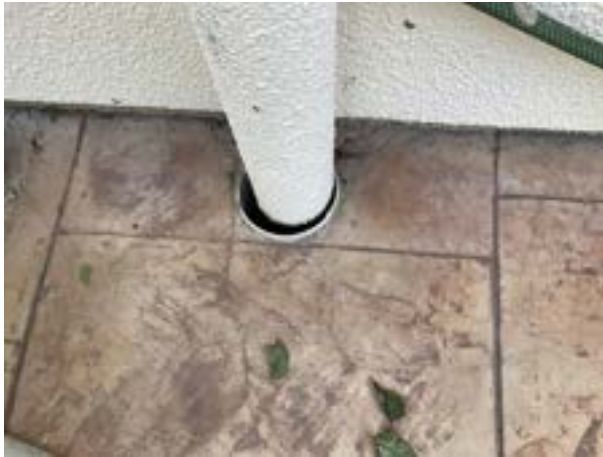
Photo 111

East side downpipe connection is visible.

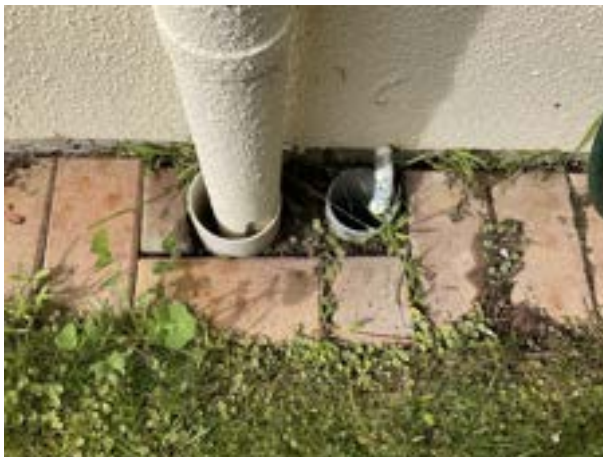
Photo 112

West side downpipe connection is visible, with hotwater cylinder overflow relief beside.

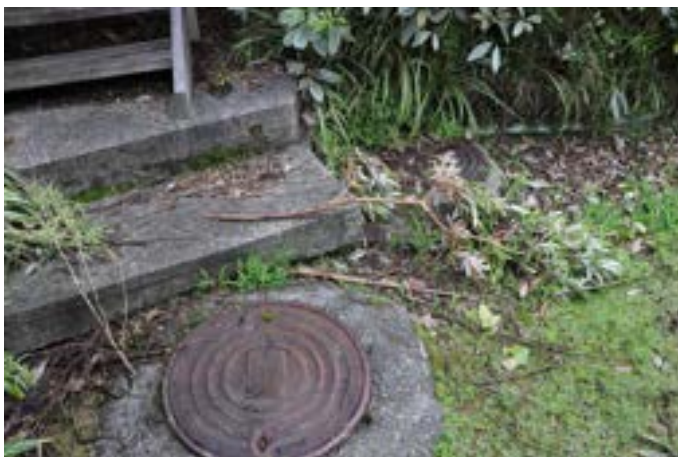
Photo 113

Two manholes located on the north east corner.

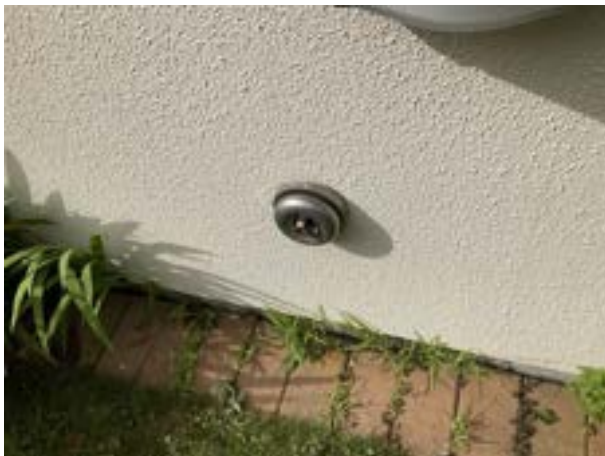
Photo 114

West side gas heater ventilation.

Service as per manufacturer's recommendations.

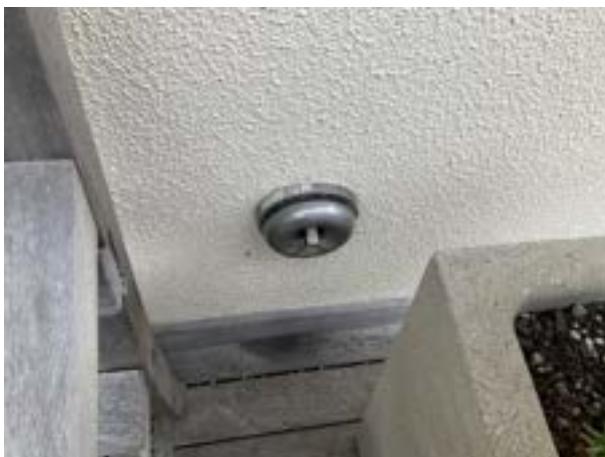
Photo 115

East side gas heater ventilation.

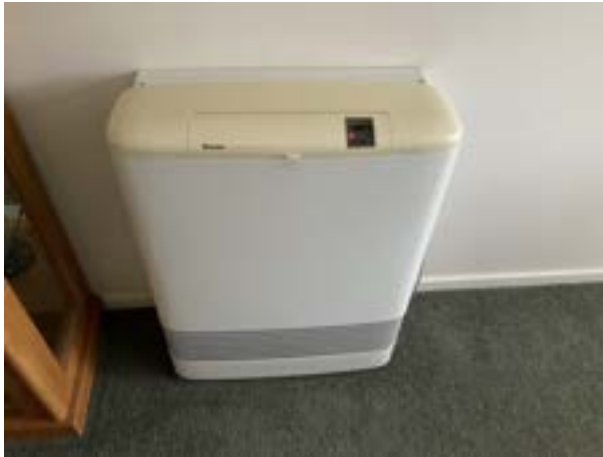
Photo 116

Gas heater located in the living room.

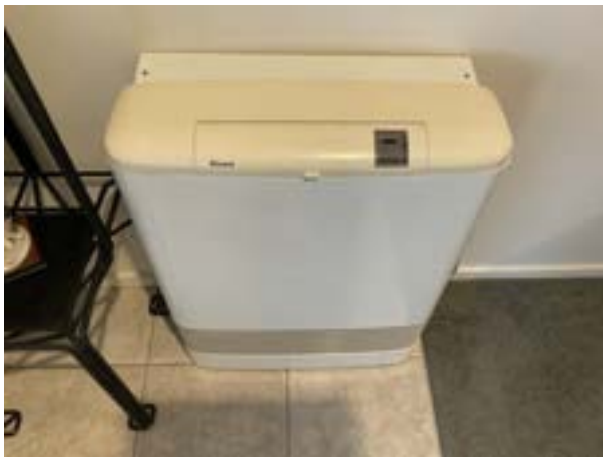
Photo 117

Gas heater located in the kitchen.

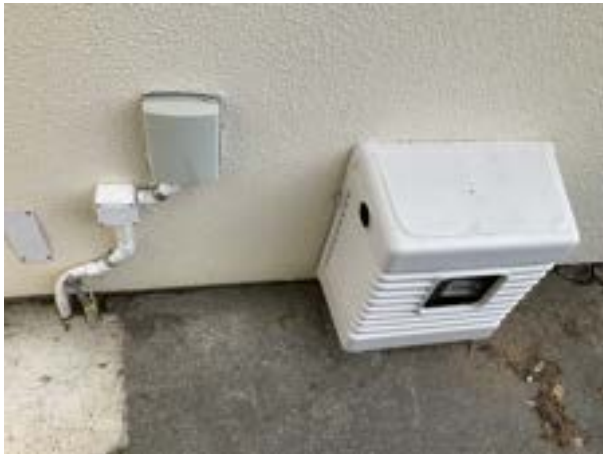
Photo 118

Data, earth stake and gas meter is located on the southeast corner.

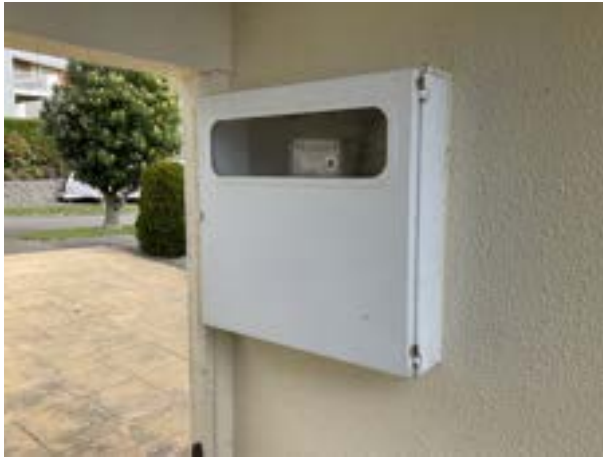
Photo 119

Meter board is located on the southeast.

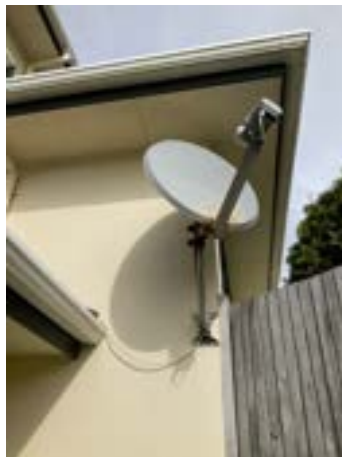
Photo 120

Sky dish is located on the west wall.

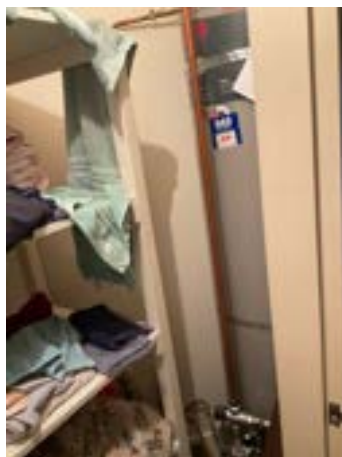
Photo 121

Hot water cylinder located in the hallway cupboard.

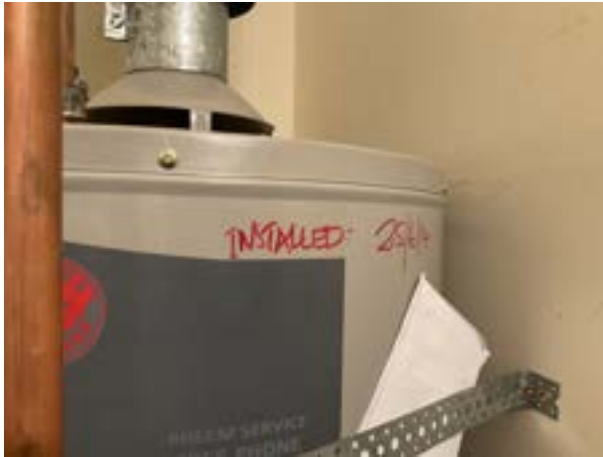
Photo 122

Gas hotwater cylinder installed in 2014, capacity is 160L.

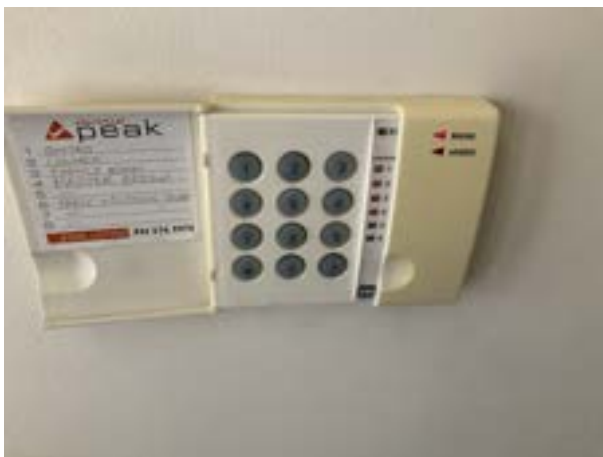
Photo 124

Security keypad is located by the front door.

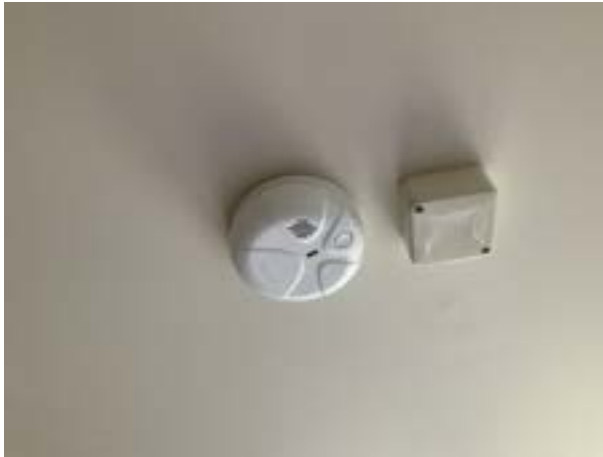
Photo 125

Smoke detector is located in garage 1.

It is recommended to install smoke detectors within 3 meters of any sleeping space and a minimum of one per level/story. Regular checks to ensure smoke detectors are functional.

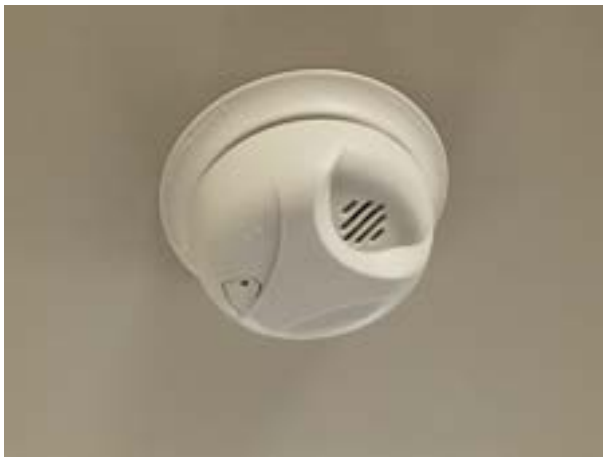
Photo 126

Smoke detector is located in the hallway.

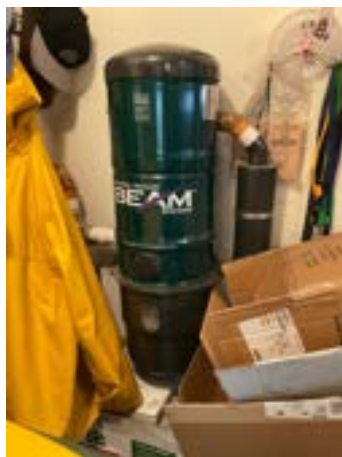
Photo 127

'Beam' brand vacuum cleaner is located in garage 2.
